1ST FEBRUARY 2017

London Underground RCF Monitoring

Andy Vickerstaff
Senior Wheel-Rail Interface Engineer, London Underground

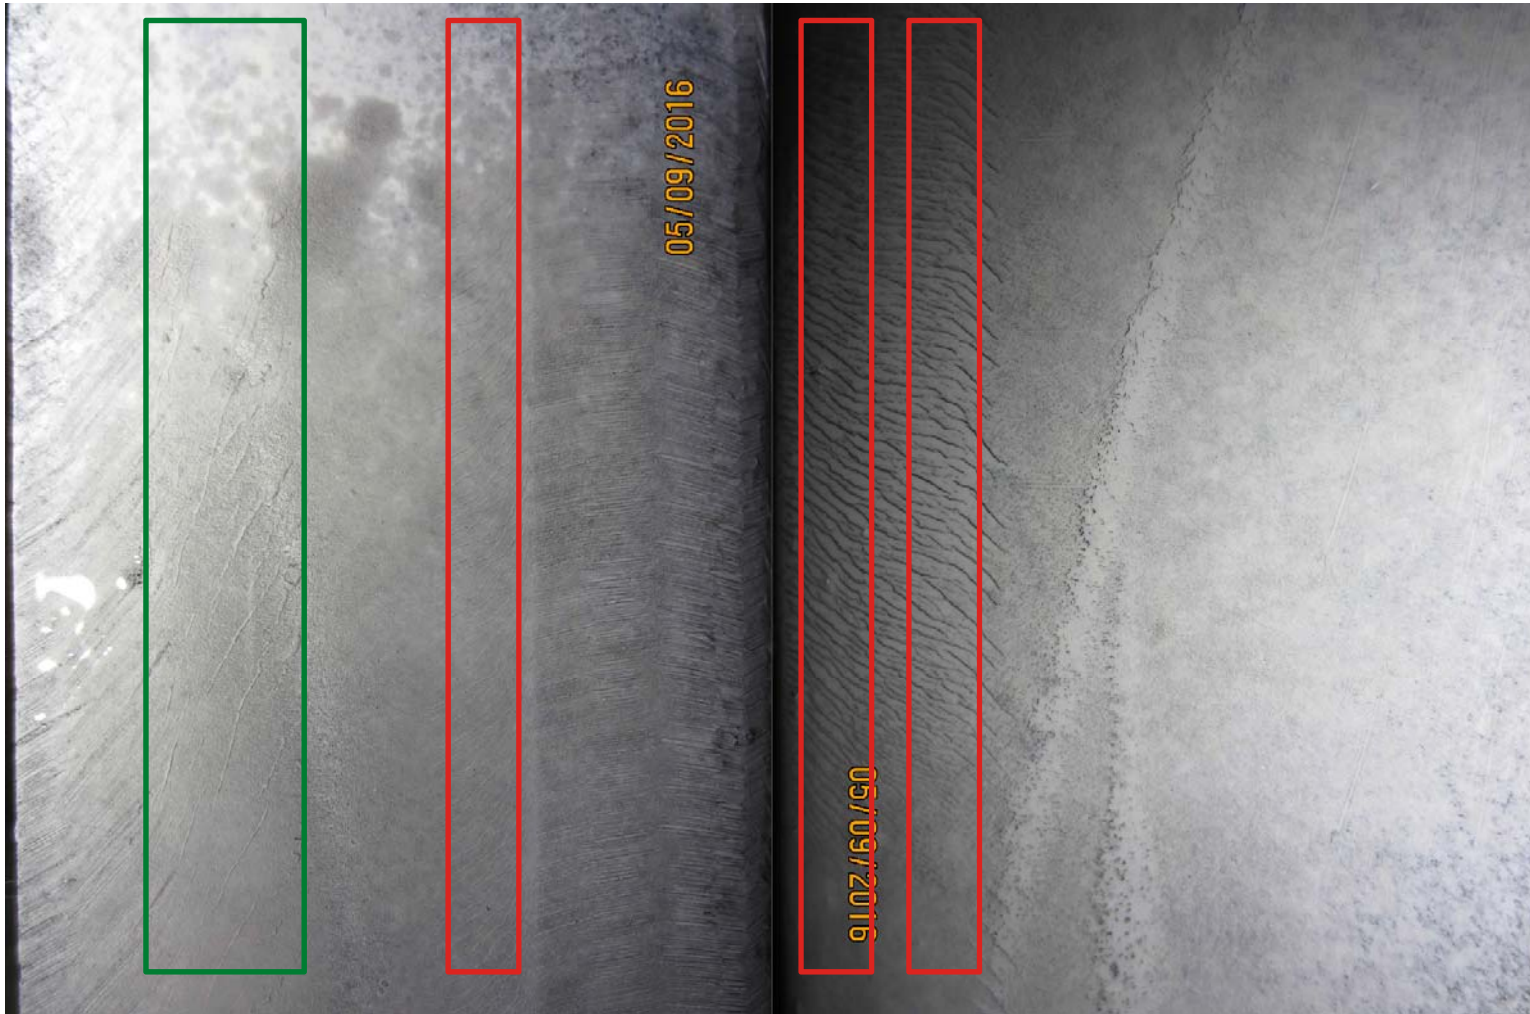
RCF-VIC-2

- No RCF appearing on RSCM
- Contact positions are all predicted by wheel-rail combinations available
- WLRM predicts 3 of 4 bands of RCF
- Rate is not necessarily accurate as rail should have 'failed' based on these results
- Very dynamically unstable with new bullhead rail, very high conicity for small lateral shift
- Only one set of friction values run but.....

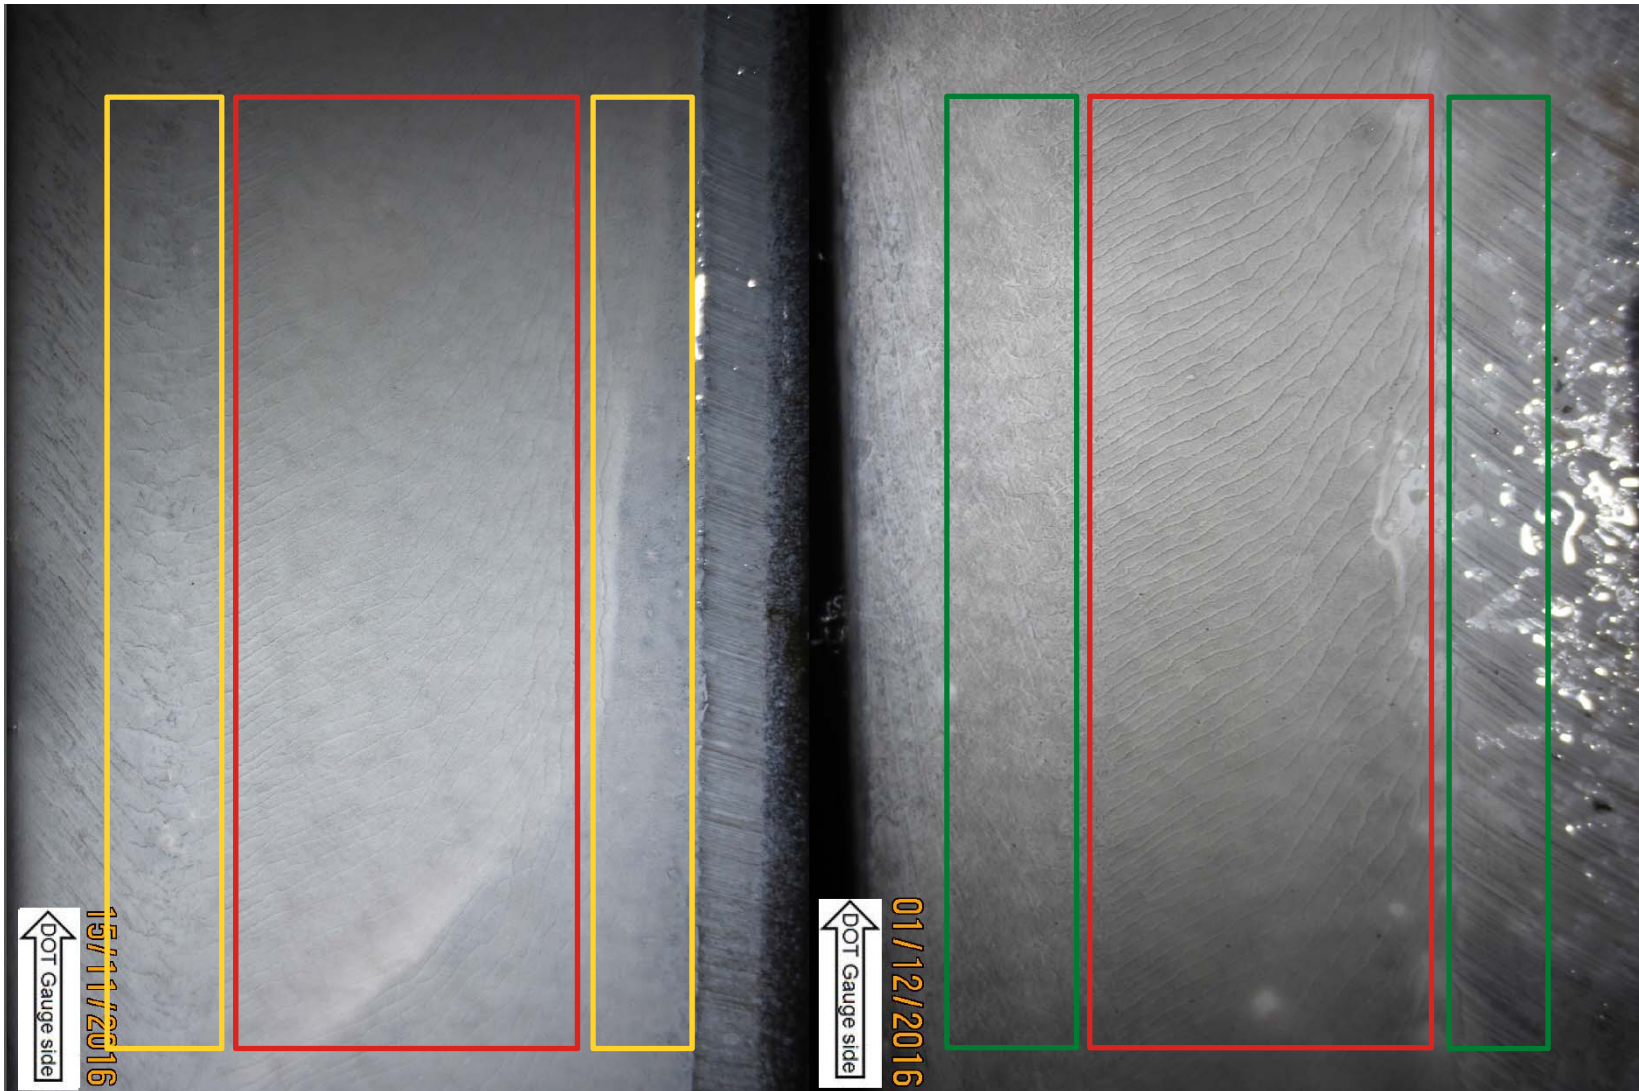
RCF-DIS-6 - Low Rail

- Reduction in T_y between pre and post grind
- No RCF appearing on RSCM
- Some cracks removed from low rail gauge corner from 0.35mm removal
- WLRM predicts low rail RCF but again should have 'failed'
- High rail should be in wear region?
- Crack density historically more likely to result in UUR at this site

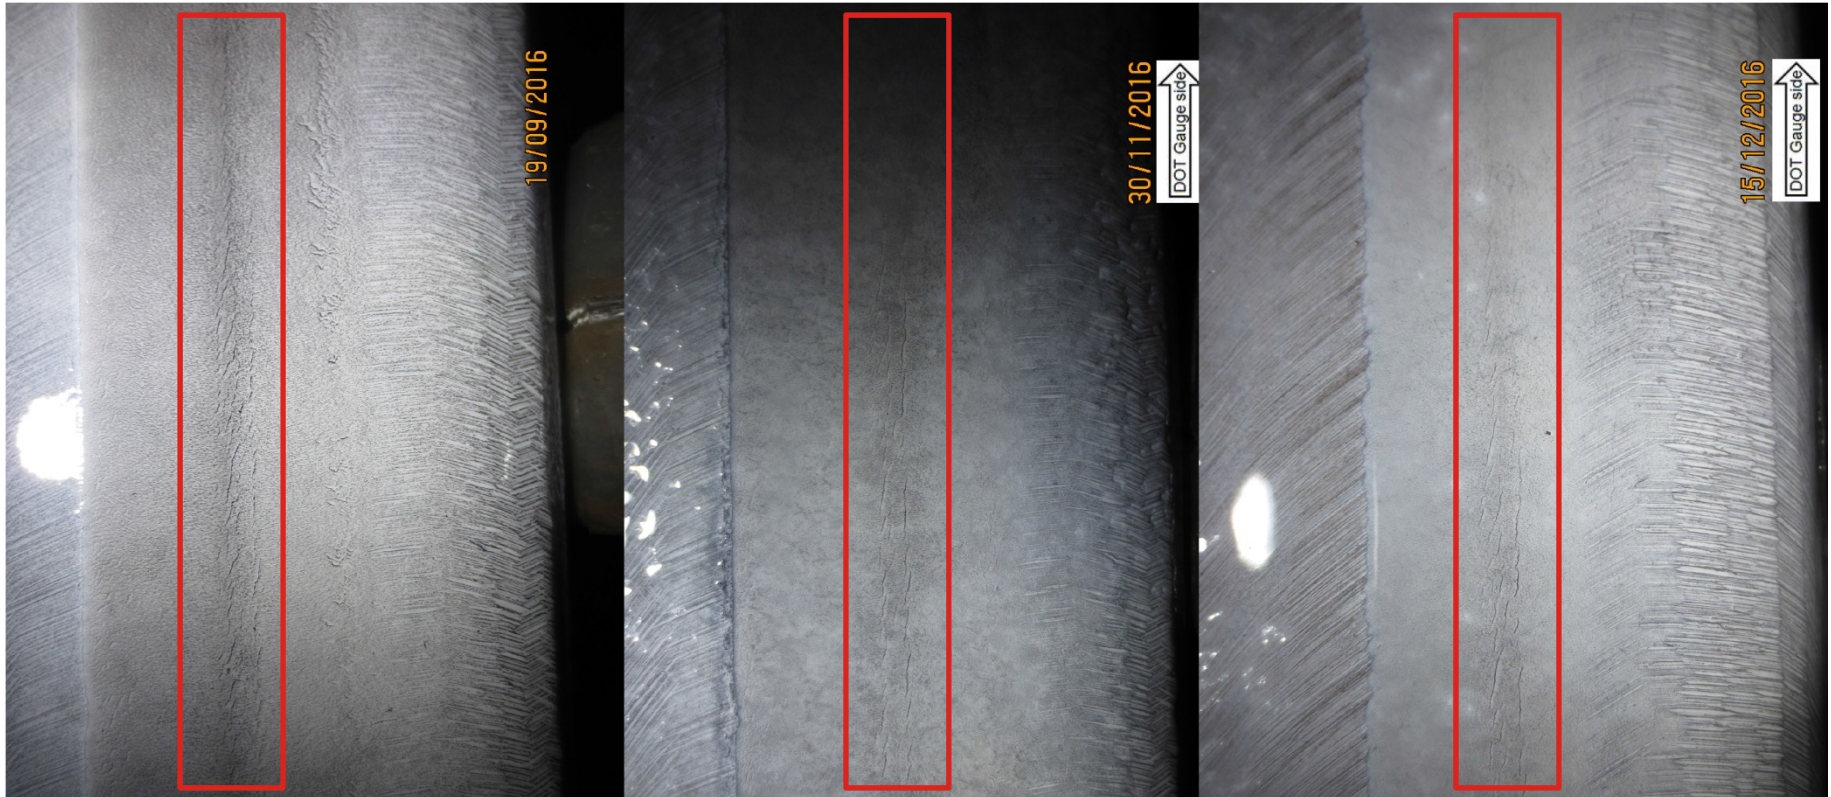
RCF-DIS-12: 670 Low Rail

- WLRM predicts high rail should be in wear
- Cracks have developed but then potentially have been worn out?
- WLRM predicts low rail should develop in transition (670) but not curve itself (720)
- Linear grinding method appears to have removed some cracks
