Grinding-induced Rolling Contact Fatigue in Rails

Carsten Jørn Rasmussen

COWI

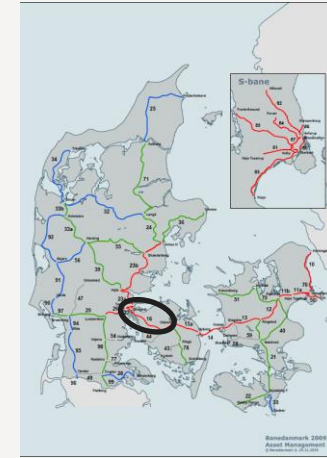
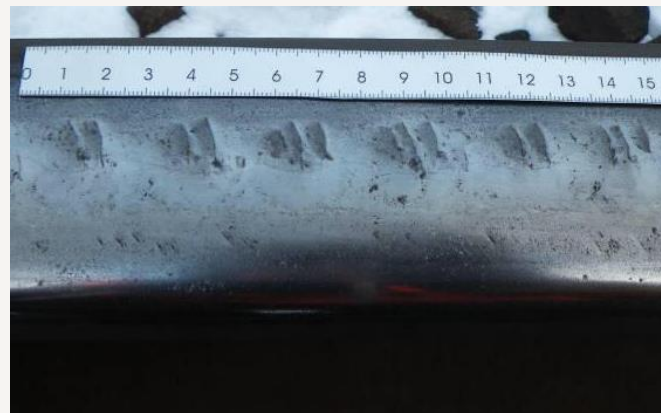
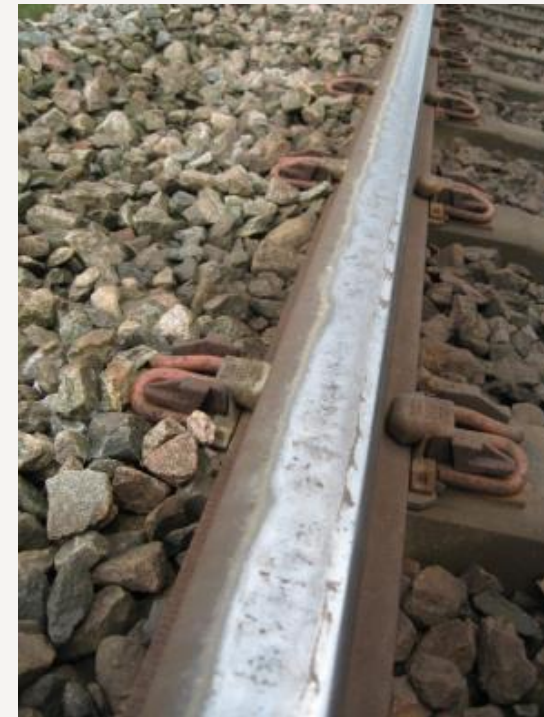
Case 1) Odense-Middelfart

- › Cracks found in 2010 after 72 MGT
- › Curves with R350HT rails
- › Mixed traffic – passenger/freight
- › 12 MGT per year

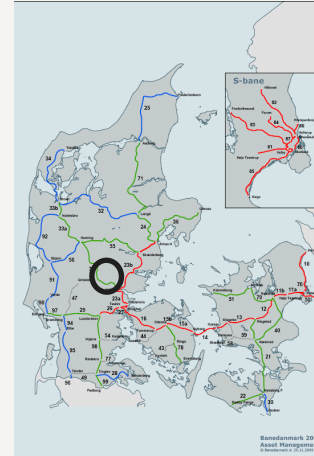
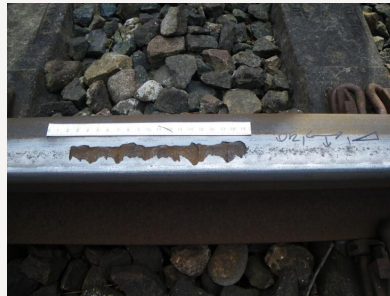
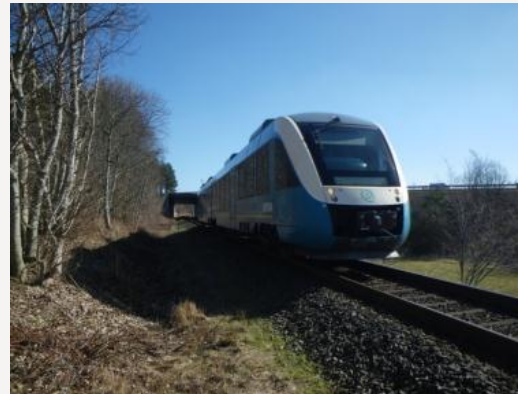
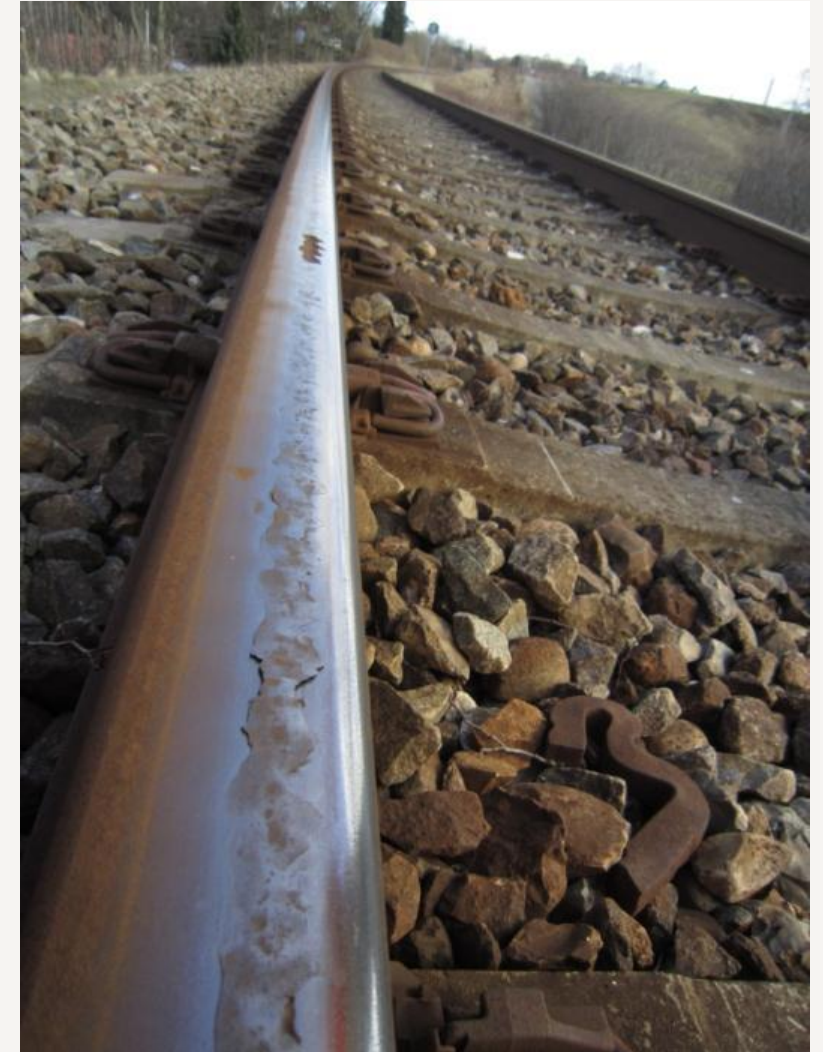
Case 2) Single track

- › Cracks in 2011 after only 20 MGT
- › Curves with R350HT rails
- › Lint41 - light passenger train
- › 2 MGT per year

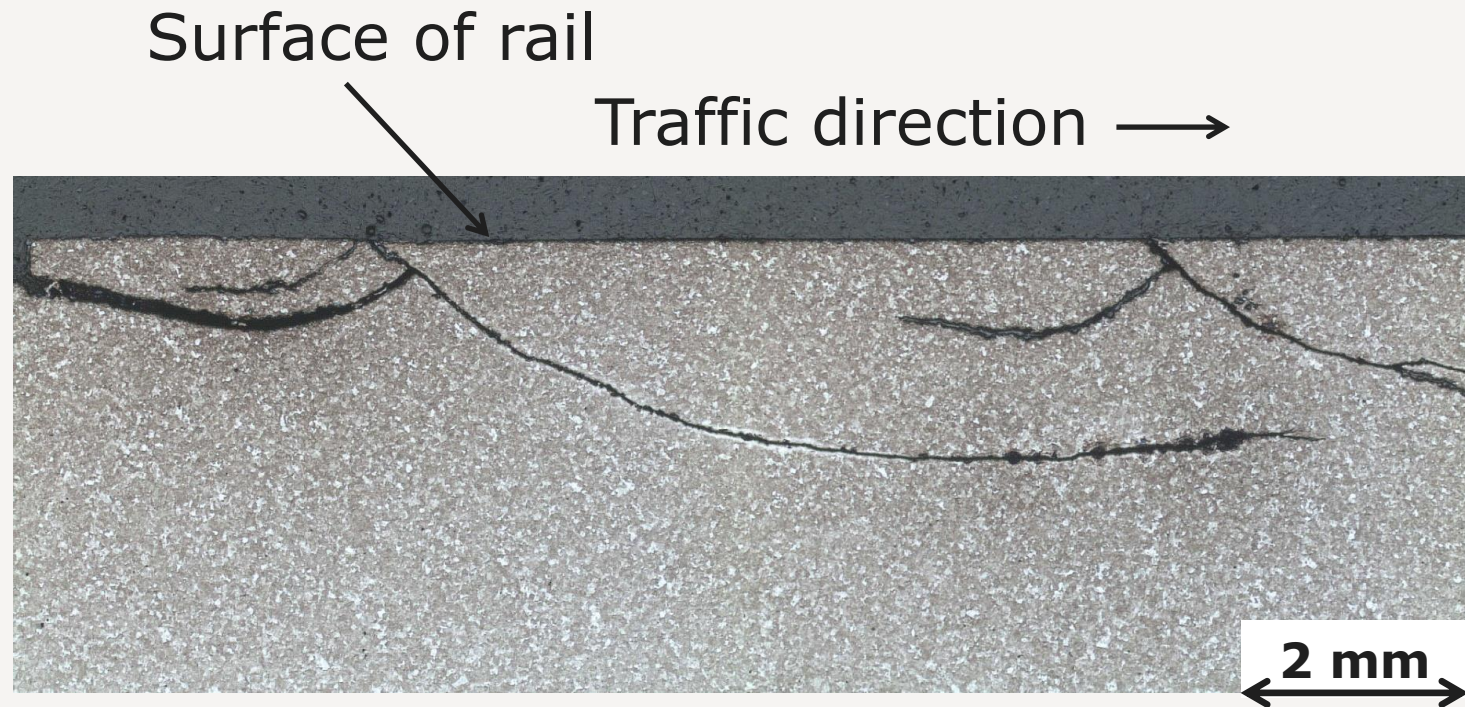
Spallation

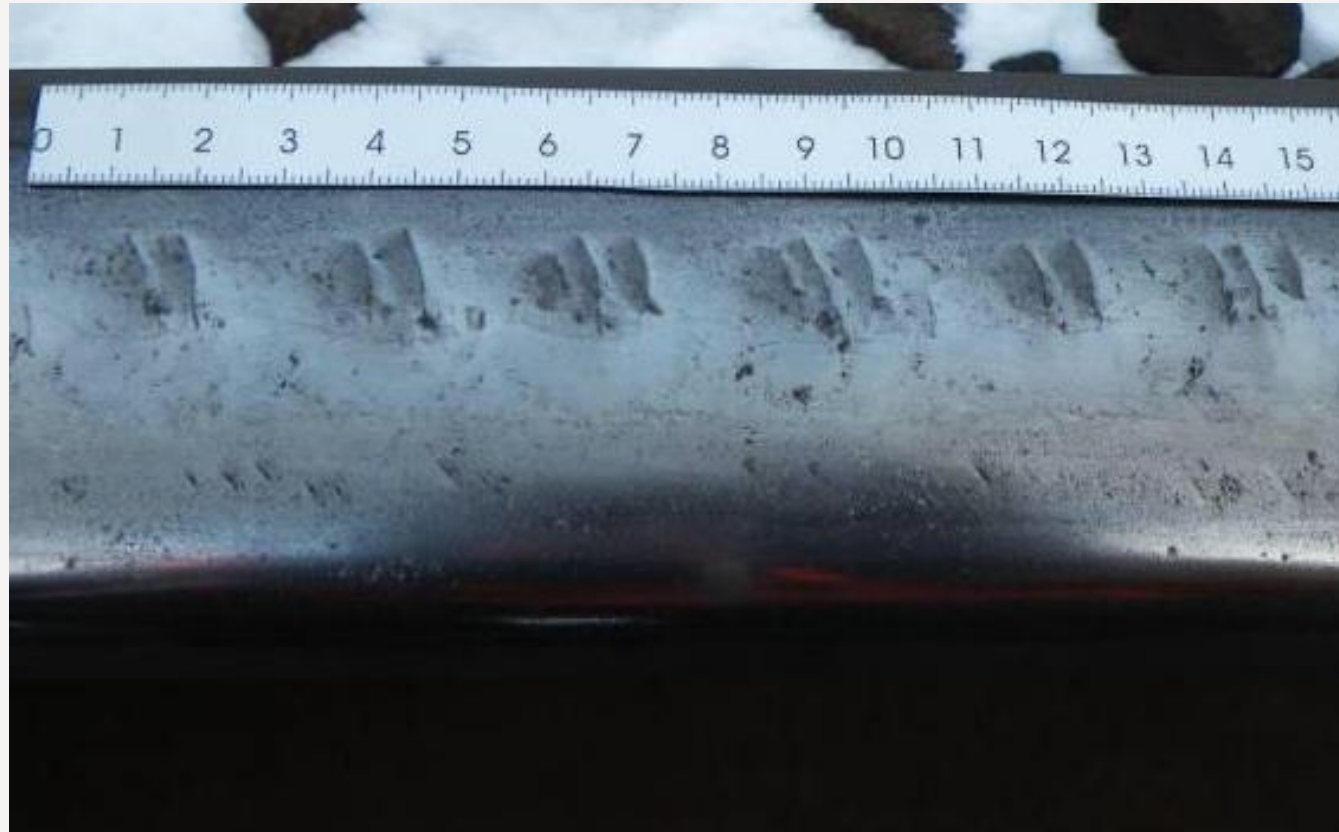
Longitudinal cut in R350HT rail

Periodic cracks of 25-30 mm !

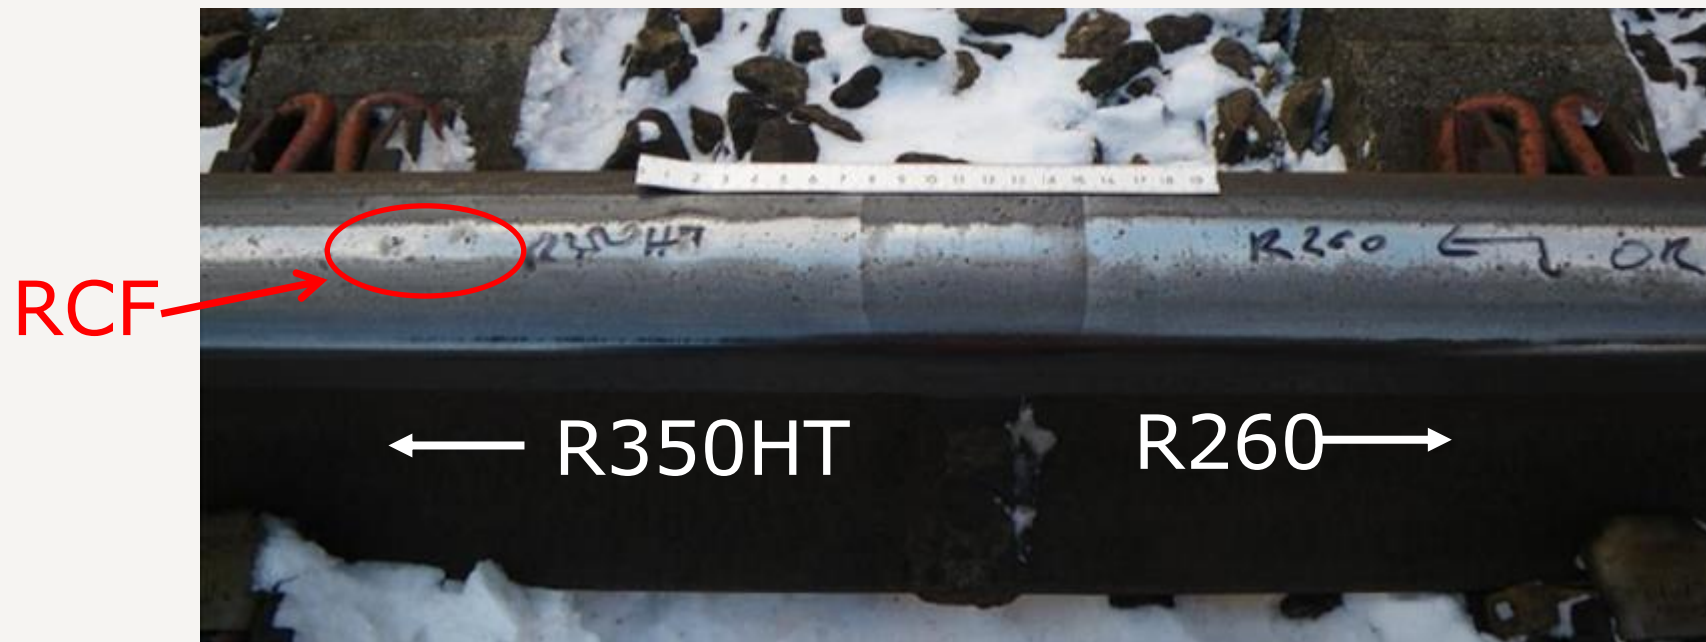
Transition weld between R350HT and R260

Also on straight track!

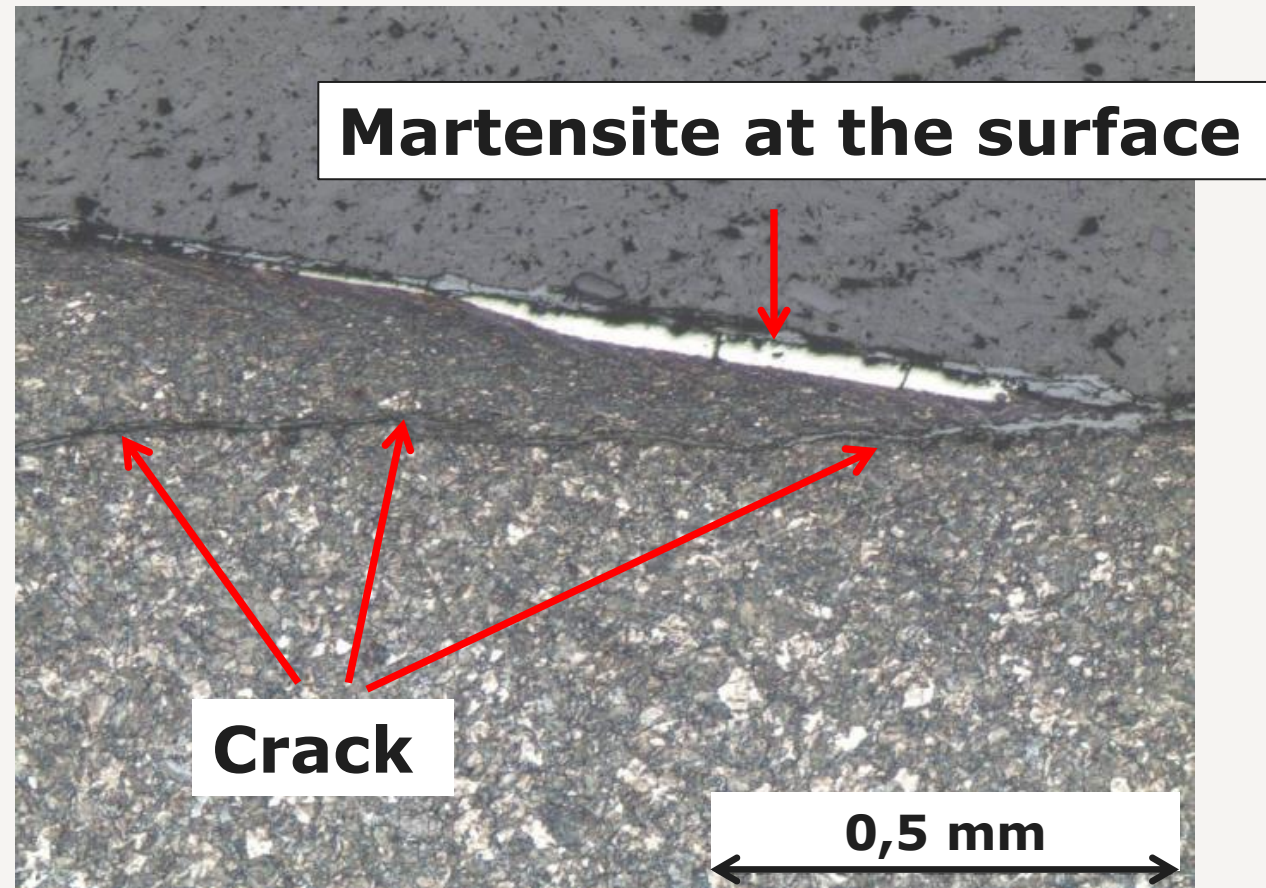
Transverse cut through a crack

- > Cracks initiates in transition zones between pearlite and martensite.
- > Must be found and cut out in a very early stage.

Martensite at the surface

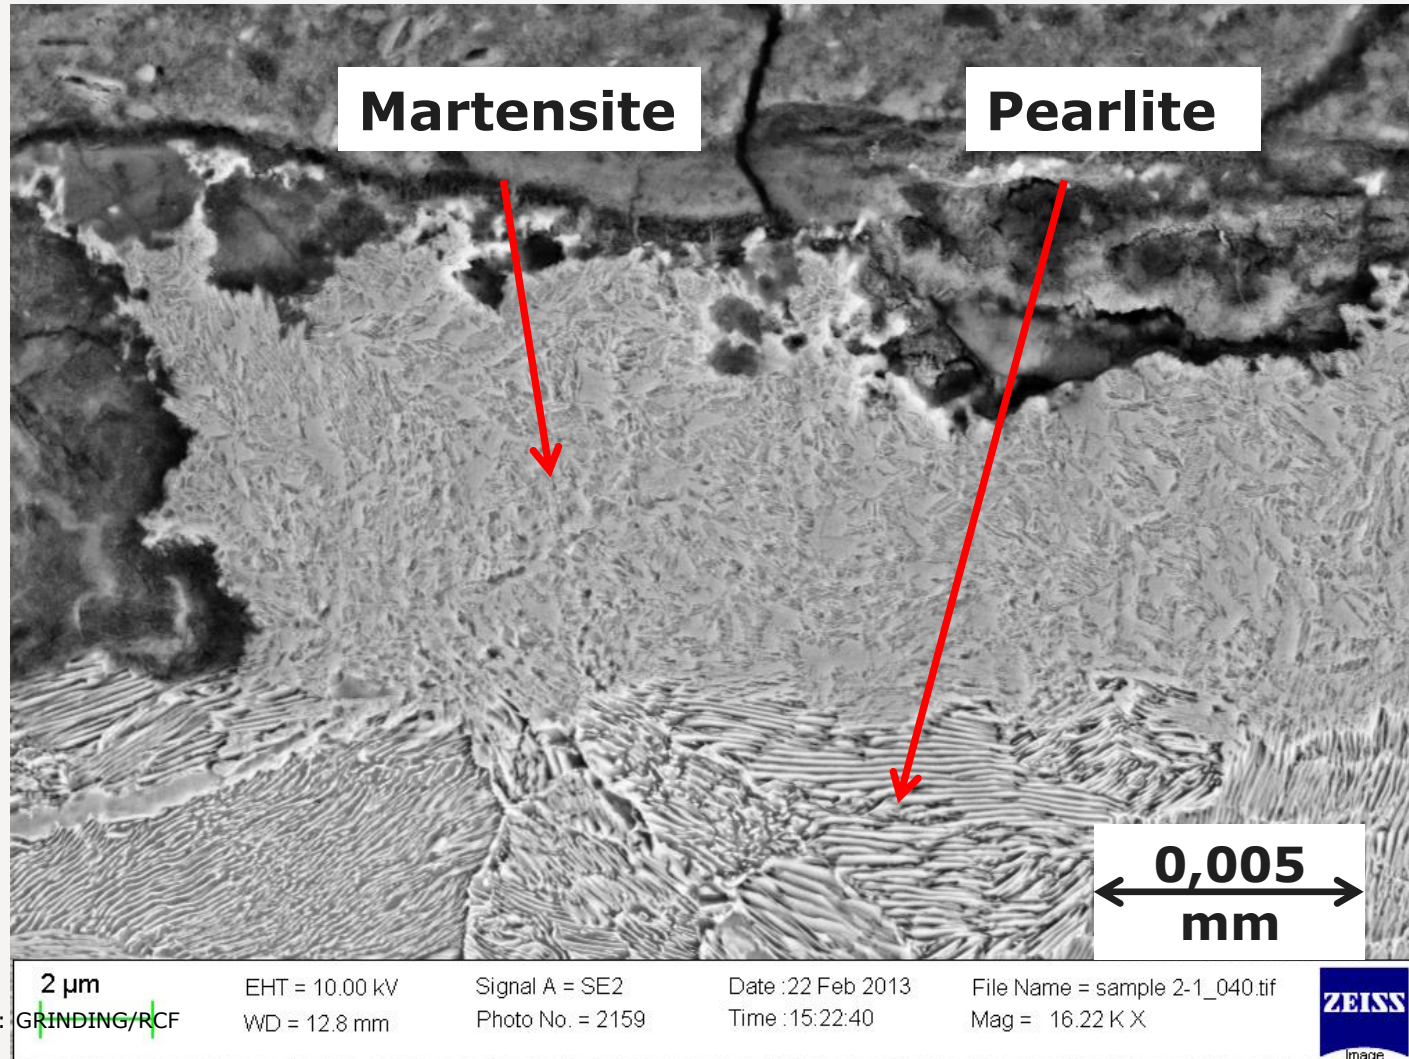
Transverse cut through a crack

Martensitic structure

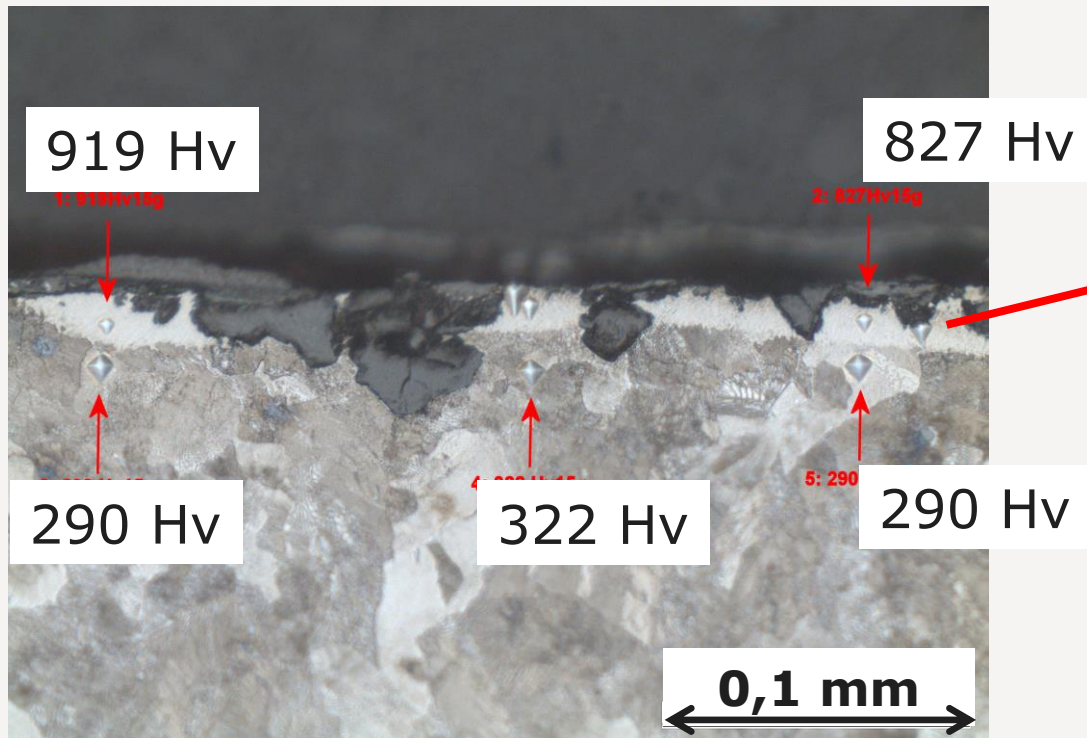
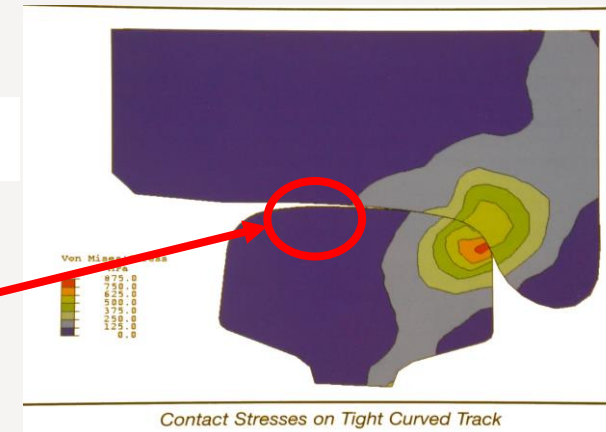
By coincidence in 2011 martensite (WEL) was detected outside wheel/rail contact band in a grinded area.

First indication of grinding induced martensite in rails!

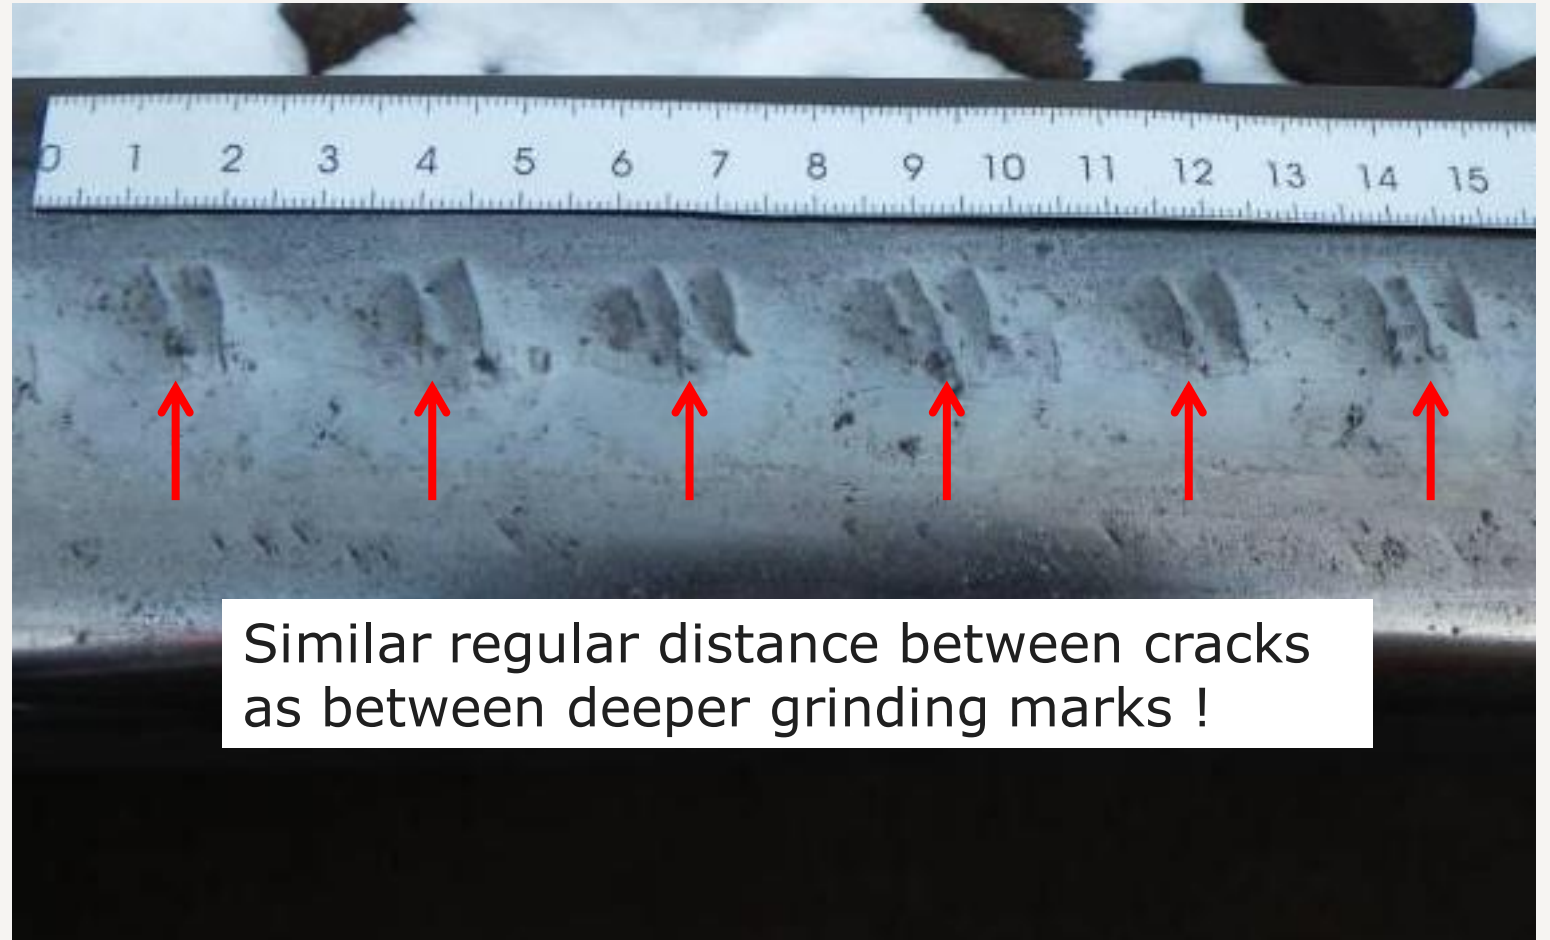
Periodic cracks

- > Cracks with periodicity of approx. 25-35 mm.
- > Similar distance as deeper grinding marks!

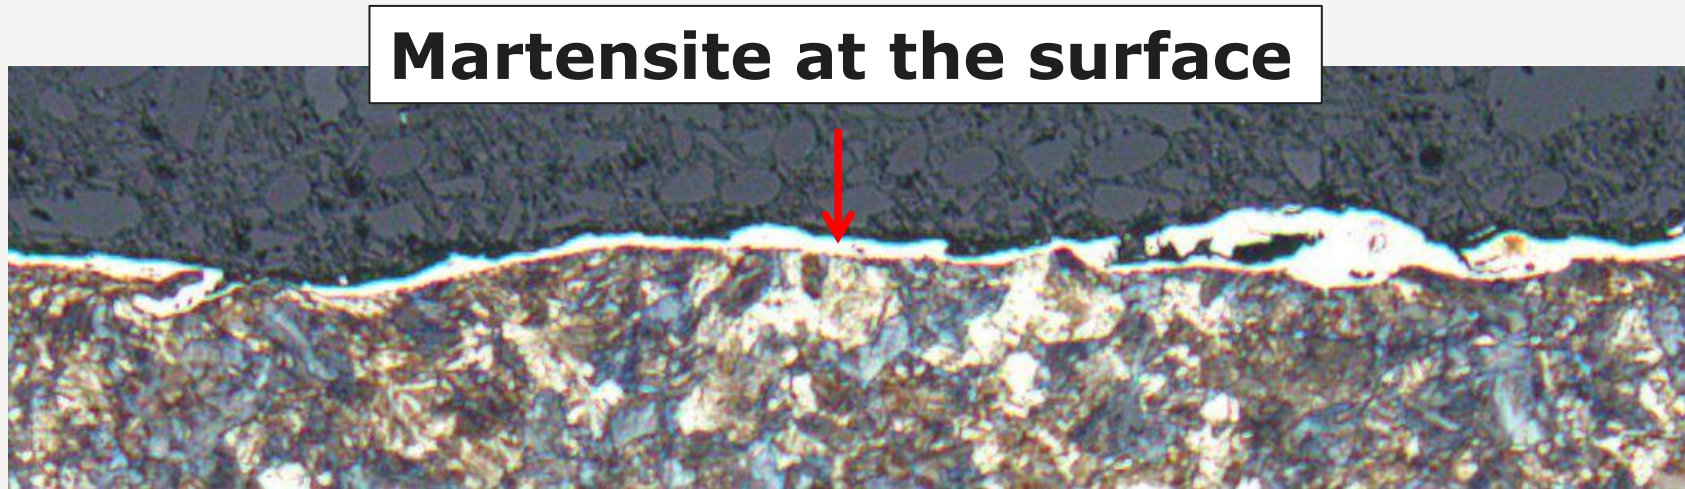
Longitudinal cut in R350HT

Martensite in both R350HT and R260 from the grinding process!

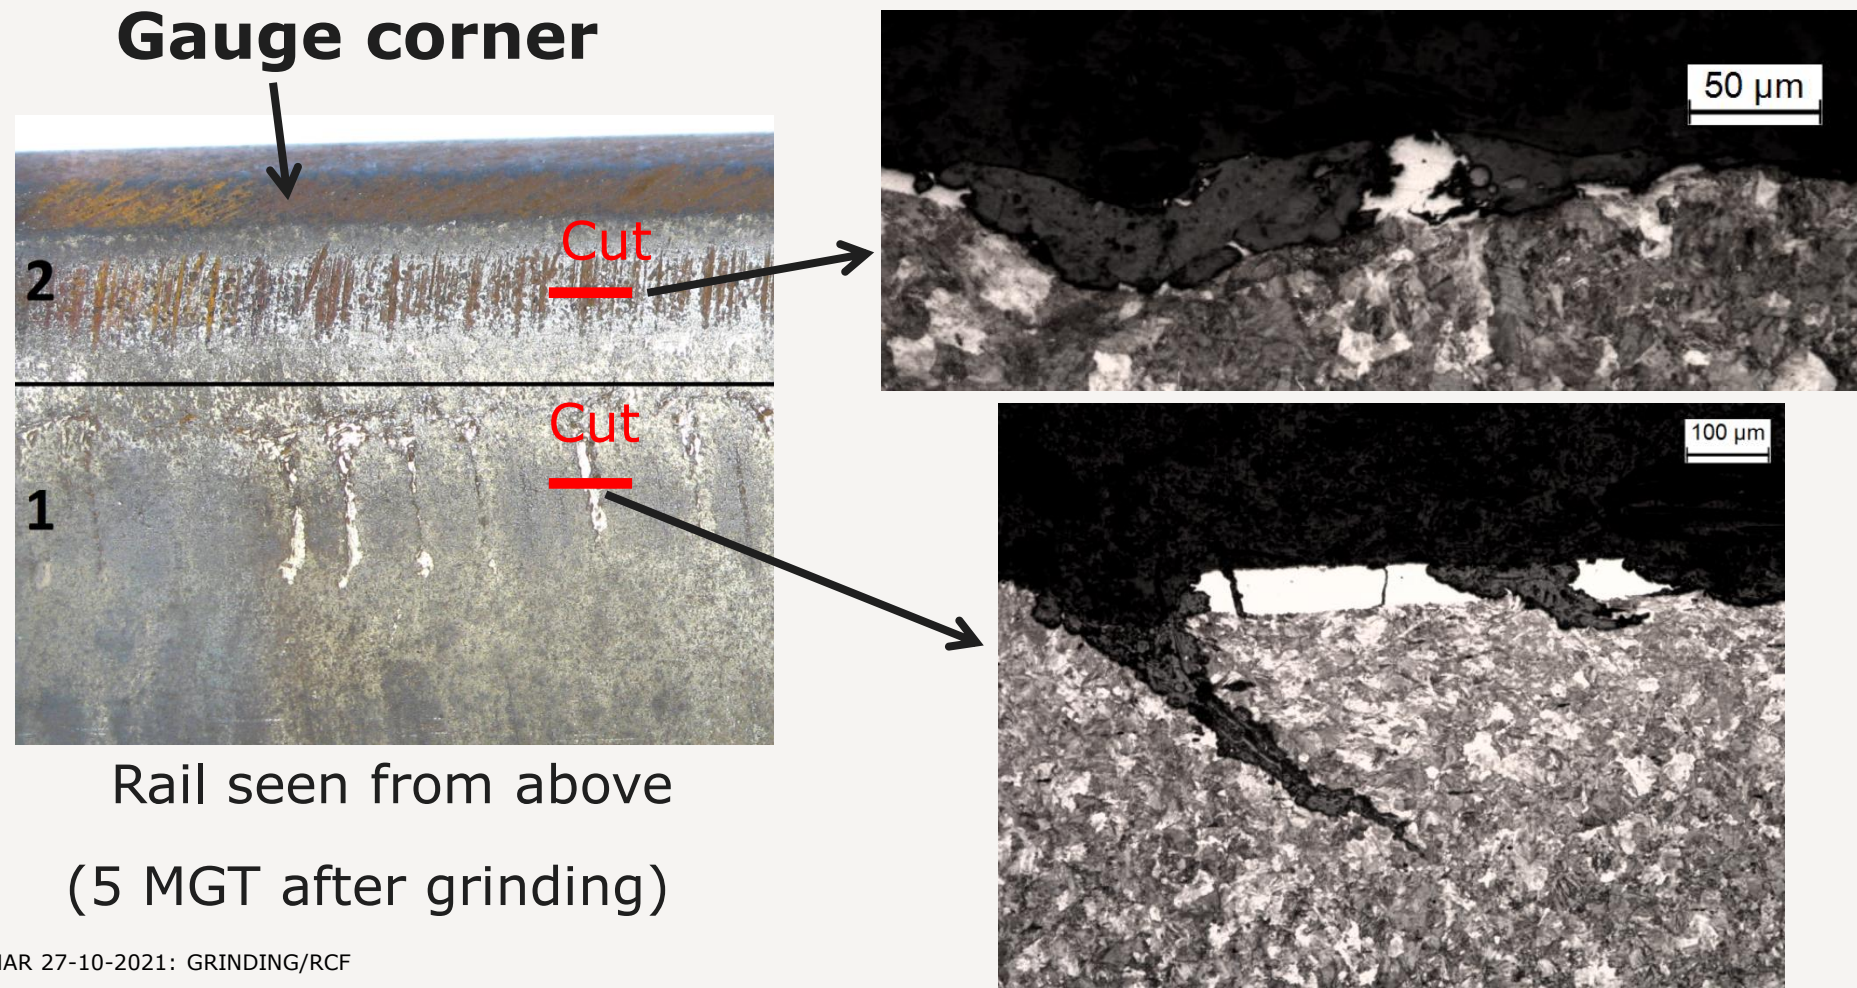
Grinded in 2010
Extracted in 2012
Total traffic: 5 MGT

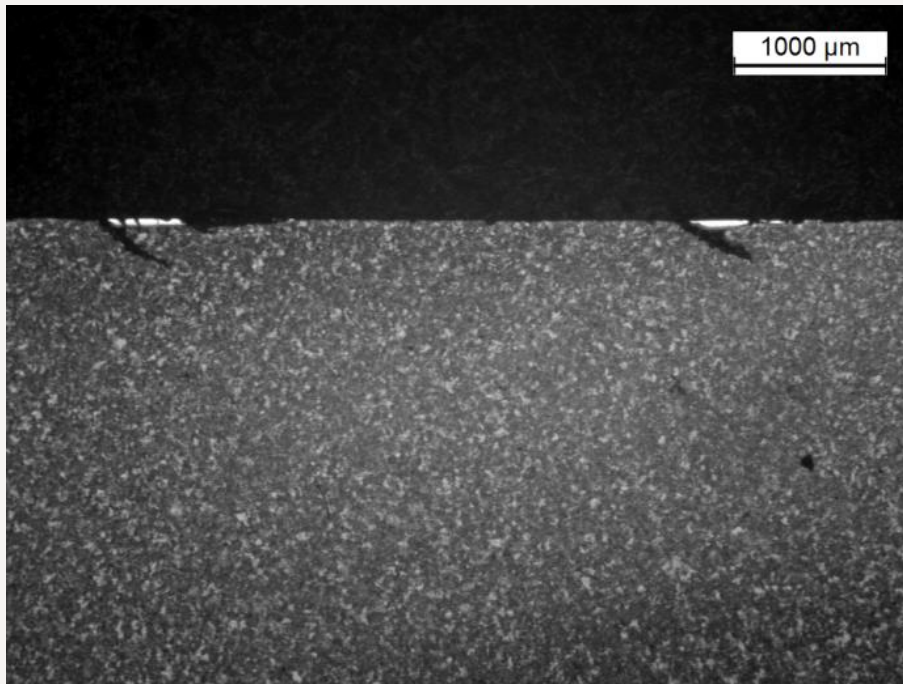
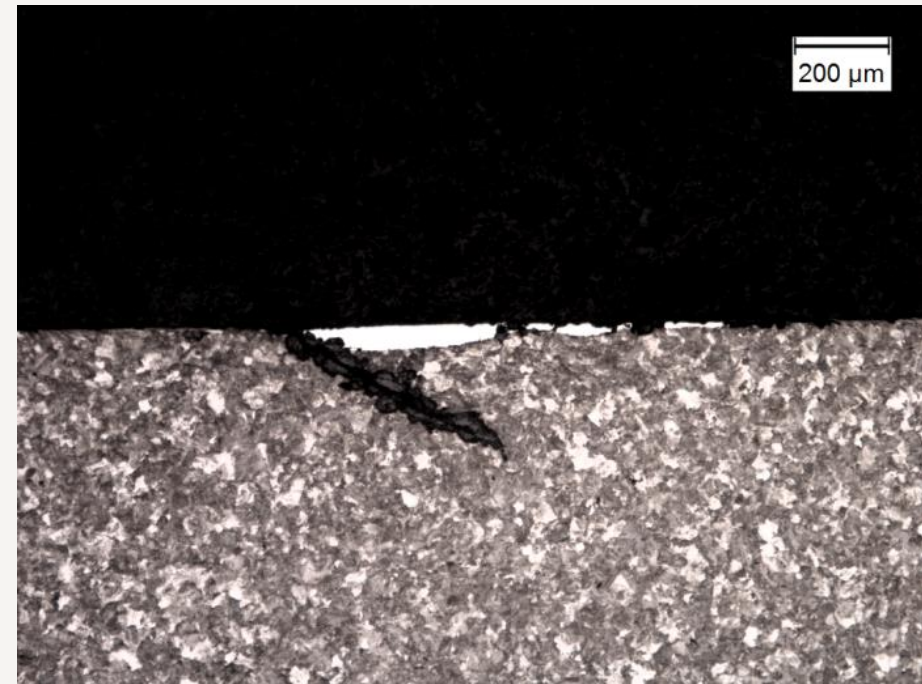
Cracks initiated at transition between martensite and pearlite in grinding marks

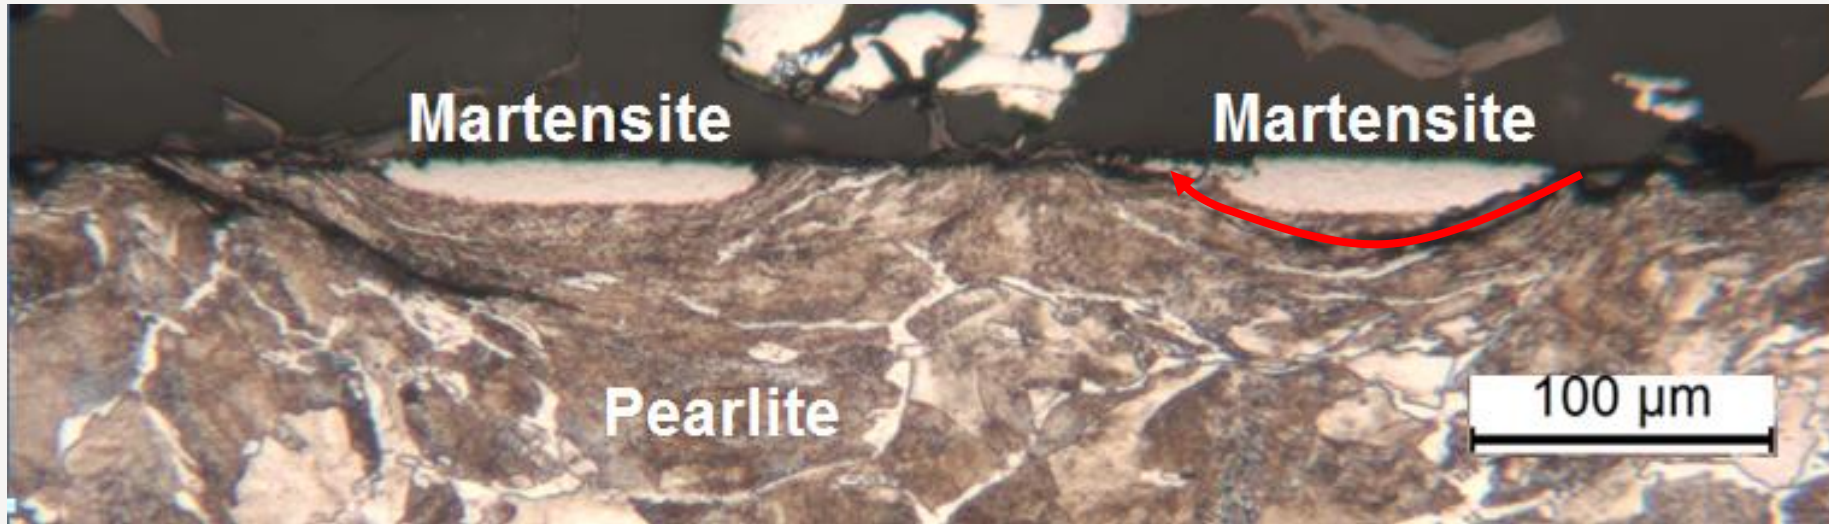
Martensite with cracks in R200

- > The martensite (≈ 1000 Hv) from grinding seems to be pressed down in the 5 times softer perlitic R200 resulting in plastic deformation under the martensite.
- > Cracks turn up with spallation to be expected.

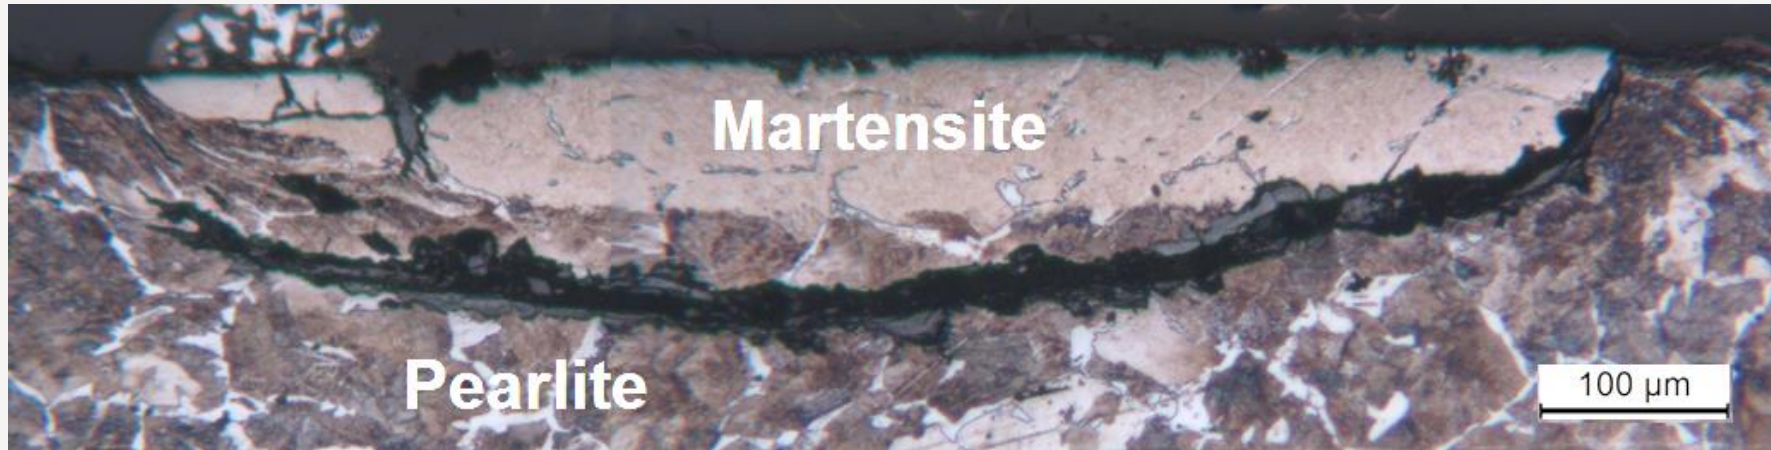
Martensite with cracks in R200

Cracks turns up - spallation to be expected
