# Effects of the lack of rail grinding on the rail maintenance

Henrique Carou
Specialist Engineer
MetroRio
hcosta@metrorio.com.br

#### Case study of a metropolitan system

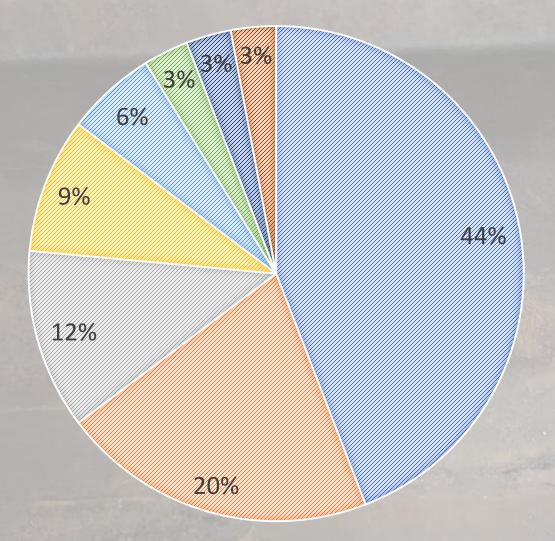
#### Causes of rail fracture

- **RCF**
- Pré aquecimento da solda
- Fuga de corrente
- Fadiga mecânica
- HOT TEAR
- falha de vedação no cordão da solda
- Fragilização por Inclusão de material da solda cadweld no metal base do trilho

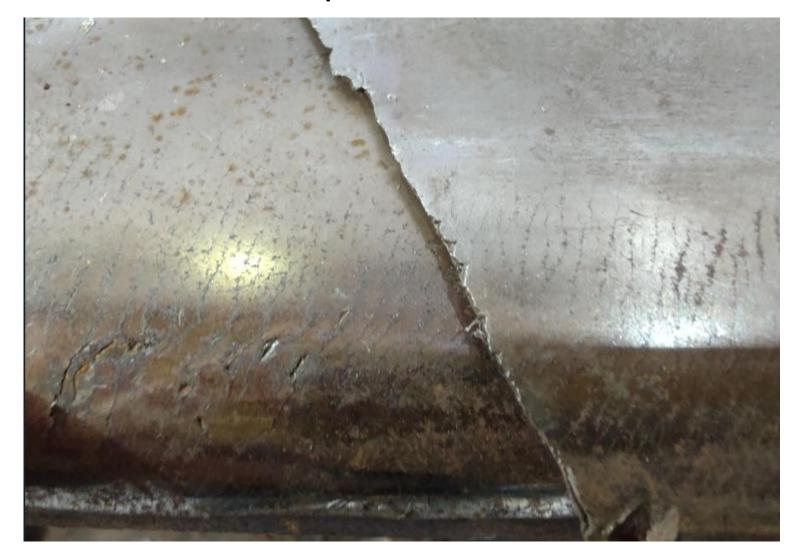
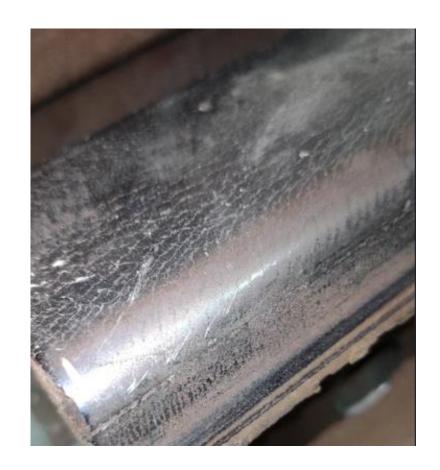
#### RCF examples

### RCF Control / Treatment

- Rail reprofiling
  - Growth prevention
  - Wheel x rail contact maintenance

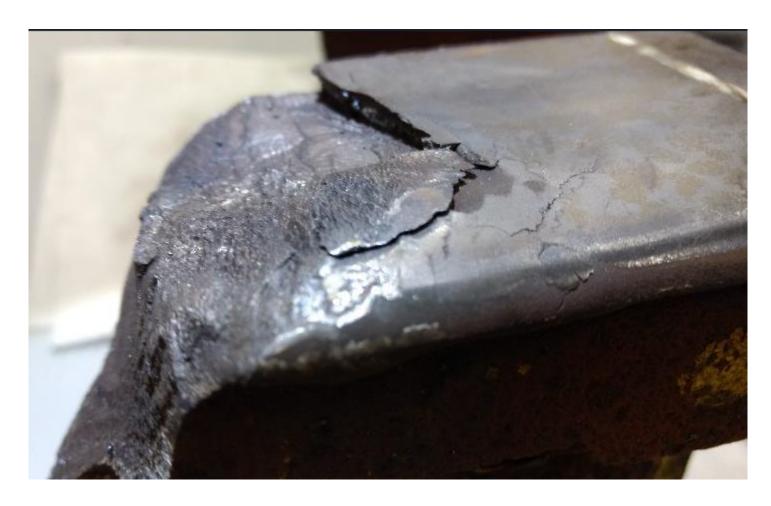
#### Fractures Examples
