# **Squat-Type Defects in Light Rail: Experiences in Inspections, Laboratory Tests, and Maintenance Approaches**

**Presentation to ICRI - CM**

**20 September 2025**

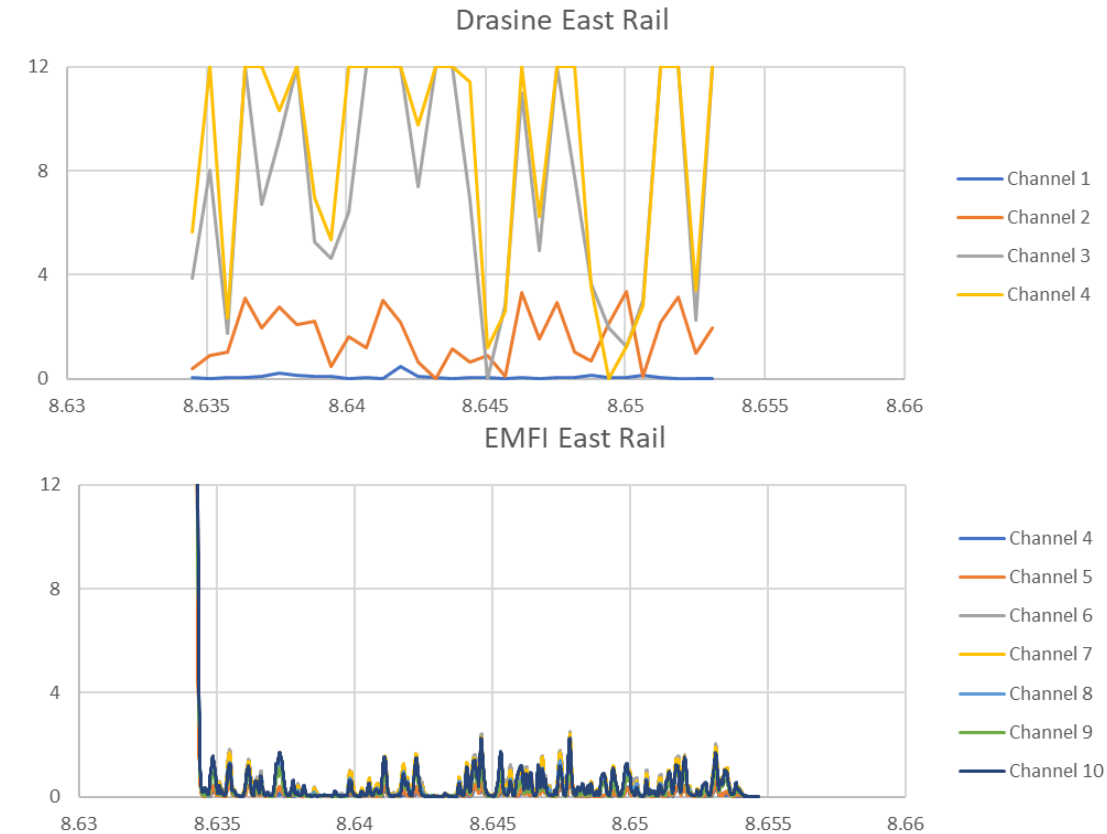
- EMFI tow behind unit was trialed and returned almost zero defects
  - Further calibration is required and the technology still could be promising
- Ongoing scope of work to calibrate technology
  - Better pick up studs and possible rail head weld repairs (to pre-emptively map out possible locations for future failures)

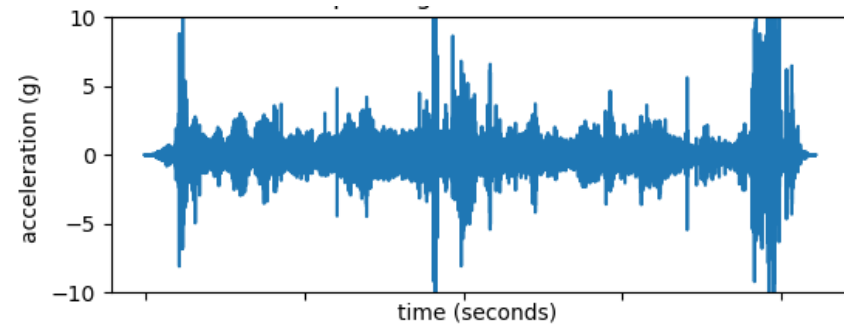
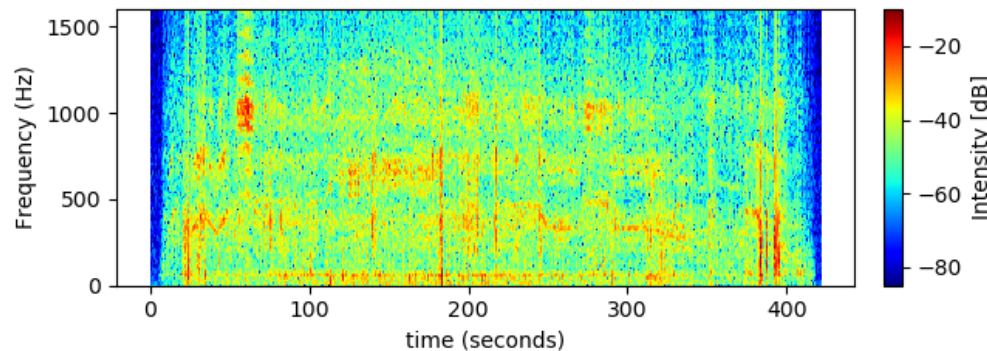
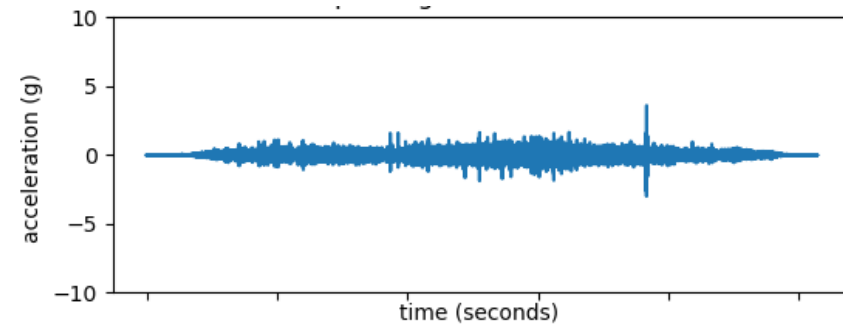
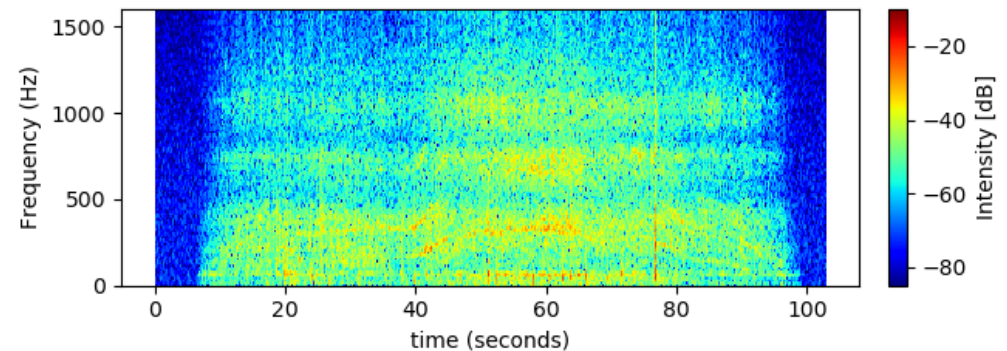
- Axle box accelerometers can give some information on areas with the presence of these defects

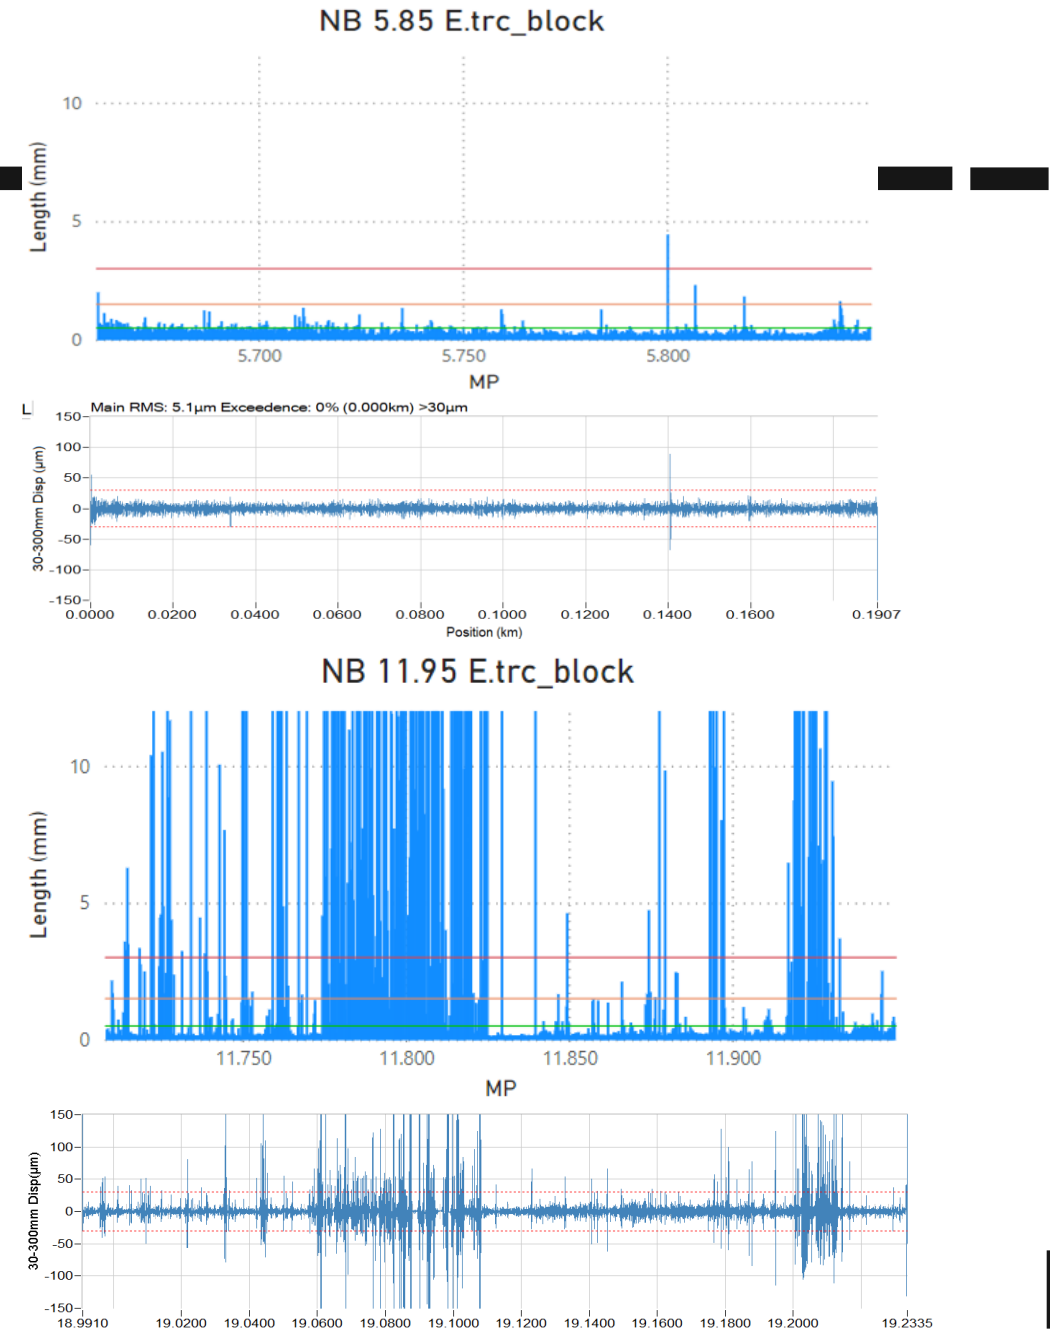
- Rail roughness measurements taken regularly in tandem with Eddy Current measurements
  - Mapped out and identified squat-type defects almost as reliably, possibly more-so as depressions form in the rail head without exposed cracks
  - If EC can't provide meaningful depth values for studs then perhaps rail roughness measurement can be just as useful to map out and rank for severity

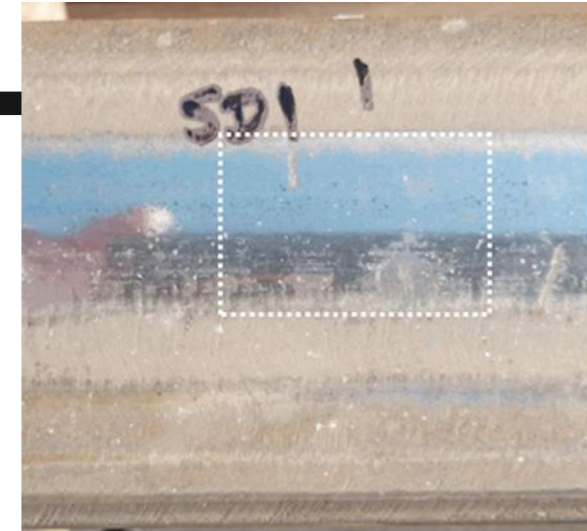
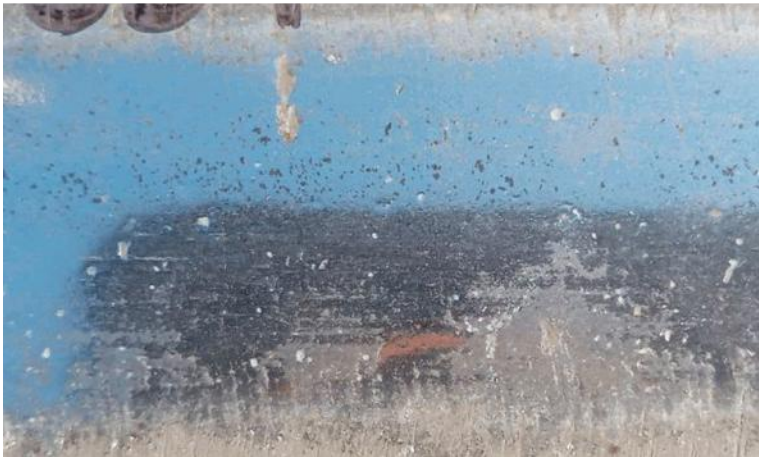
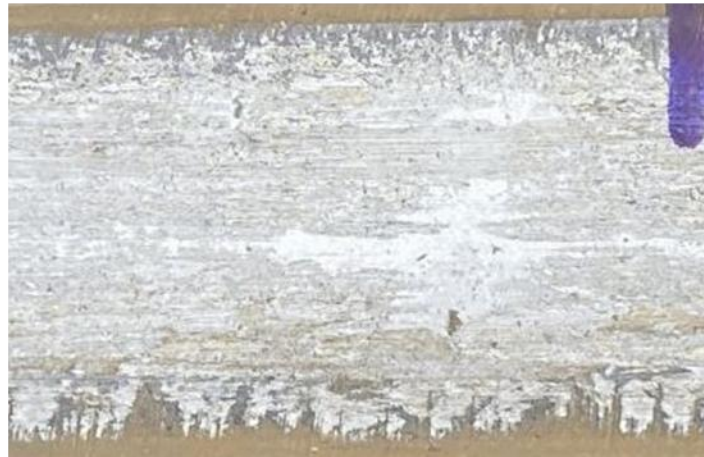
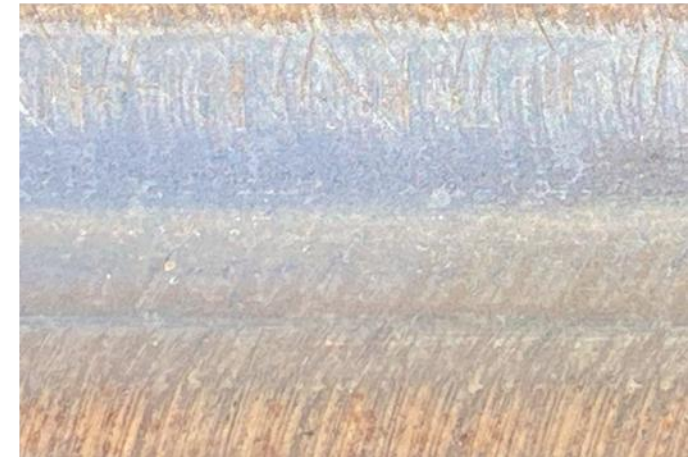
- Sight ground a month or two before inspection in July 2025

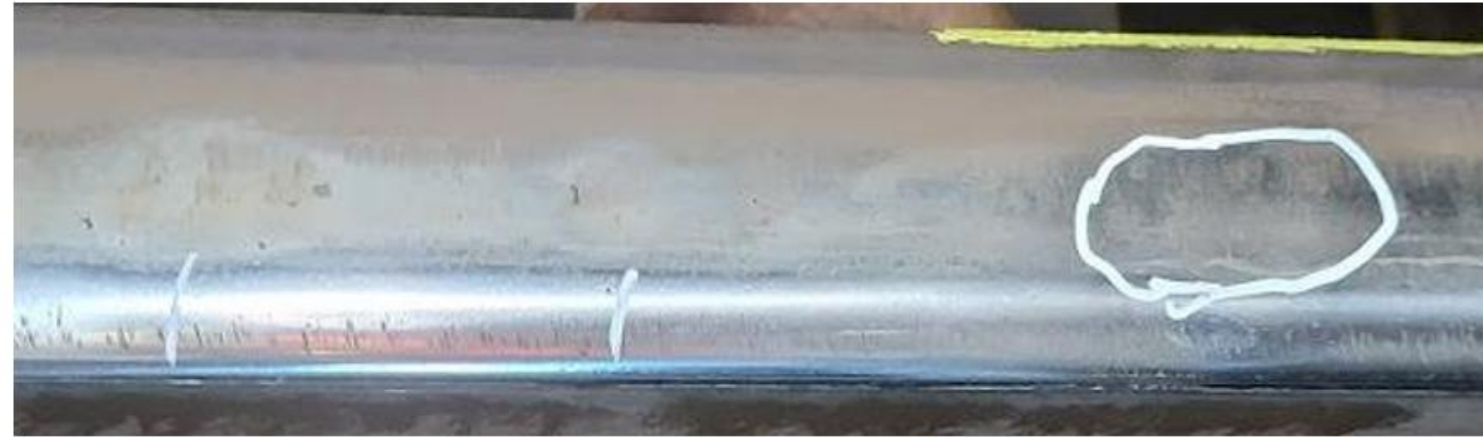
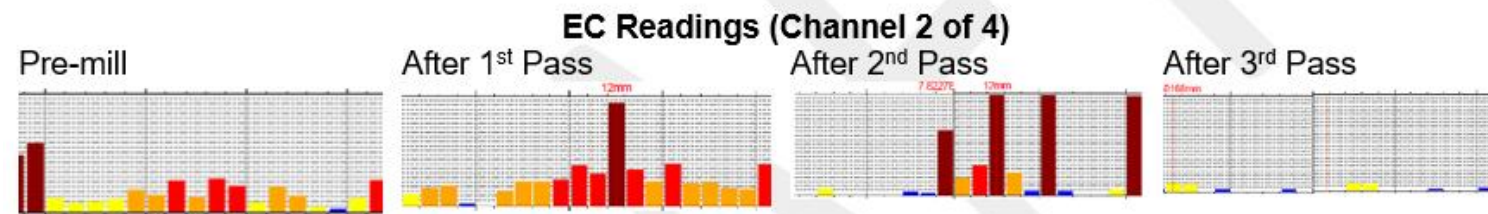
- Rail Milling program in one curve provide detailed analysis on metal removal, eddy current, and photos with dye penetrant
- Initial visual assessment and EC measurement did not typically match to expected level of effort
