# Reverse Transverse Defects/Detail Fractures

**ICRI-RCF WebEx**

**December 2016**

**Institute of Railway Technology**

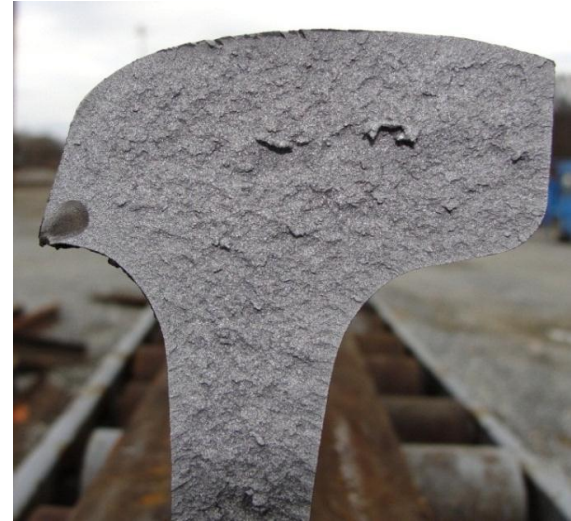
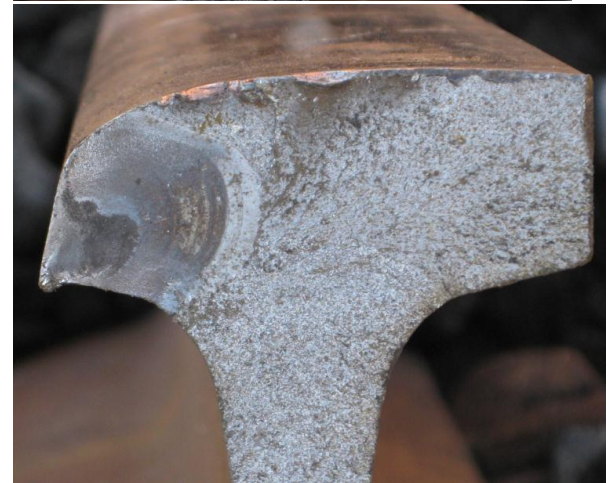
- Fatigue defect initiates at lower corner of gauge face
  - Typically initiators are flow lips resulting from severe plastic deformation down gauge face
- Fatigue crack propagation up from lower gauge corner and across rail head
  - Major growth direction is transverse, not vertical
  - Significant influence of lateral bending on growth behaviour

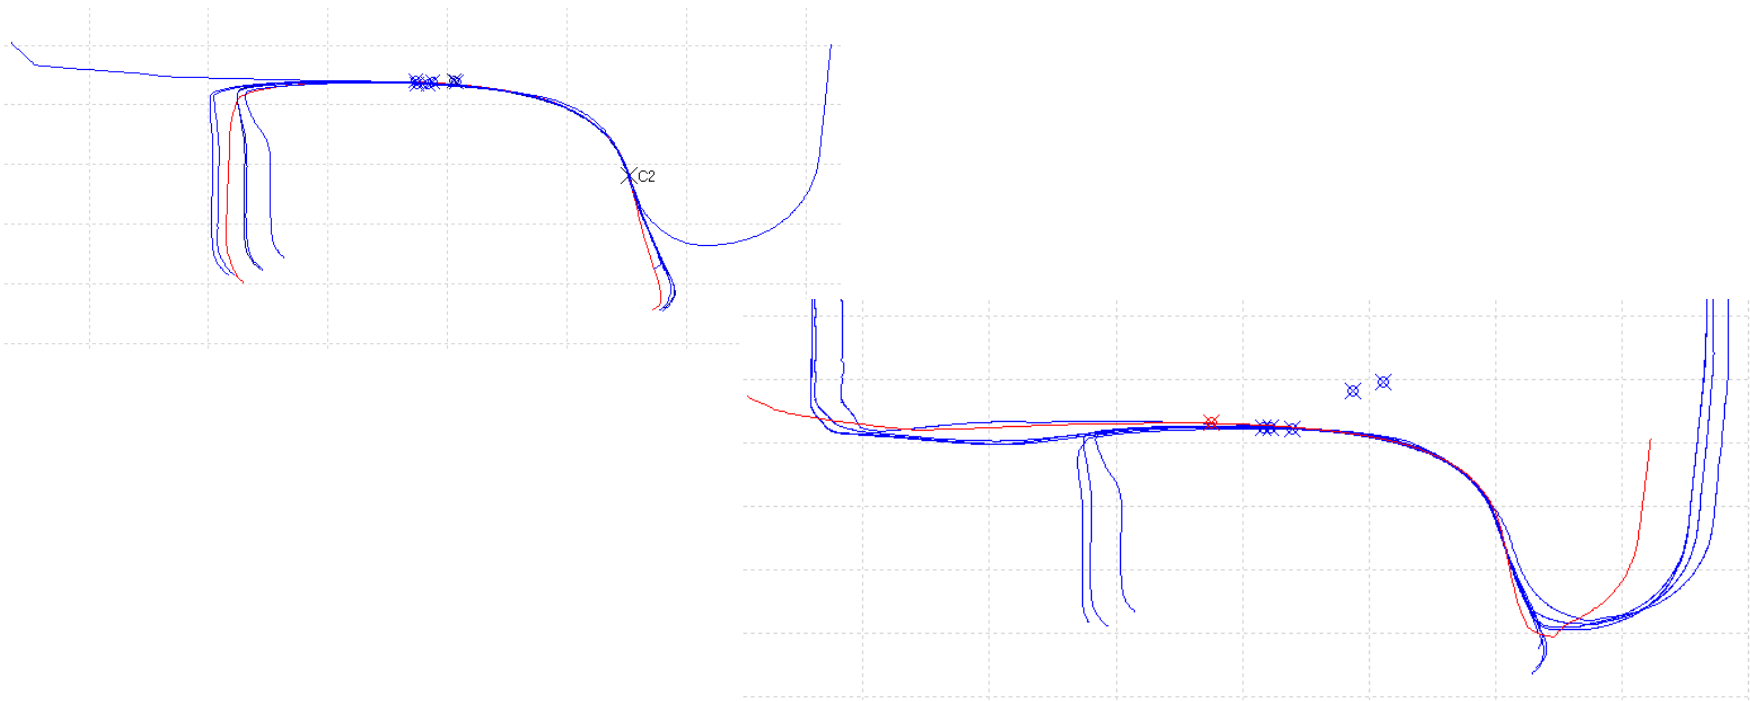
- *Defect initiation appears to require a combination of (a) flow lips and (b) high stresses from wheel-rail contact at lower gauge corner*

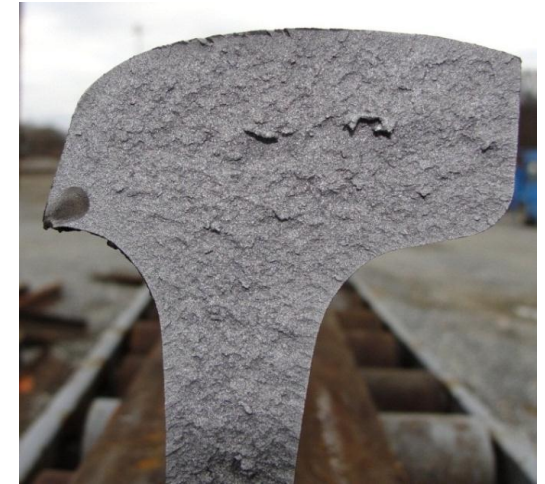
## A. Fatigue cracks initiate in flow lip at lower gauge corner

- Local bending of head is the dominant stress mode
- Initial rate of crack growth appears to be very low, and possibly associated with flange contact towards lower gauge face
- *Limited number of wheels may contribute to crack initiation and initial growth stages*

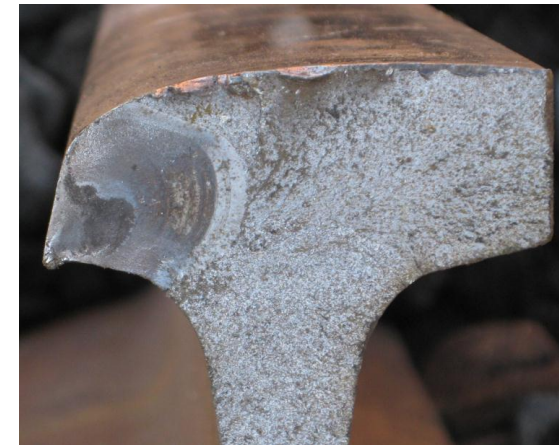
## B. At larger crack sizes (>~15mm)

- Increasing influence of stresses from reverse bending
- Increased lateral loading results in higher bending stresses and increased crack growth rates
- Major growth direction is transverse
- *Increasing proportion of wheels contribute to crack growth*
