ICRI-Safety – an International Collaborative Research Project

Use of Premium Rail Steels An International Survey

Automotive and Surface Transportation
National Research Council (NRC) Canada

Surface Fatigue Initiated Transverse Defects and Broken Rails – Untestable Rails An International Review

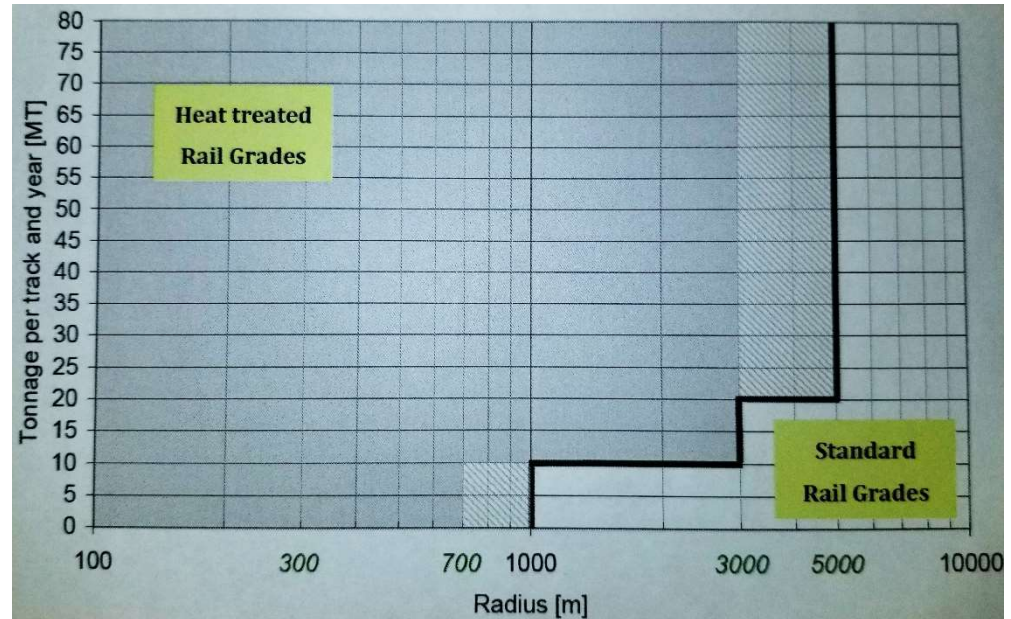
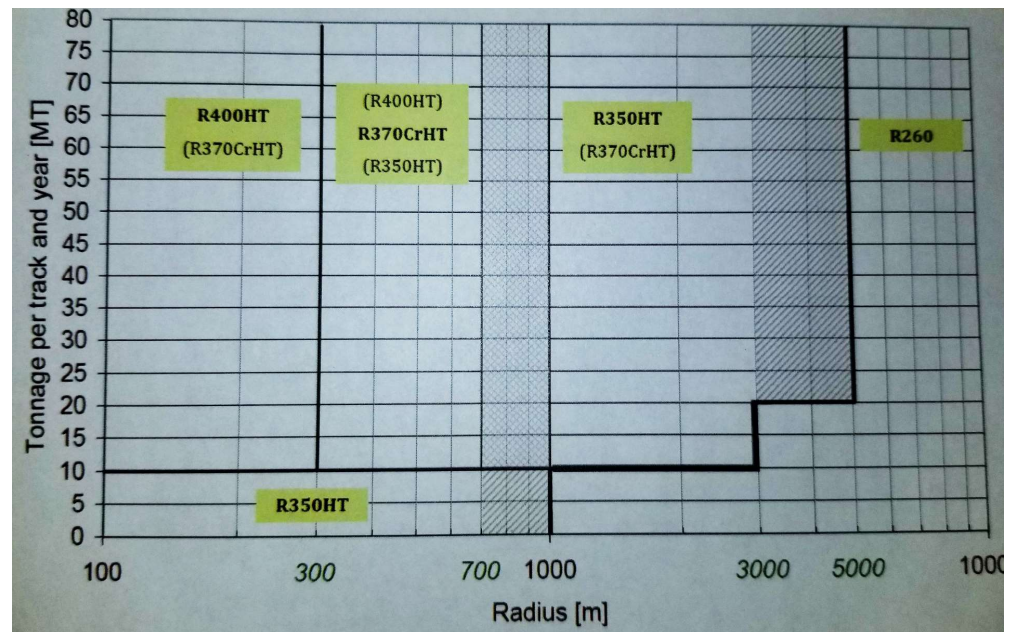
Rail Grade Selection Criteria

- Heat treated vs. standard grades
- Expected annual tonnage vs. curve radius
- Detailed rail grade selection map
- Expected annual tonnage vs. curve radius

- For tight curves ($R < 300\text{m}$) use R400HT
- For medium curves ($300\text{m} < R < 700\text{m}$) use R370CrHT (when MGT ↓) R400HT (when MGT ↑) followed by R350HT when curvature ↑
- In case of MGT ↑ use of R350HT is also recommended in shallow curves ($3000\text{m} < R < 5000\text{m}$)
- If RCF is negligible:
 - Use R350HT in $R < 700\text{m}$ - 1000m (depending on boundary conditions)
 - Standard rail grade (R260) $R > 700\text{m}$ - 1000m (depending on boundary conditions)
- Detailed mapping of rail selection for specific radii curvature was carried out 10 years ago as part of European project InnoTrack
- Part of this report details rail grade selection based on track curvature and yearly tonnage accumulation

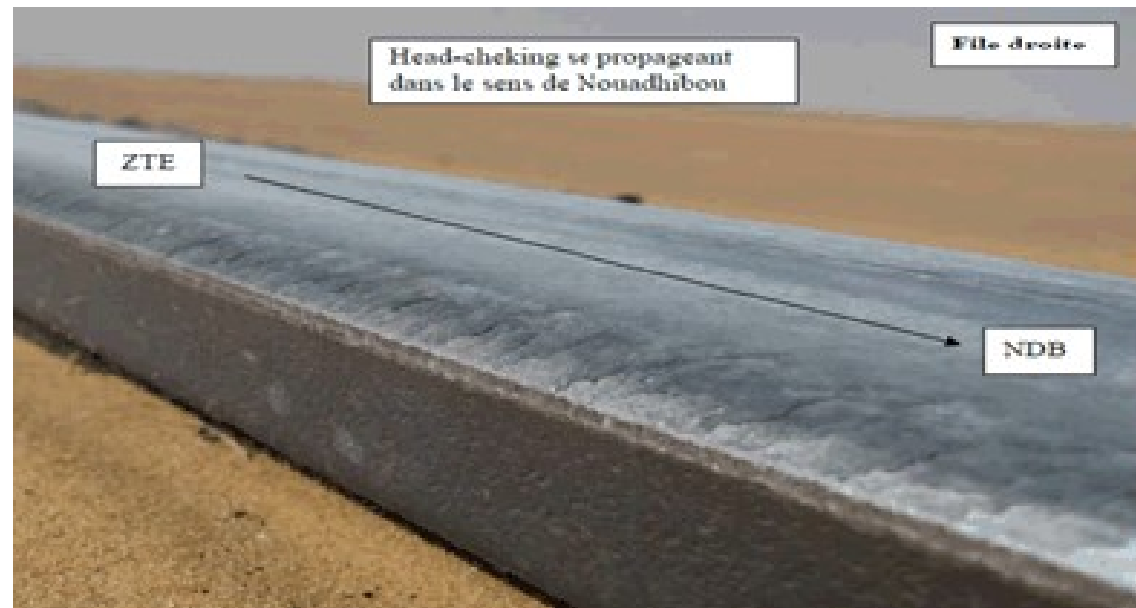
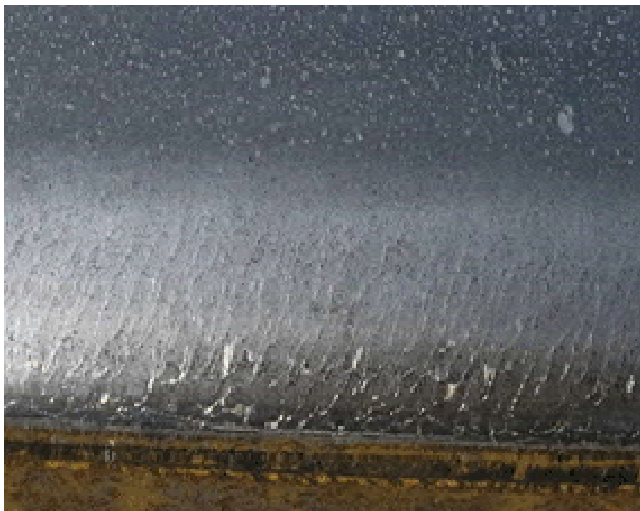
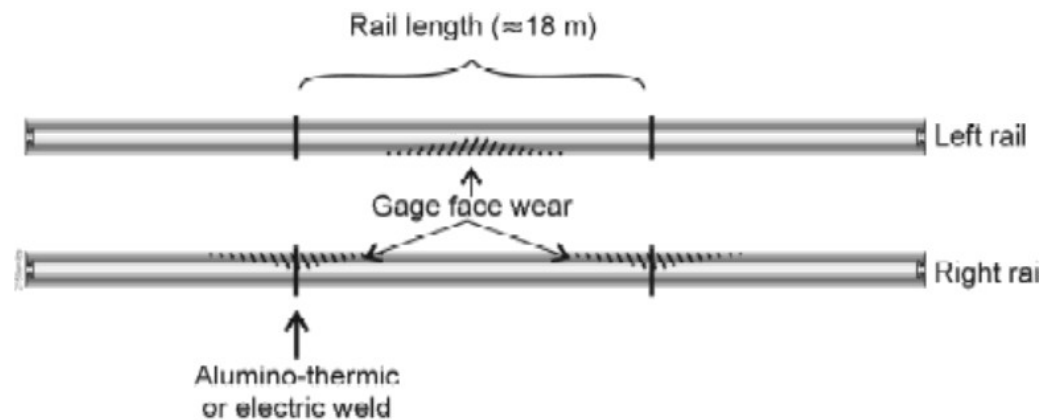
Abrasive pitting
and hunting wear,
as well as head
checking

- 30tonne/axle loads
- Dominant reason for rail replacement is wear
- Presence of sand on track accelerates abrasive head wear,
 - Shifting sand dunes and constant wind along most of track
- Wear replacement threshold is $UV + UL/2 = 24\text{mm}$
 - UV – vertical wear [mm]
 - UL – lateral wear [mm]
- Wear rate (natural + grinding)
 - 0.104mm/MGT (metric) in curves (life cycle ~230-460MGT)
 - 0.030mm/MGT (metric) in tangents (life cycle ~400-800MGT)
- Tangent rails undergo both vertical and lateral wear
- Max lateral wear is often in 16-18mm range

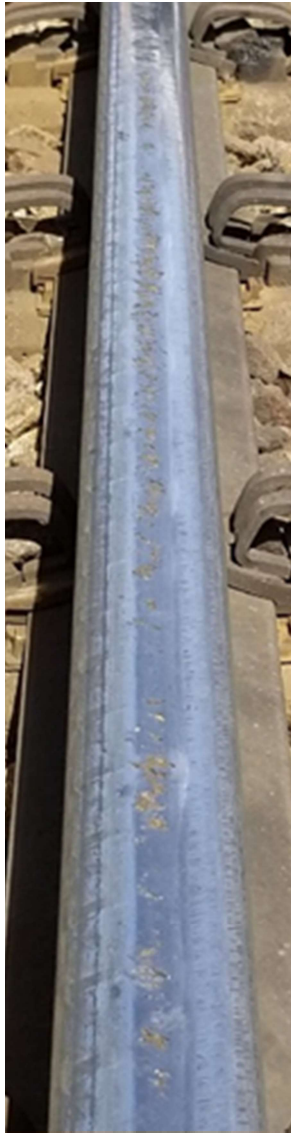
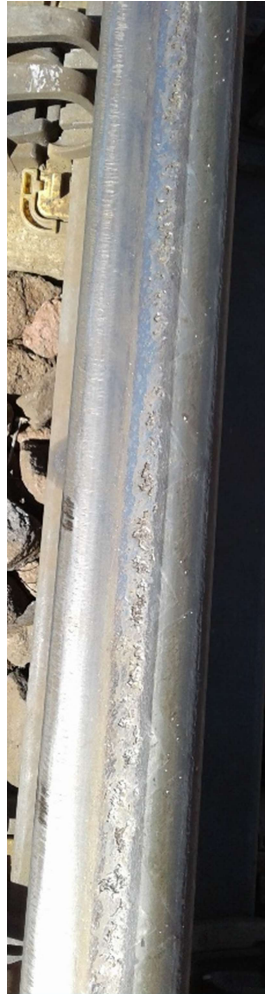
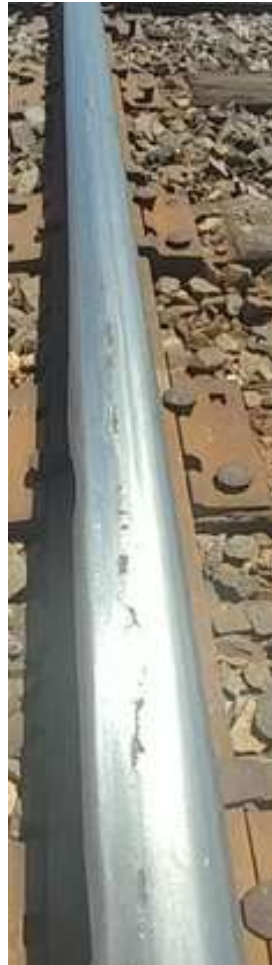
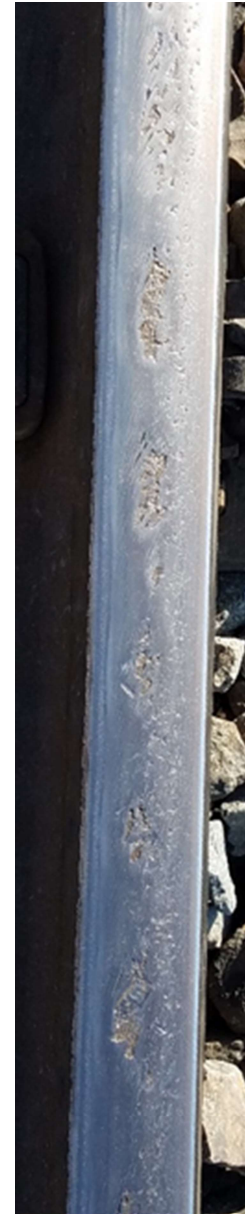
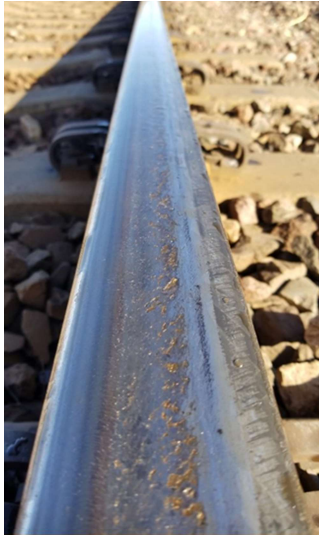
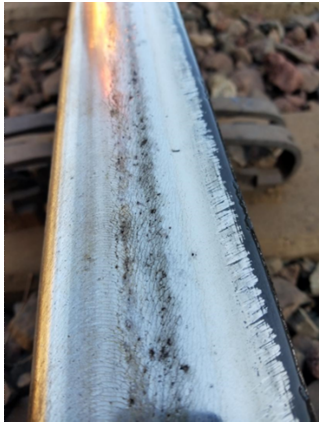
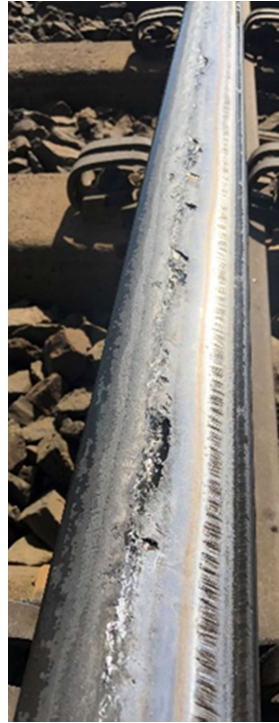
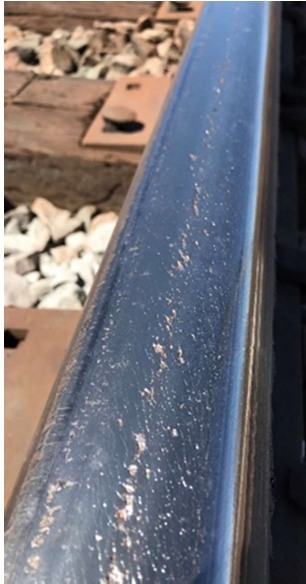
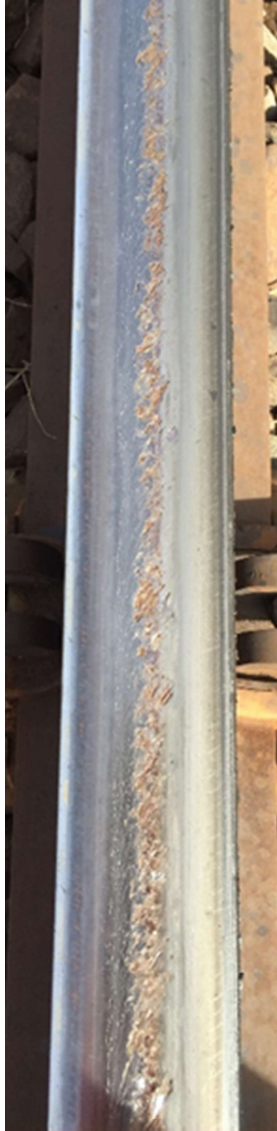
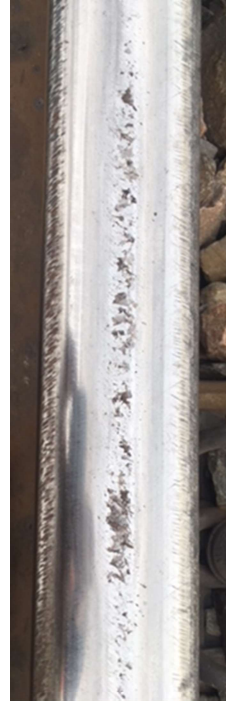
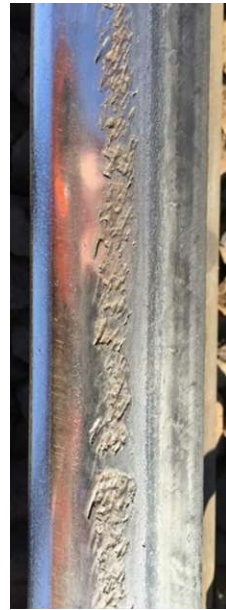
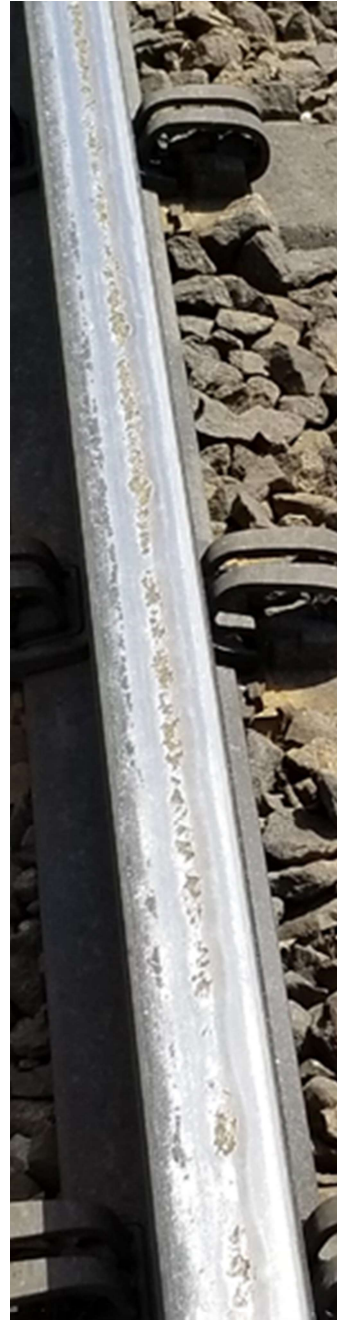
North American HAL – Survey Summary

- Problems persist primarily on intermodal service lines
- Rail mostly affected is premium 141RE, 2006-2015 production years
- Damage mostly on low rail
- Curvature <6 deg. (>281 m-radius curve)
- Rail is mostly dry (i.e. lubricator positions mostly far away from trouble spots)
- Rail is mostly on concrete ties (i.e. stiff track condition)

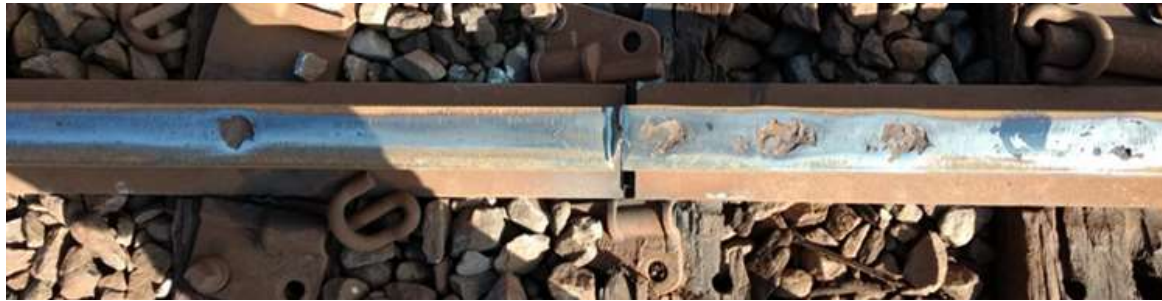
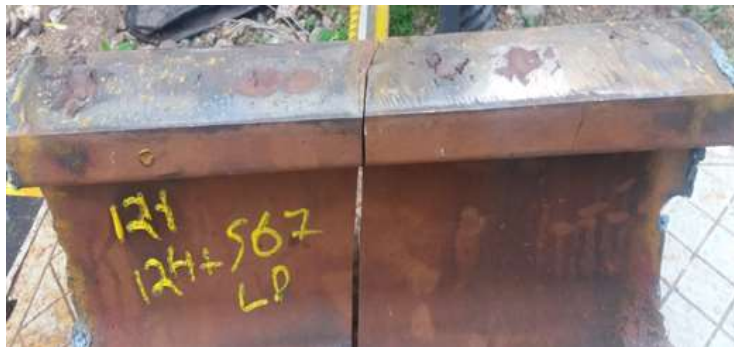
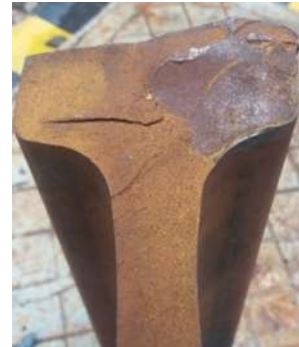
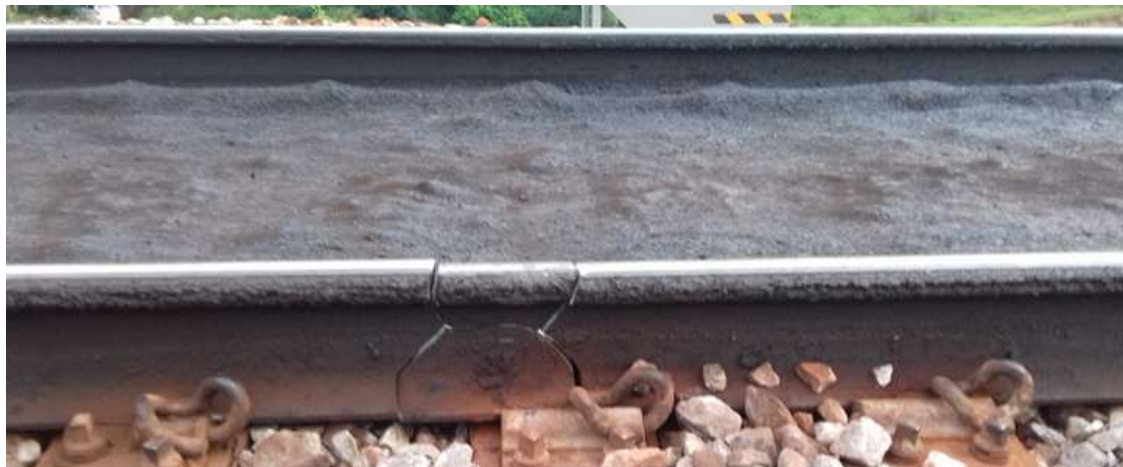
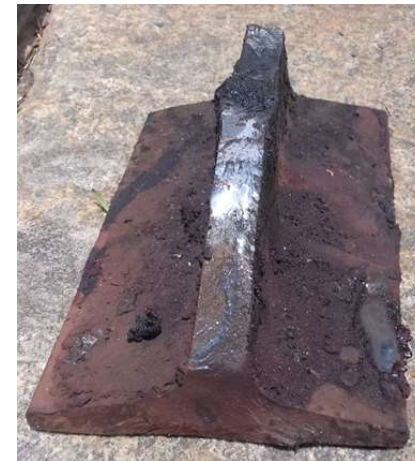
South American HAL – Survey Summary

- Problems persist on freight service lines
- Rail affected is 136RE head hardened premium rail (2006, 2008, 2011)
- Substantial vertical wear (10-17 MGT/mm)
- Damage on tangent rail (or low rail in shallow curves)
- Rail is mostly on wood ties with elastic fasteners
- Periodic spalling and fatigue defects originating at surface witness marks

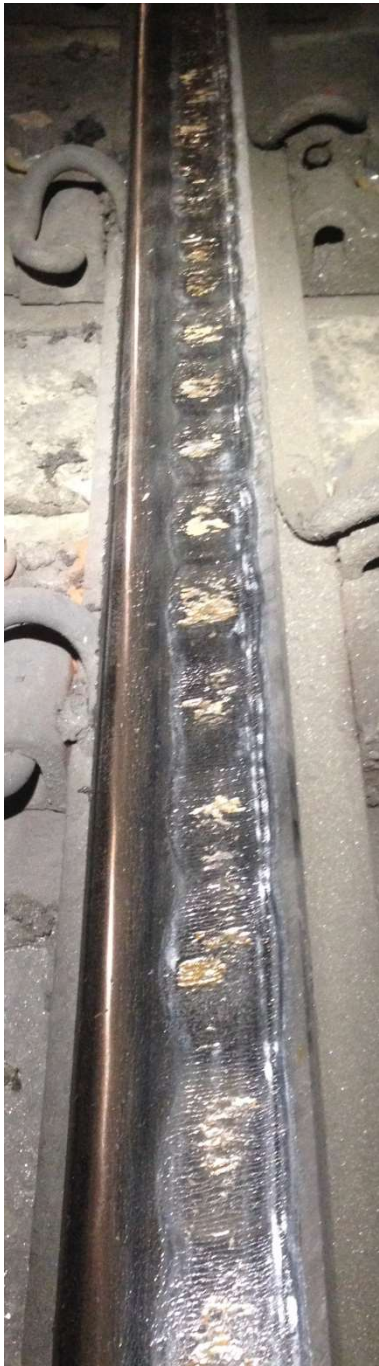
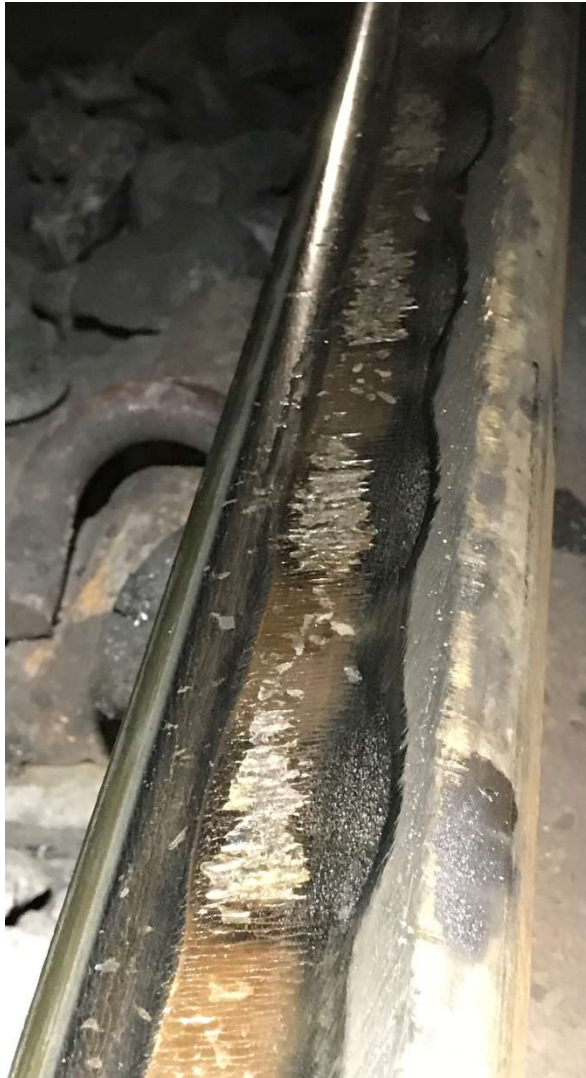
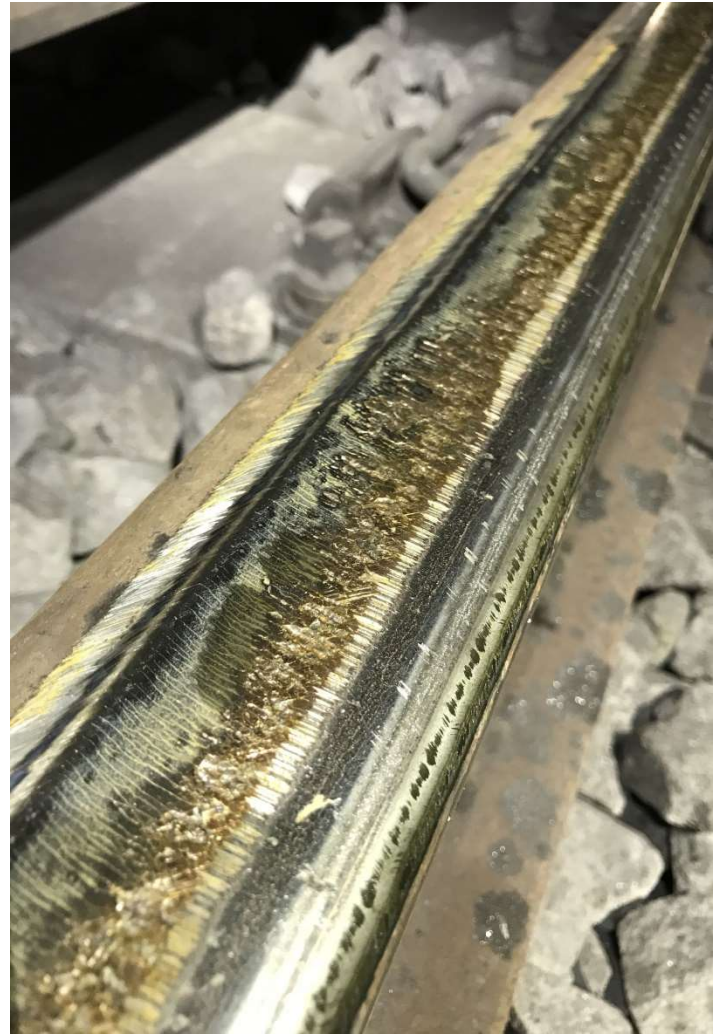
European – Survey Summary

- Problems on transit lines
- Standard grade rail: 115RE, 2011, grade 220
- Curvature approx. 5deg (325 m-radius curve)
- 130MGT accumulated tonnage
- Wear: 6mm vertical (22 MGT/mm), 3mm horizontal (43 MGT/mm)
- Fall leaf problems, high humidity, well lubricated, TOR FM applied
- Wood ties with elastic fasteners
- Periodic high rail corrugation damage

Pre-Grind

Post-Grind

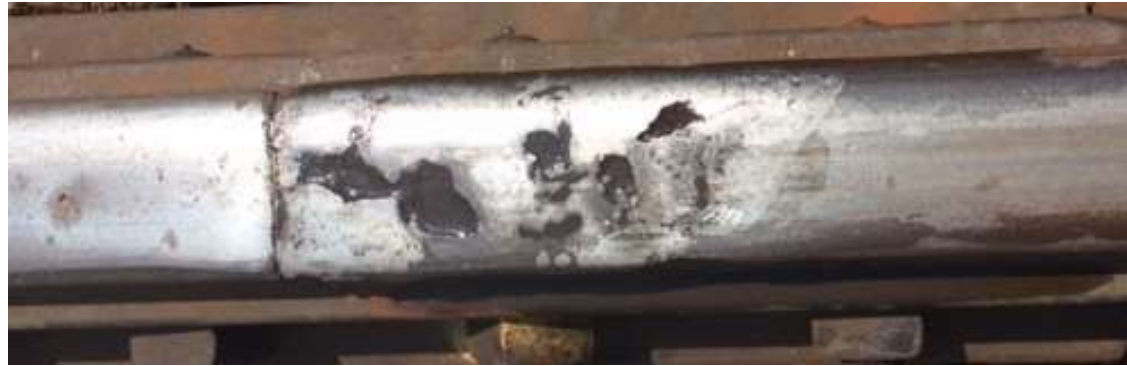
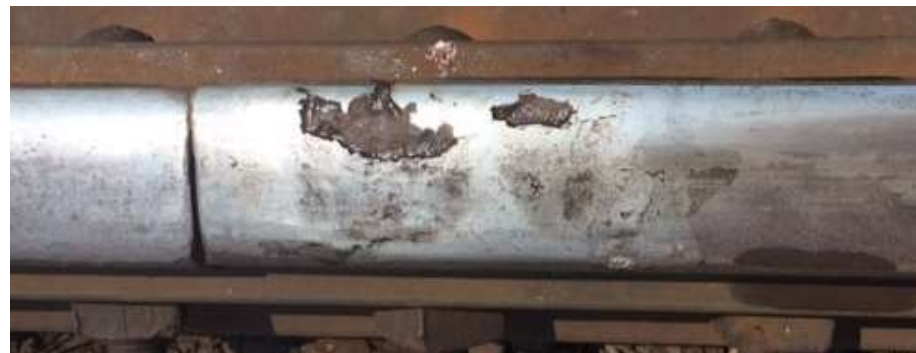
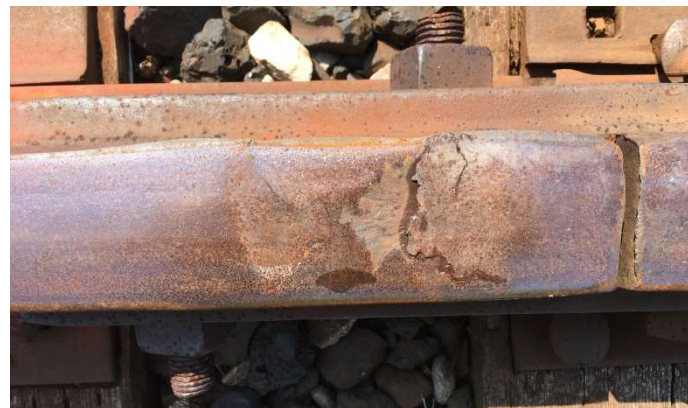
Additional North American HAL Line Defects

- Freight line traffic
- No visual evidence of recent grinding
- Severe batter on rail ends leading to spalling
