An ICRI task: Broken Rails

Broken Rail Derailments

ICRI Broken Rails Workshop

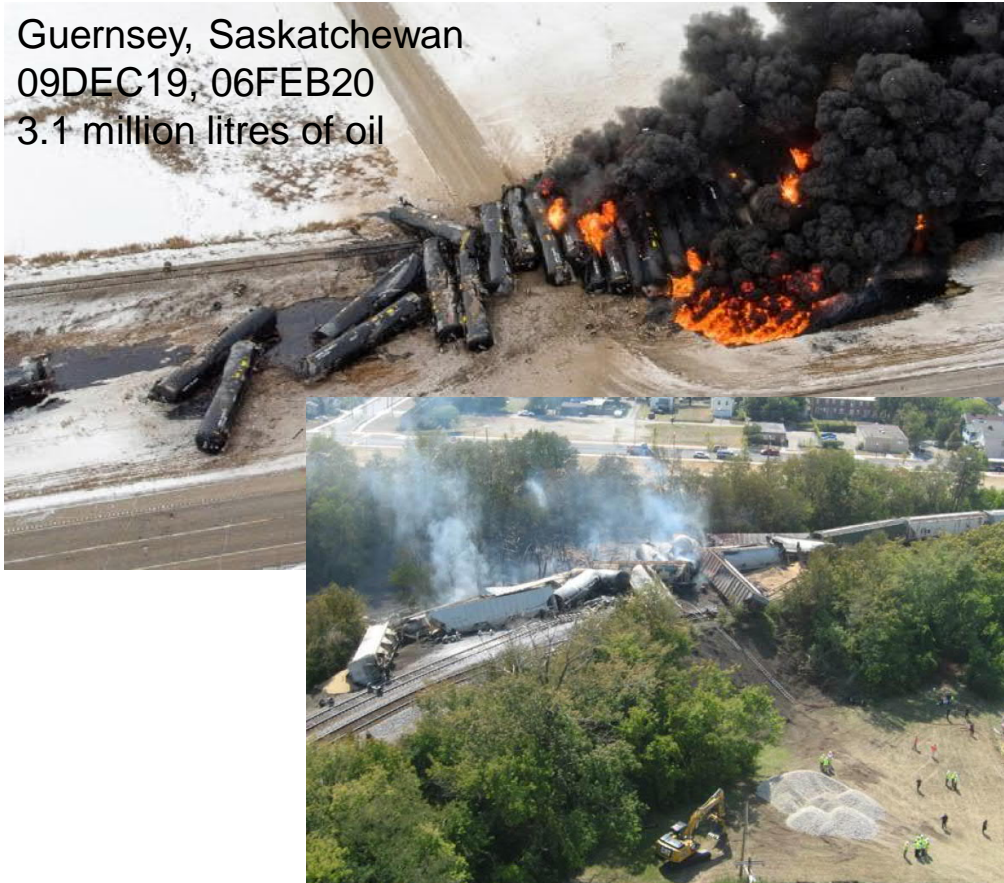
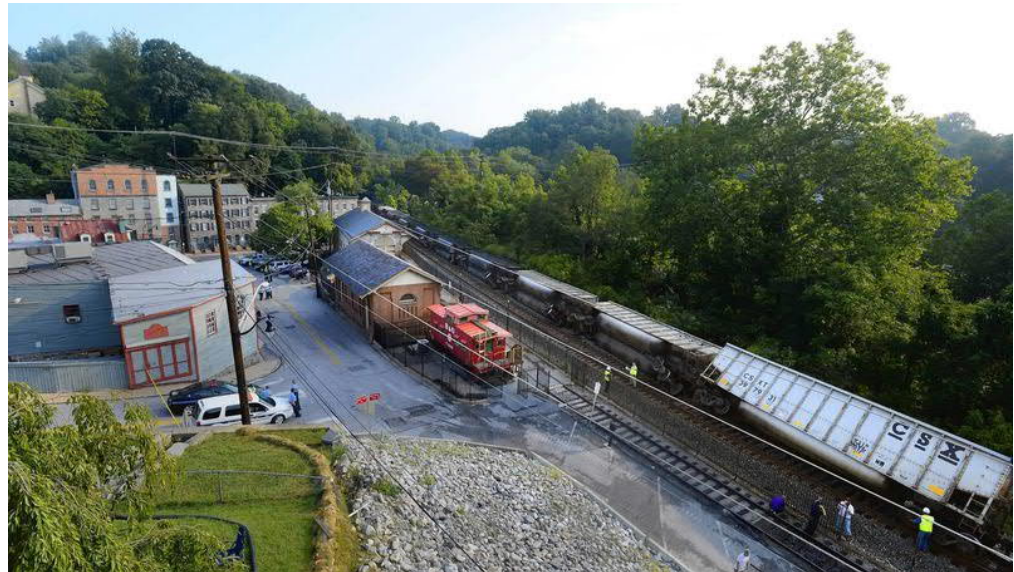
Guernsey, Saskatchewan
09DEC19, 06FEB20
3.1 million litres of oil

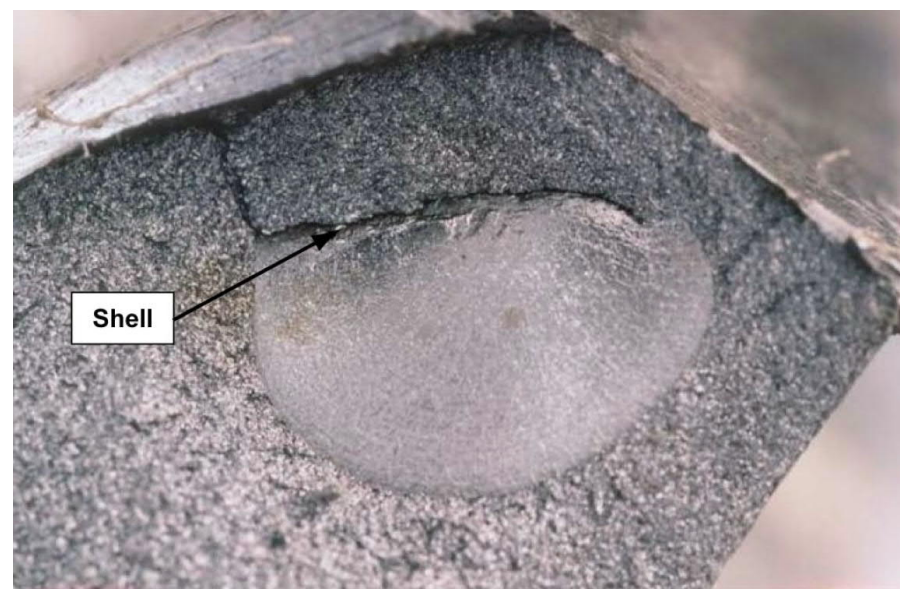
TSB #R05E0059 2005-08-03 CN Edson Wabamun, AB

800,000 litres of oil spilled into Wabamun Lake AB,

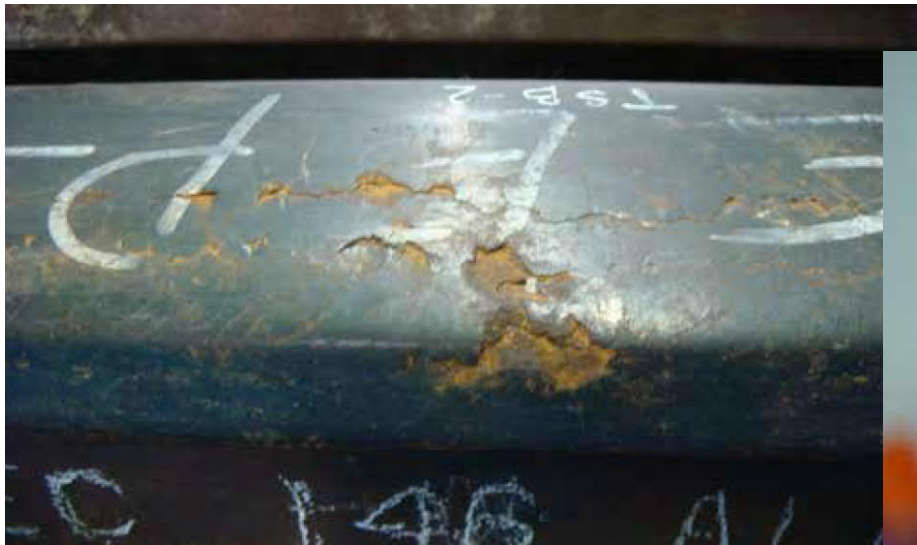
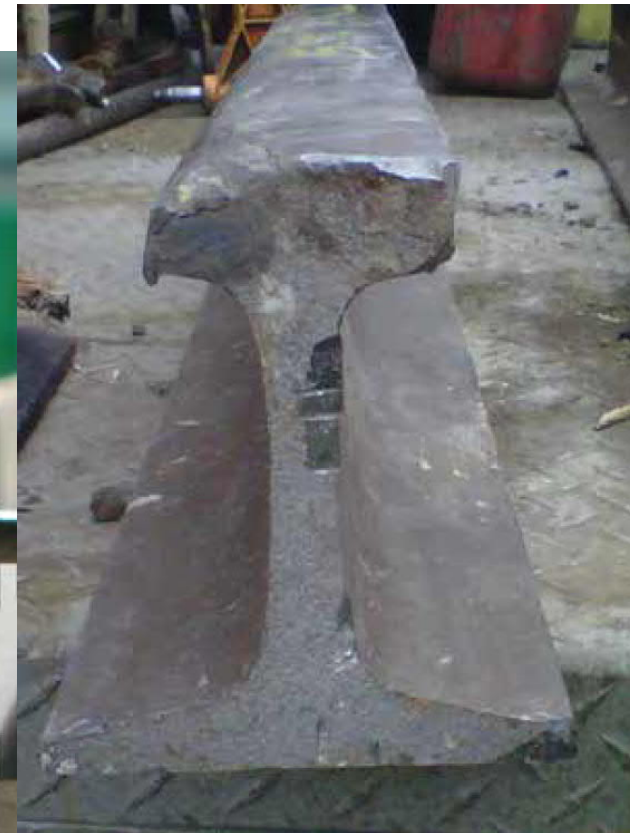
TSB #R13E0142 2013-10-19 CN Edson, Gainford, AB

13 fuel cars derailed, explosion, evacuation

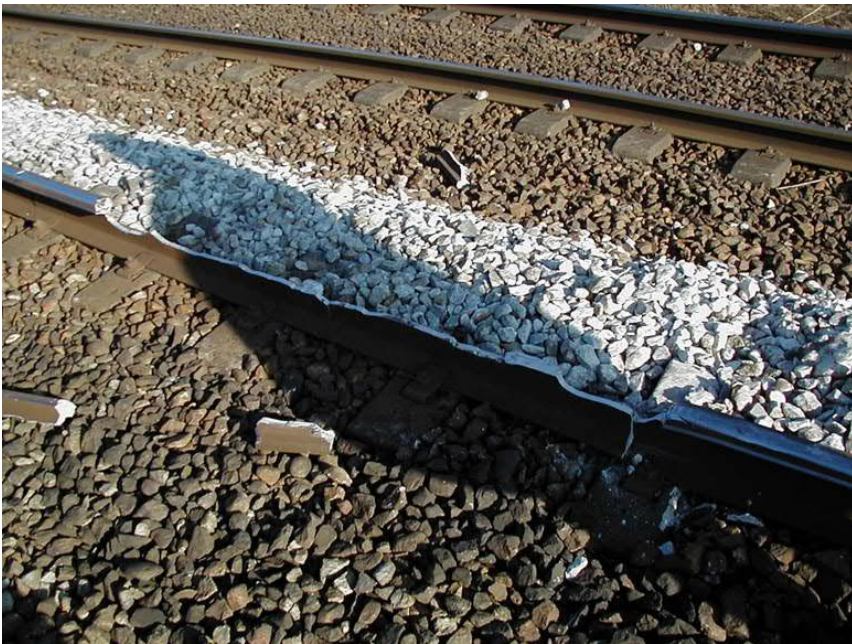
European example: horizontal cracks

- Example from passenger train derailment in Denmark. Crack propagated horizontally along rail until a section broke off. Suggests that in winter the rail would have had a more vertical break

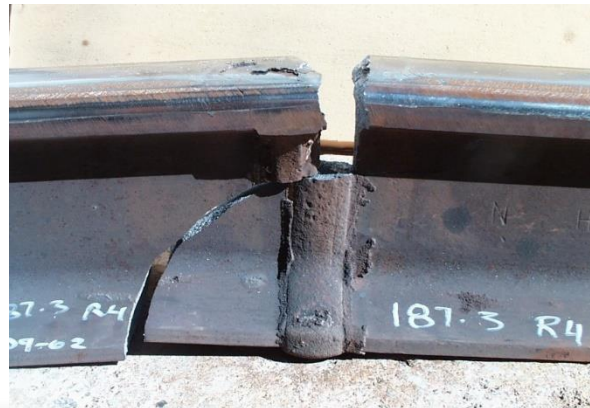
Measured stresses, 873m radius curve, low rail

- *Peak stresses on outside of weld collar typically up to 1.5 times parent rail stresses under same service conditions*
- *Increased risk of web fatigue failures*

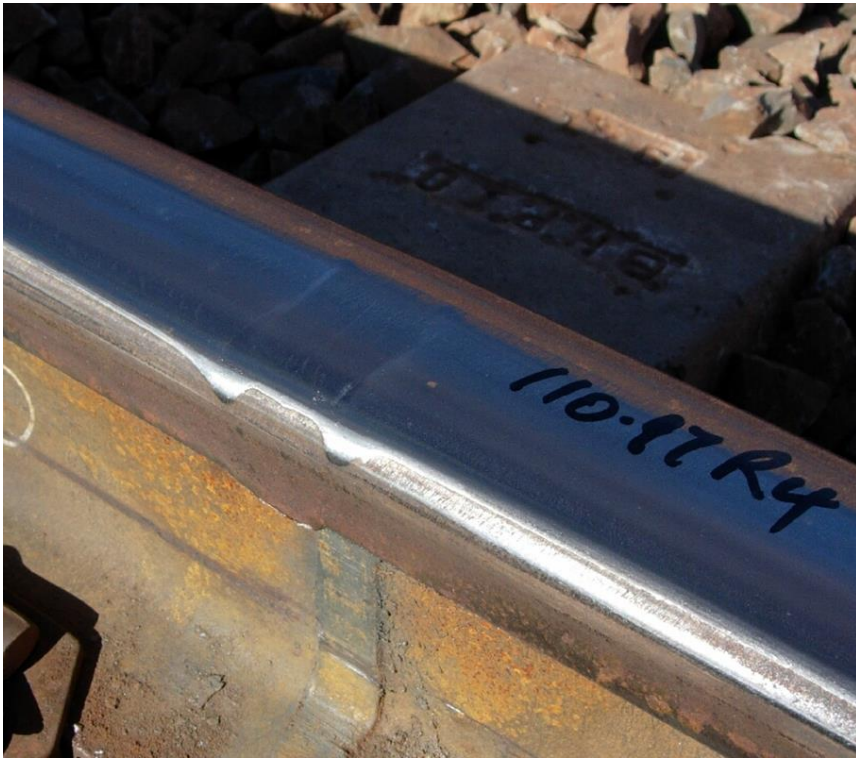
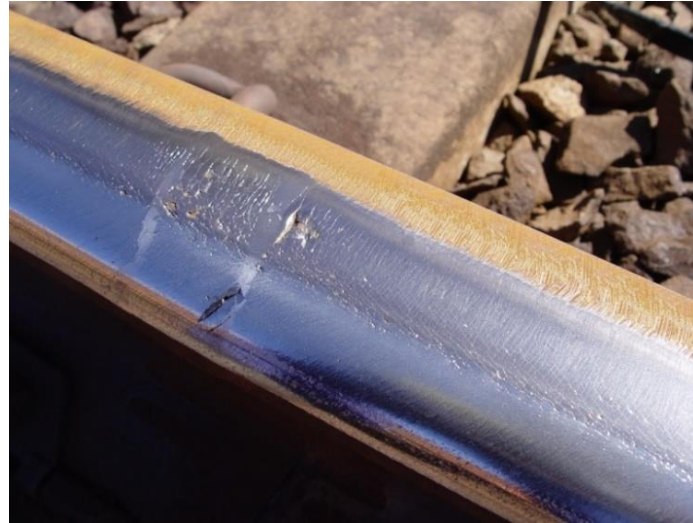
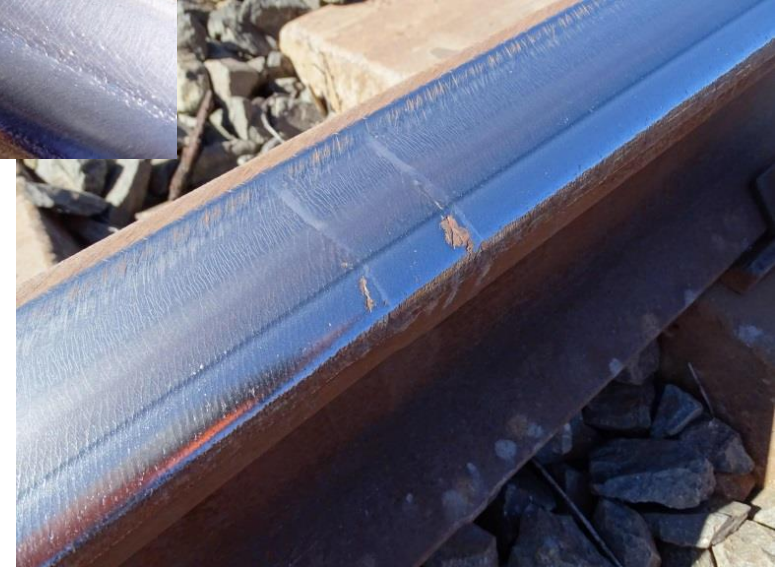
Behaviour in wheel-rail contact

Localised plastic deformation, wear and rolling contact fatigue associated with variation in material characteristics

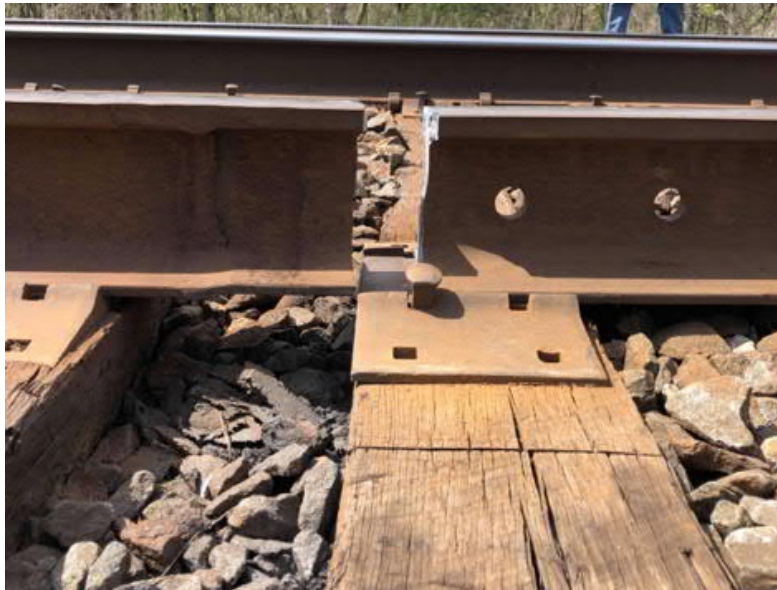
The majority of broken rails do not cause a derailment

A straight break on reasonably good track will pass a train safely. ("Good track" supports the rail ends so that they do not mismatch enough to catch a wheel flange.)

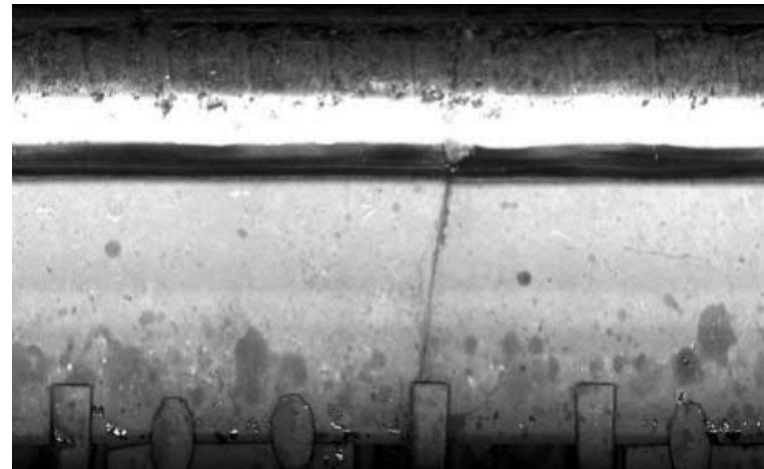
This straight break passed trains for at least two weeks! (This detector car image is from a test conducted two weeks prior to a broken-rail derailment.)

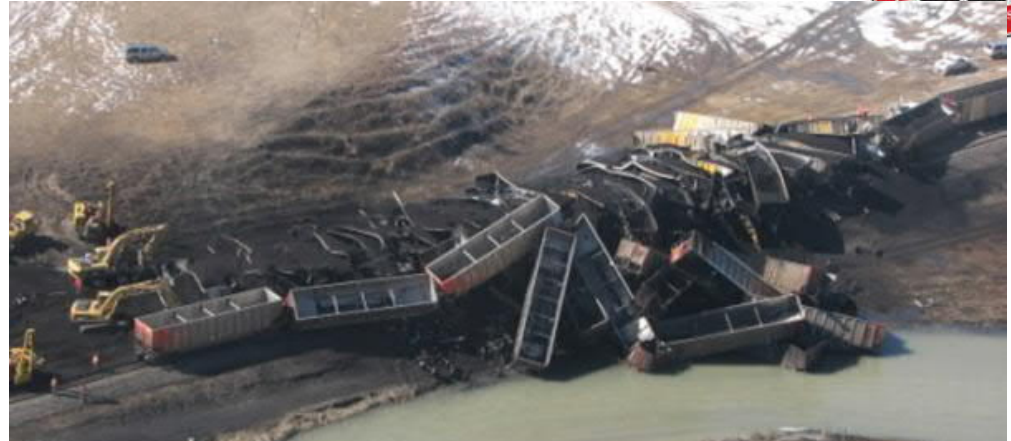
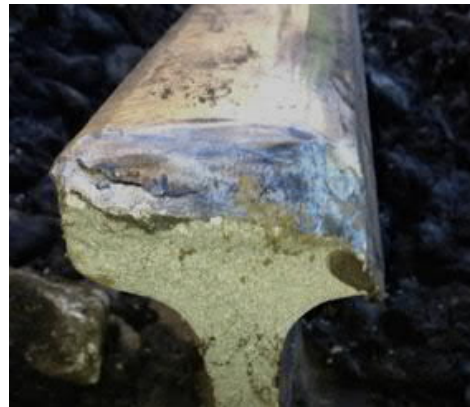
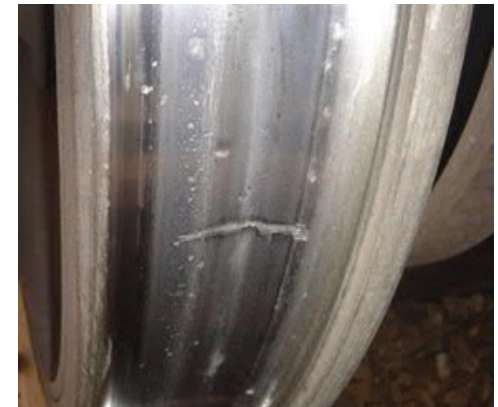
- Sudden and total track destruction with no prior indication of derailment
- Derailed cars in a pile
- One or more broken rails, each with
 - an internal defect
 - receiving end batter
- Impact mark on wheels ahead of those derailed
- History of rail defects
- Often, confirming the cause may be difficult because evidence is buried under the pile-up

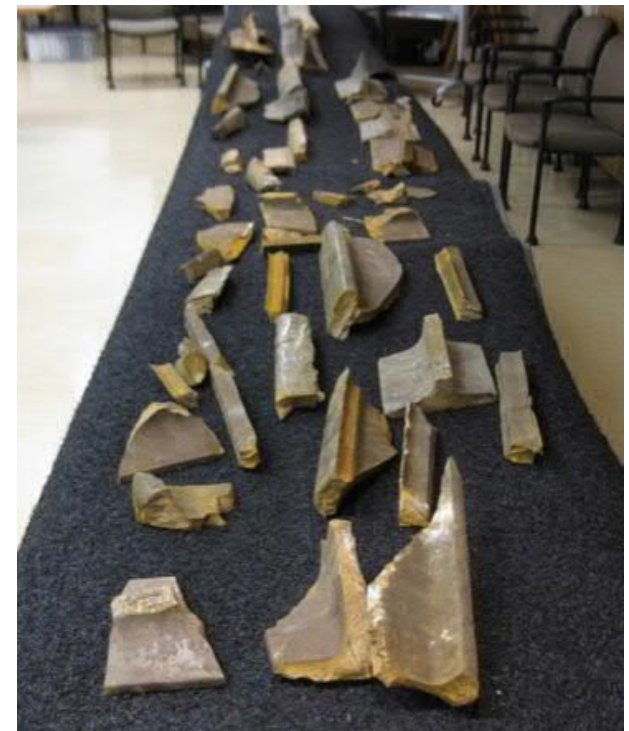
When there is a second break - either a completely new break, typically within several feet of the first, or a progressive fracture of the first break

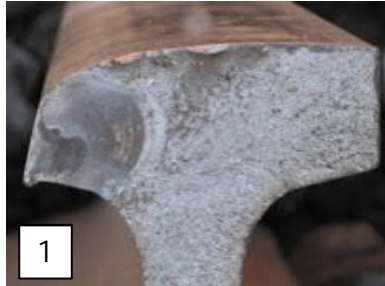
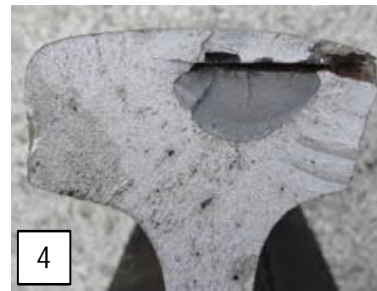
NS archives: Examples of broken rails that cause derailments

Broken rails originating from these type defects:

1. Reverse TD (TDR)
2. Transverse defect detail (TDD), often from surface cracks on gage corner of high rail
3. Gage-corner shell (high rail)
4. Center shell (example here - stock rail)
5. Vertical split head (VSH)

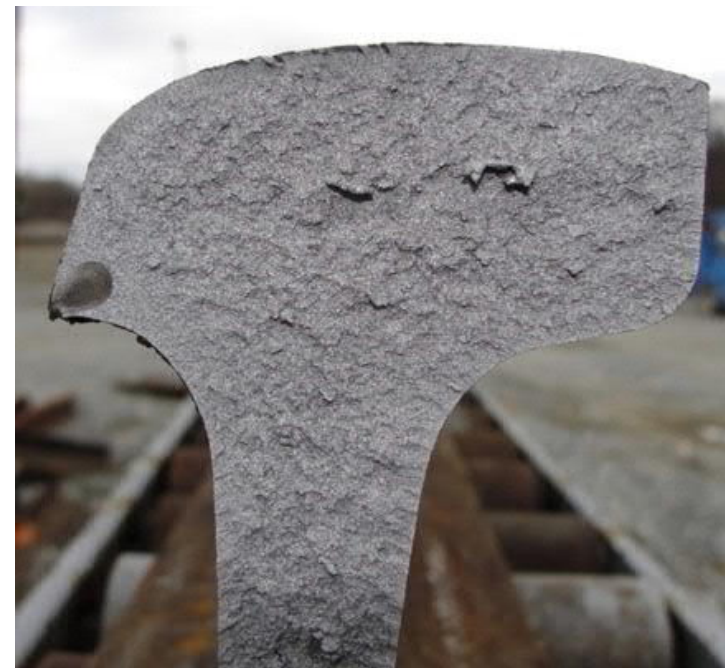
Multiple Reverse TDs - Kimball, WV

- One break, by itself, is unlikely to cause a derailment
- However, the conditions that generate a reverse TD are present elsewhere (in other words, one TDR is a predictor of additional TDRs)
- If a TDR fractures, and if there is a second TDR located within several feet, the increased wheel impact caused by the first break may accelerate the fracture of the second
- The resulting short rail is unstable and will cause a derailment

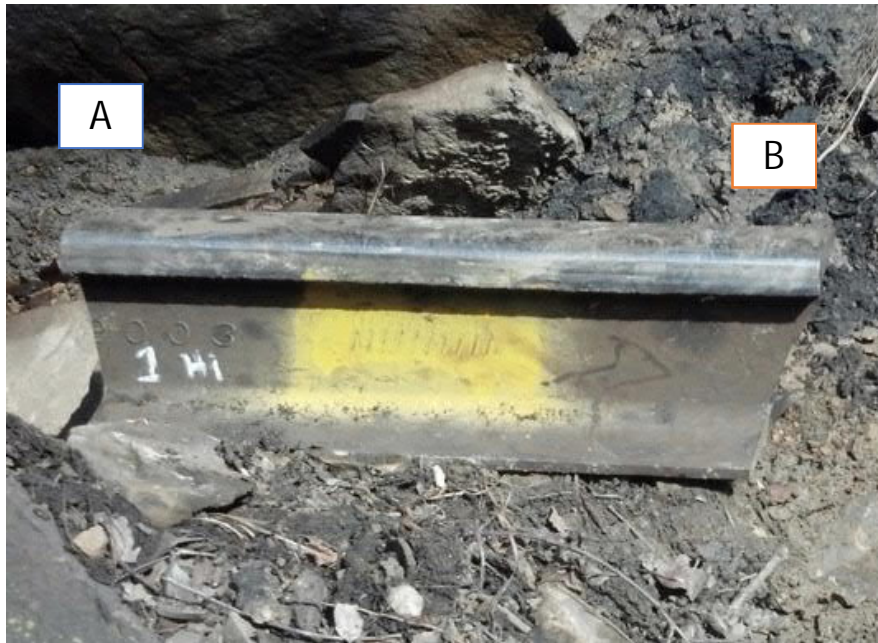
Multiple Reverse TDs - Kimball, WV

DIRECTION OF
TRAVEL
→

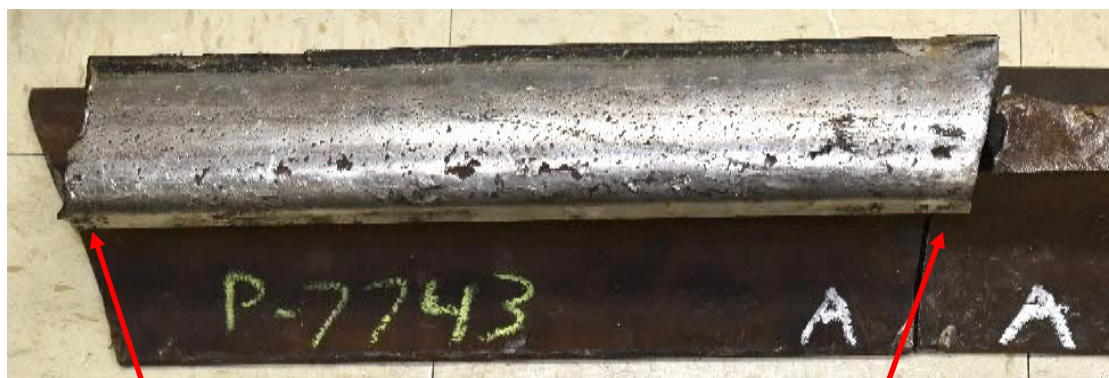
Multiple TDDs – Pittsburgh, PA

Both broken rails were caused by TDs originating from RCF at the gage corner.

The fracture face on the right is polished due to the rail ends rubbing.

The fracture on the left was the second break that caused the derailment.

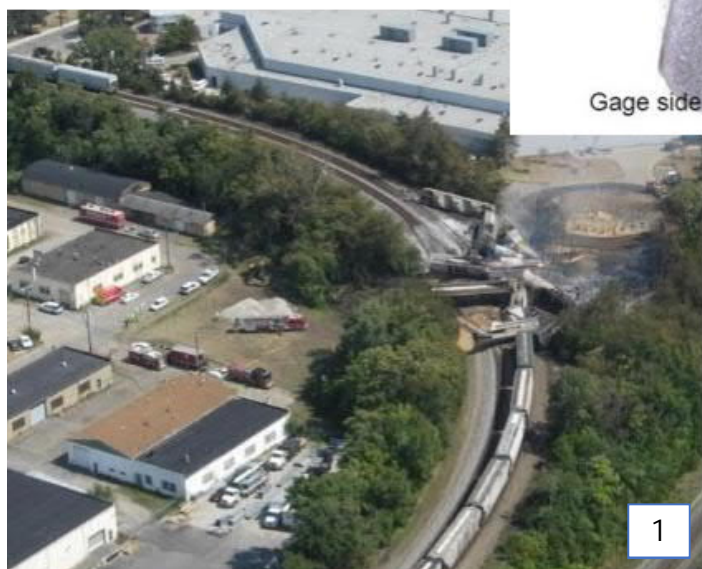
Multiple TDDs - Columbus, OH

1. Aerial view
2. Cross-section of high rail (not at defect) from NTSB report
3. High rail laid out in parking lot

Derailment cause: Multiple TDDs (originating from surface cracks)

The back story: A worn-out low rail from a nearby curve (132RE, 7/16" top wear) was relocated to this 9° curve to replace a curve-worn high rail. Three months passed between installation and derailment. During the first month, the Sperry car found 3 TTDs. During the second and third months, there were 5 TDD broken rails.

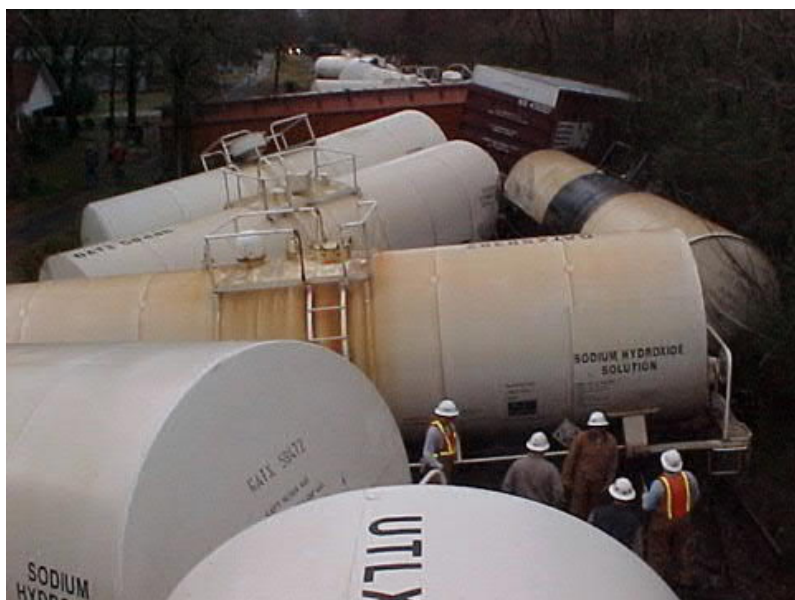
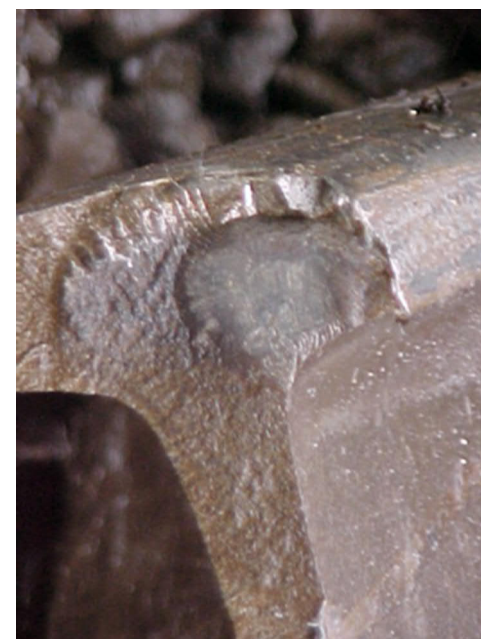
Multiple TDs - gage corner shells (high rail) - Wilton, AL

Derailed cause: Multiple TDs (at least two) that developed beneath gage-corner shells of a moderately curve-worn high rail

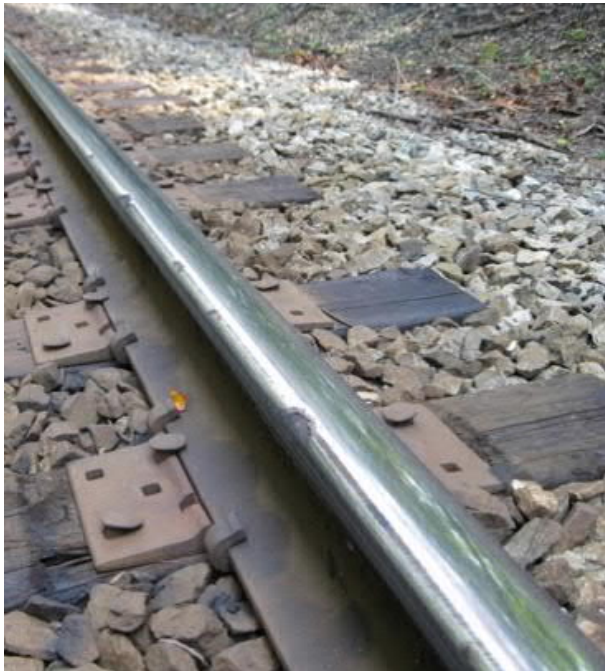
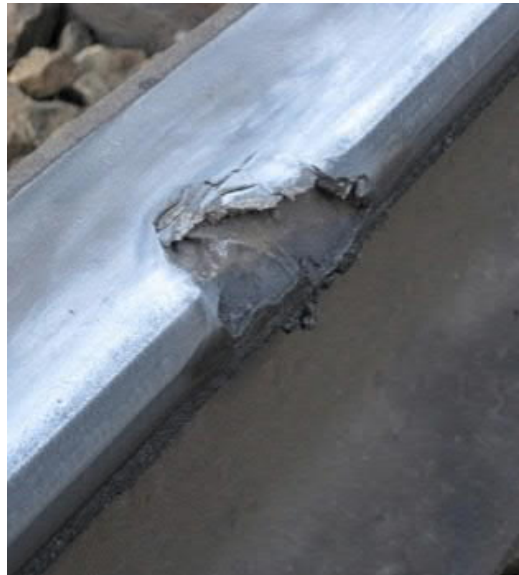
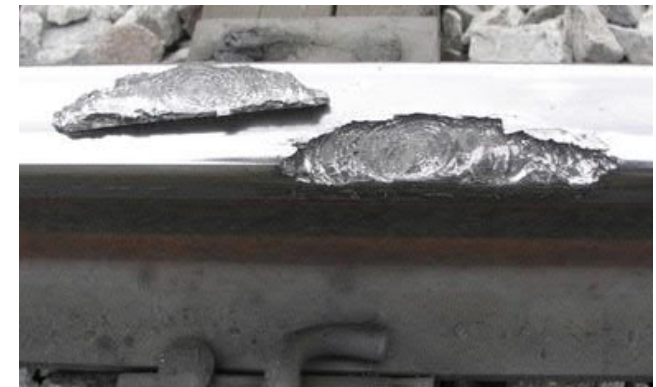
But not all gage-corner shells are problematic!

Some gage-corner shells exist for years without causing a broken rail!

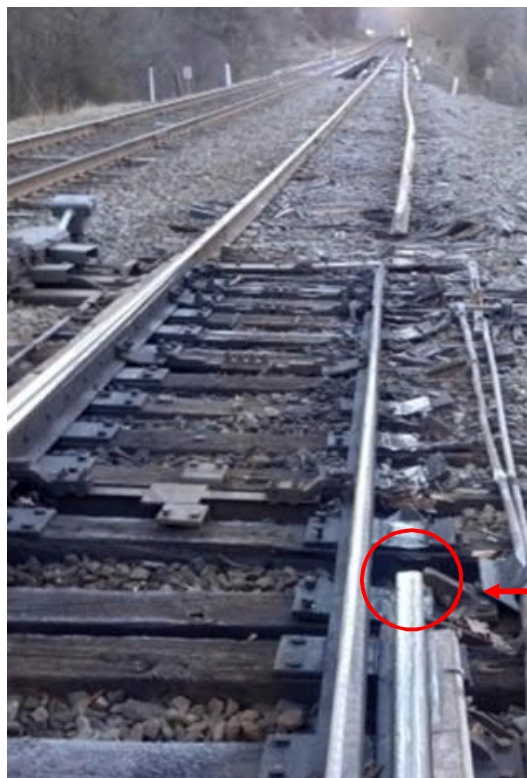
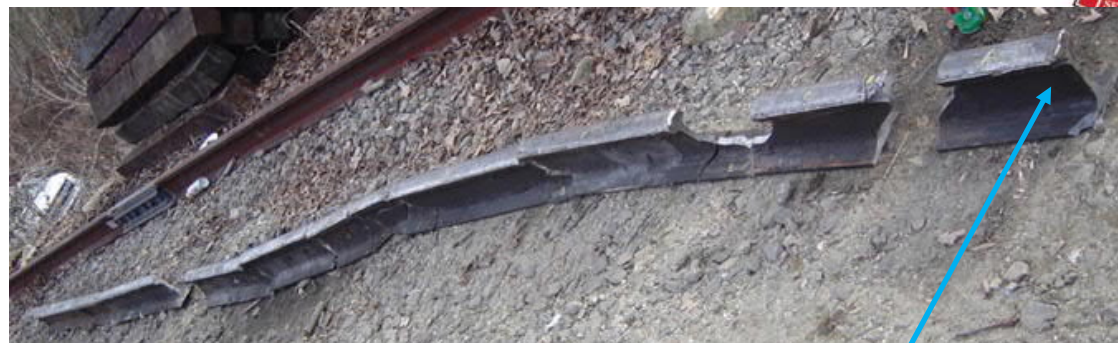
Multiple TDs - center shells (stock rail) - Frey Creek, SC

The straight stock rail and next rail broke into 21 pieces; 19 pieces were recovered

Both leaving and receiving ends of the initial break showed a significant center shell

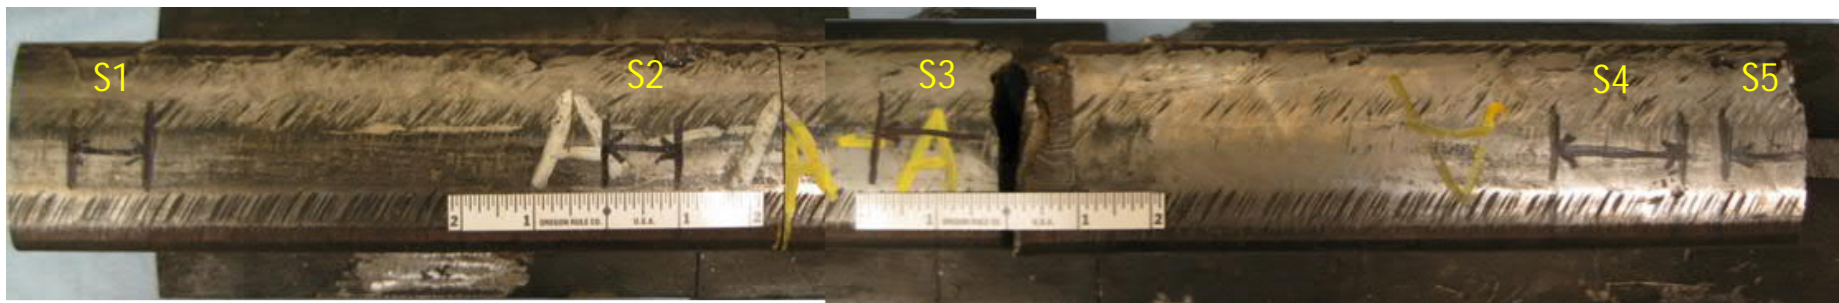
Multiple TDs - center shells (stock rail) - Frey Creek, SC

We hand-mapped 5 shells with 12 inches of the initial break

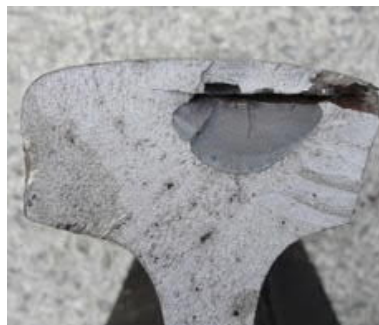
The first piece to break out

Shell S3 developed a TD, which caused the first fracture. The resulting wheel impacts contributed to subsequent fractures at shells and TDs downstream.

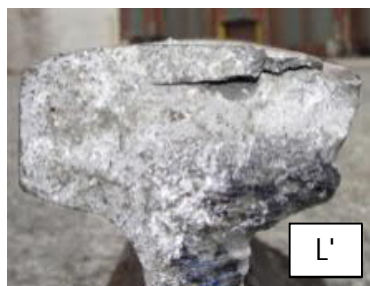
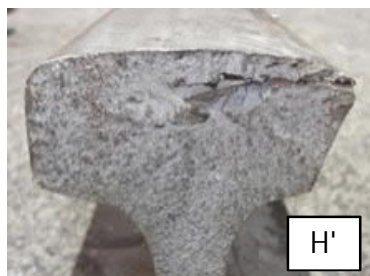
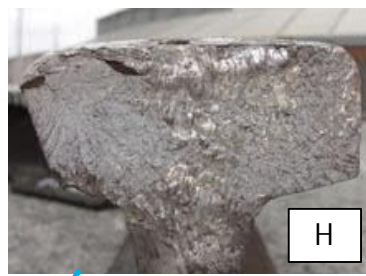
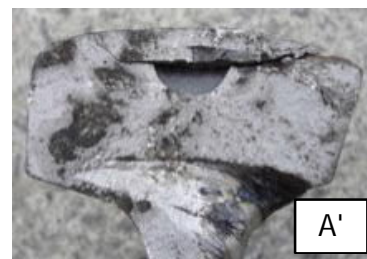
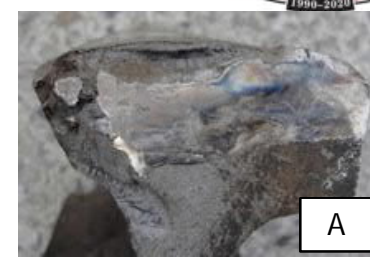
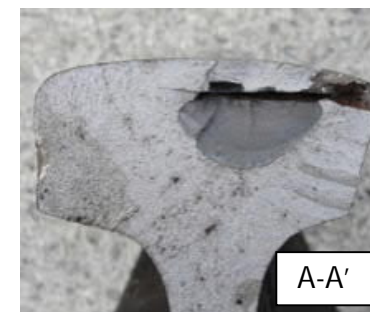
Multiple TDs - center shells (stock rail) - Frey Creek, SC

' indicates leaving end;
otherwise, receiving end

A-A' is the mate fracture
face to A. This was the
first break.

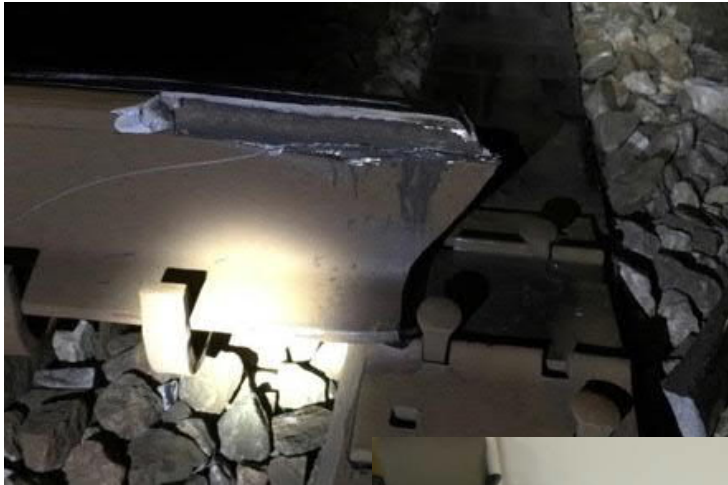
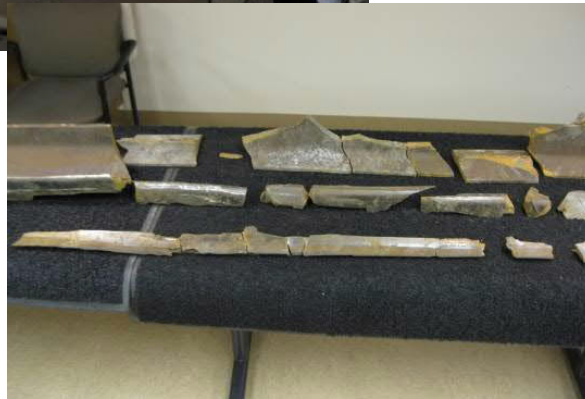
Vertical split head - Ft Wayne, IN

A VSH (a longitudinal separation in the head of the rail) can cause a derailment when the defect turns out (or in) and a piece of the head breaks out.

Other longitudinal defects, such as horizontal split head, head-web separation and piped rail, have a similar risk profile.

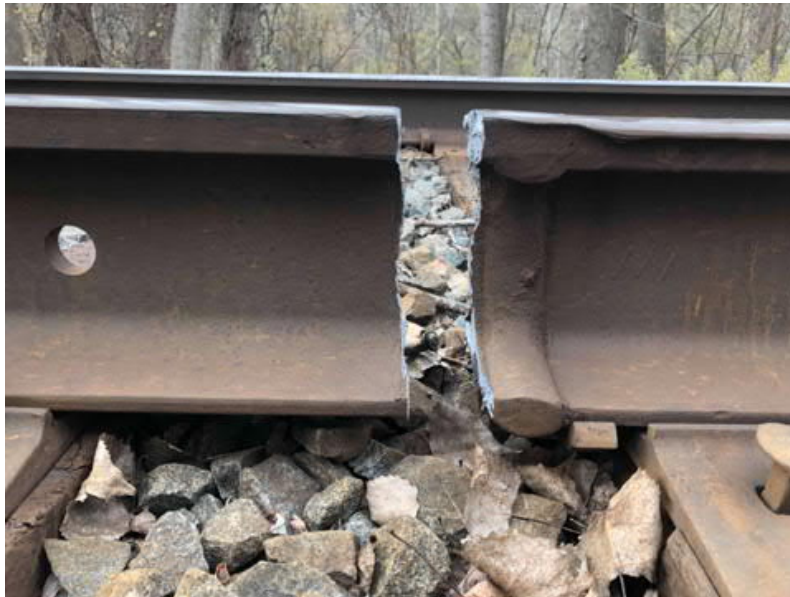
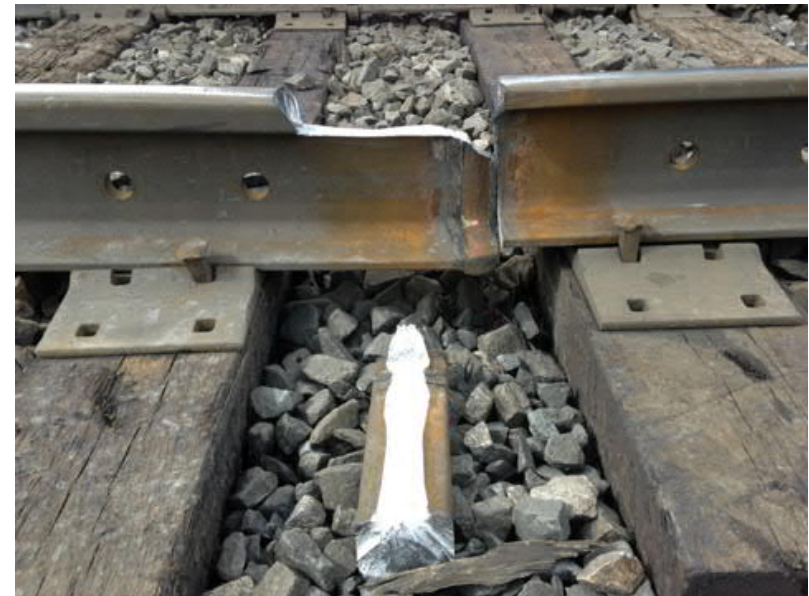
An exception to the second break rule: a broken field weld

Most broken field welds are straight breaks (and do not cause derailments)

Some field welds may fracture with a more complex geometry - such as a longitudinal component. If enough of the head breaks out, a derailment can occur.

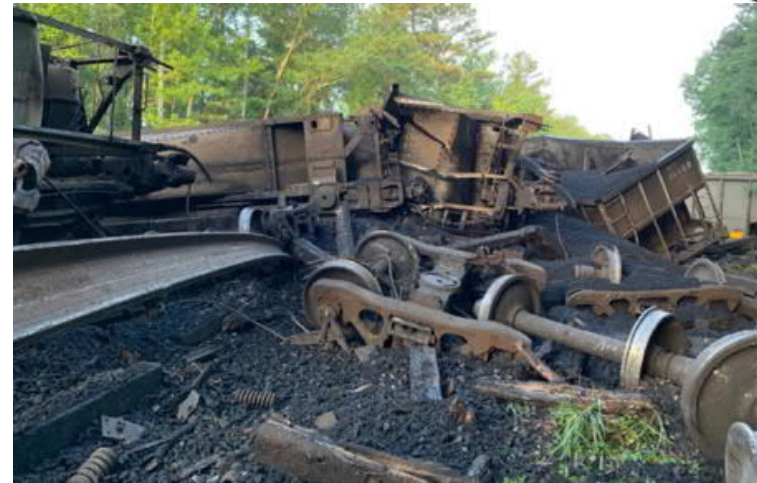
- It is important to recognize that the first detect, or the first broken rail, caused by a TDR, shell or surface RCF is an indication of more to come

This warning gives us the opportunity to change out the rail or increase rail test frequency.

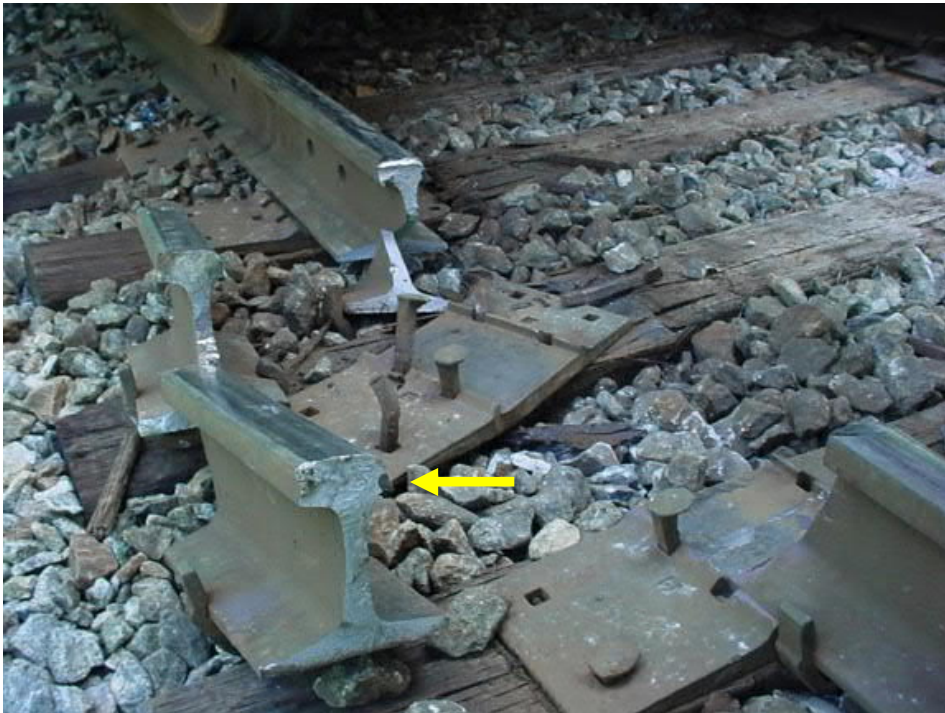
This broken rail certainly fits the multiple break category. But it did not cause a derailment!
