# In-situ Optical Monitoring of Very Early-Stage Rail Wear and Rolling Contact Fatigue Crack Initiation in Laboratory Testing

Adam Wilby<sup>1</sup>, David Fletcher<sup>1</sup>, Roger Lewis<sup>1</sup>, Jacob Corteen<sup>2</sup>

EngD Project Funded by British Steel and the Engineering and Physical Sciences Research Council via the Advanced Metallic Systems CDT

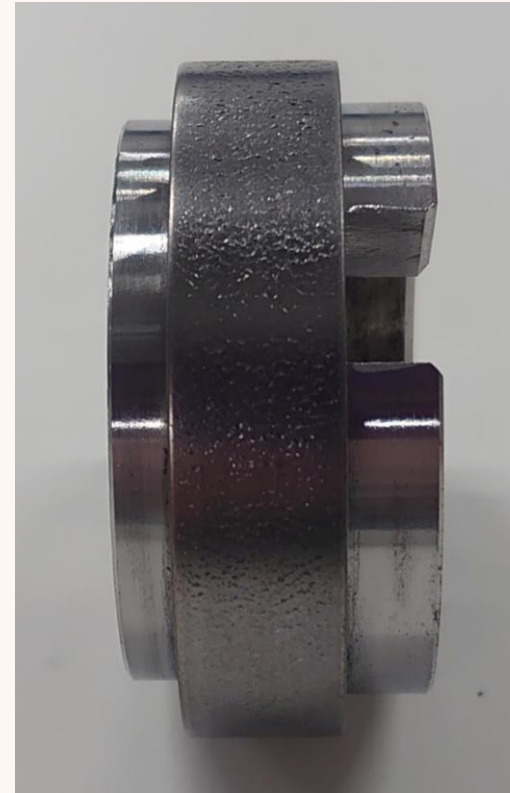
Wear Twin-Disc Sample

- **Study 1** - Assess how the optical monitoring system was able to visualise wear flakes and RCF cracks
  - Twin-disc samples tested:
    - R260 wear twin-disc sample previously test against R8T wheel steel (1200MPa, 1% slip, dry) up to 80,000 contact cycles
    - Calibration disc with a spark eroded RCF crack
    - Unworn twin-disc sample
- **Study 2** – Assess the performance of the system during a test when the disc are in contact
  - R260 rail steel against R8T wheel steel for 1200MPa, 1% slip, dry contact conditions up to 40,000 contact cycles
  - Image captured every 30 secs
