Real-Time Railhead Friction Estimation Using Machine Learning: Development of An On-Board-Train Data Capture System.

Presented at the UKRRIN 2025 STUDENT CONFERENCE ON
7TH JANUARY 2025

Morinoye Olufunmibi Folorunso^{1*}, Mike Watson², Roger Lewis¹

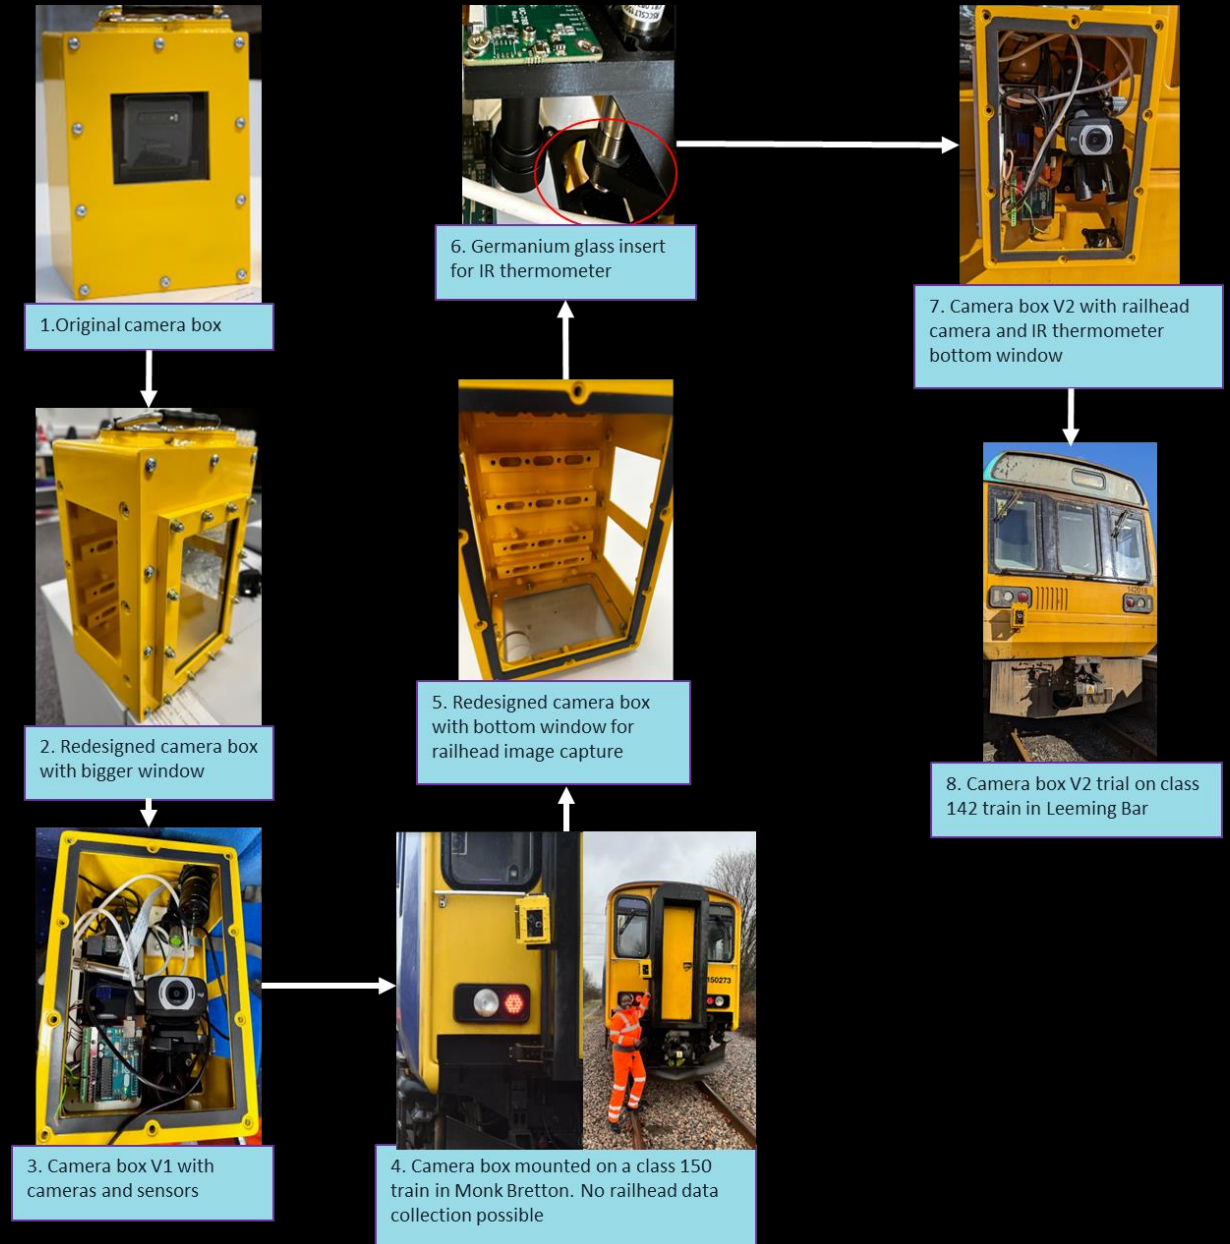
- The process followed to reach the final design chosen for the on-train data capture design, “The yellow camera box”.
- It underwent different modifications before reaching the final stage.

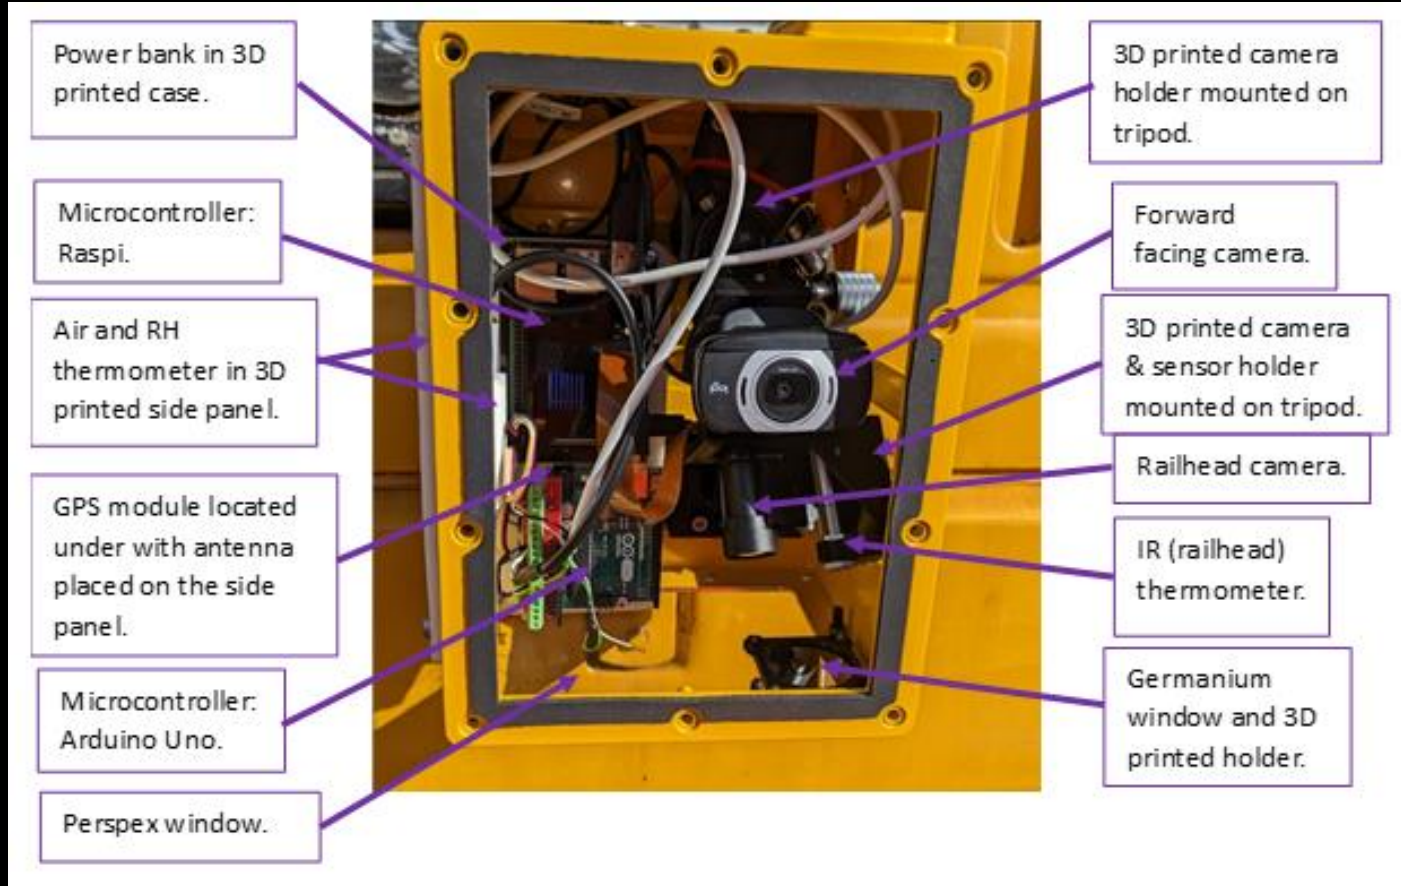
- The camera box final design and its components
- Temperatures are validated using a hand-held Infrared thermometer (off-site) and Met Office “Weather Observation Website” (on-site)

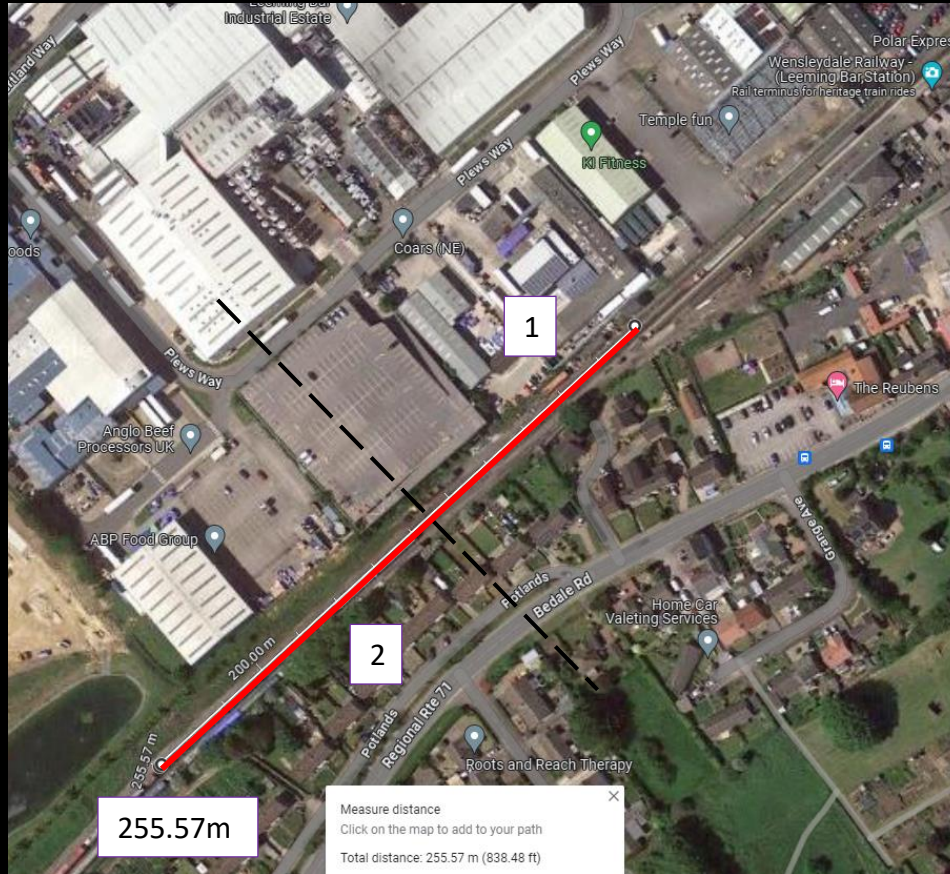
Short Run Tests

- WHR depot area over a short distance of approximately 260 metres
- Low speed of maximum 10mph
- Data collection rate of 1 per 2 seconds.

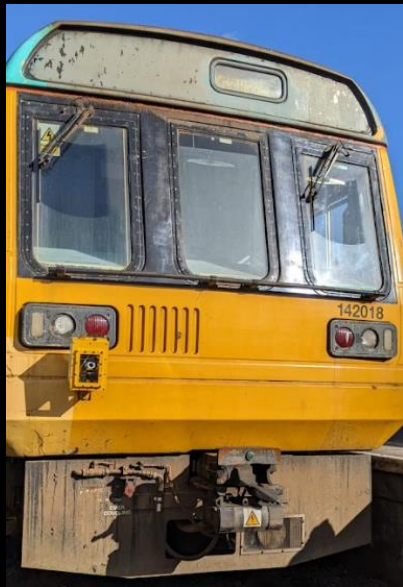
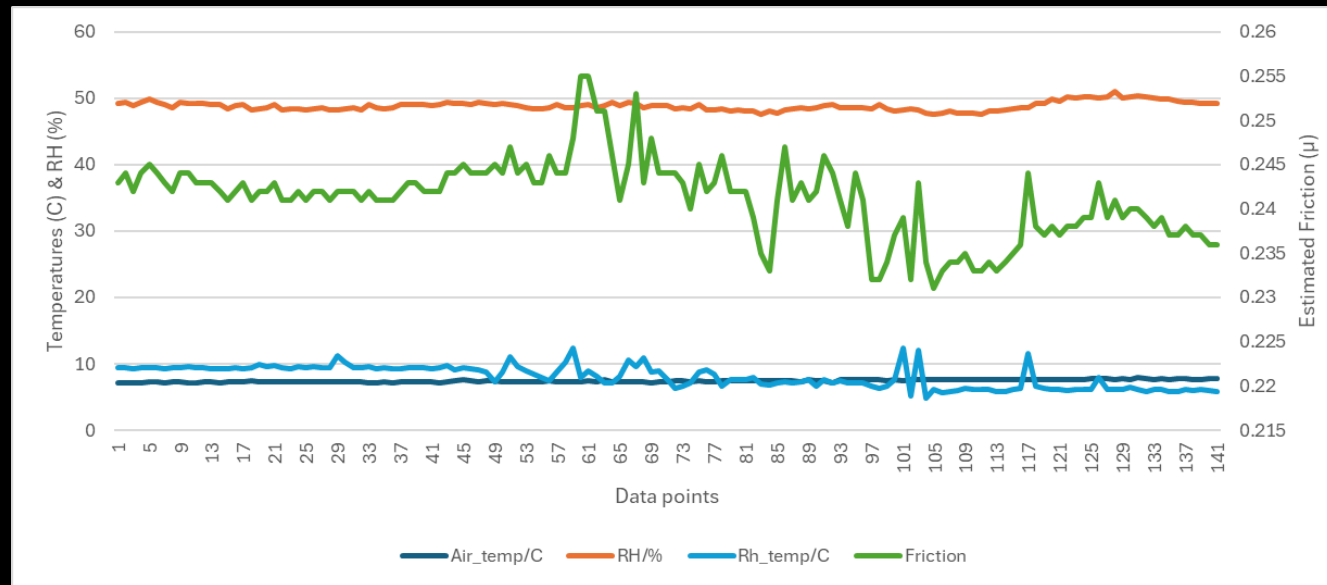
First test
(Short run)
carried out
with camera
box in WHR
on 14-03-23

- The movement of the train during testing, caused some image blurriness. However, this did not affect the friction estimation tool's ability to process the images or determine friction coefficients, as it could still identify key colors.

- Forward-facing images remained clear enough to recognize vegetation and surroundings, and future work may include using strobe lights and specialized cameras to enhance railhead image quality.
- Friction estimates ranged from 0.231 to 0.255, consistent with the conditions at WHR. Railhead temperature sensors effectively captured real-time variations (4.8°C – 12.4°C), with sunlight exposure on certain rail sections causing temperature peaks, while shaded areas remained cooler, as confirmed on corresponding forward-facing images showing the surroundings.

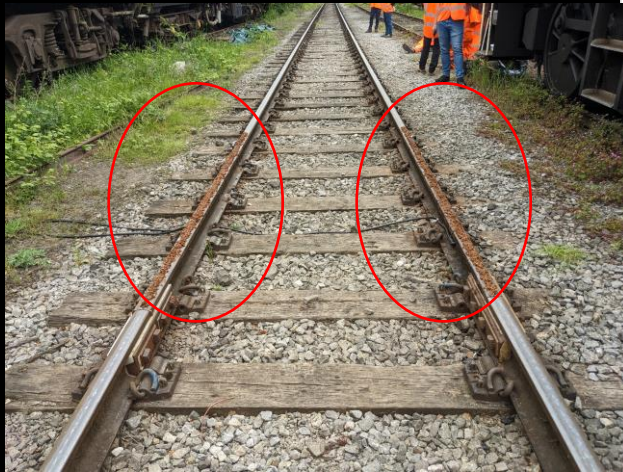
- Black leaf layer tests on 28-11-23 using dried Sycamore leaves

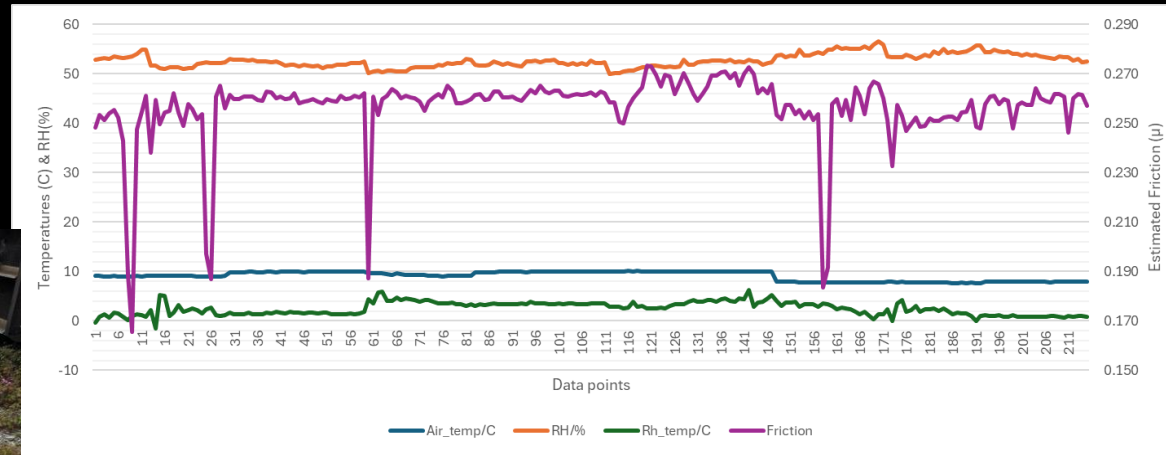
CAMERA BOX 1: Troughs showing effects of leaf layers created

- Two camera boxes were used; camera box1 in front of the train and camera box2 at the rear end.
- They captured railhead images from 2 different rail tracks (ie both opposite tracks).
- Camera box 1 estimated a maximum friction of 0.282 and minimum friction of 0.166
- Camera box 2 estimated a maximum friction of 0.272 and minimum friction of 0.174.

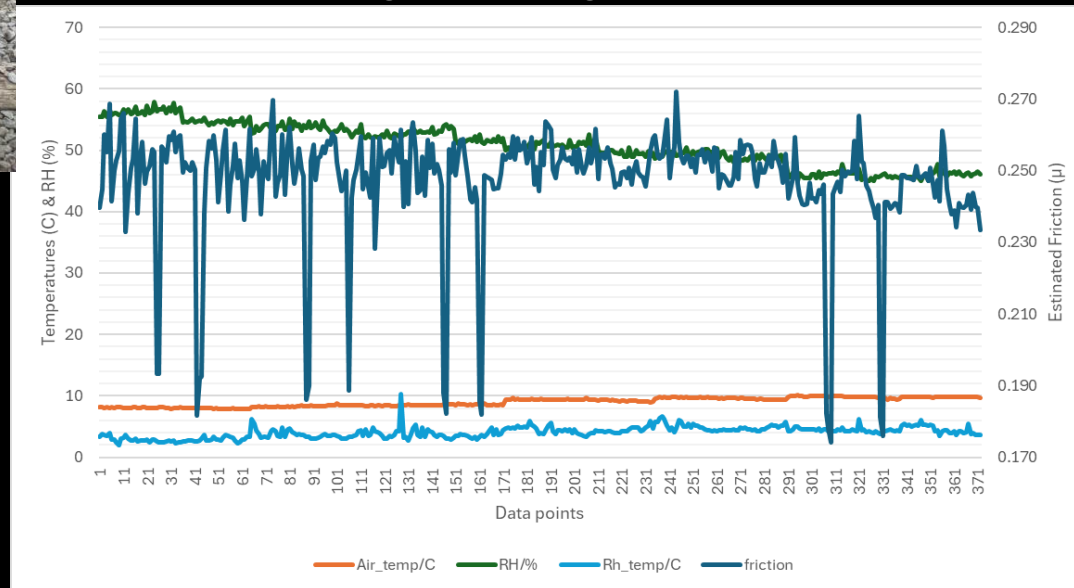
CAMERA BOX 2: Troughs showing effects of leaf layers created

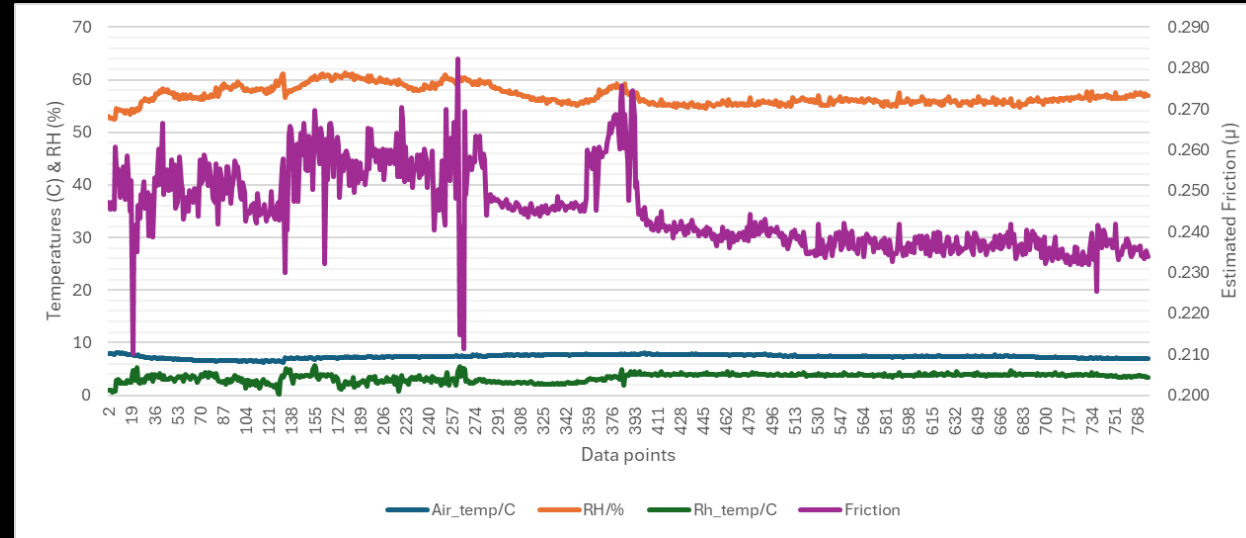
CAMERA BOX 1: Long run tests from Leeming Bar to Bedale

- The estimated friction for the long run ranged between 0.227 to 0.282 and 0.227 to 0.270 with exclusion of the tunnel effects and railhead temperature anomaly for camera box 1 and 2 respectively.

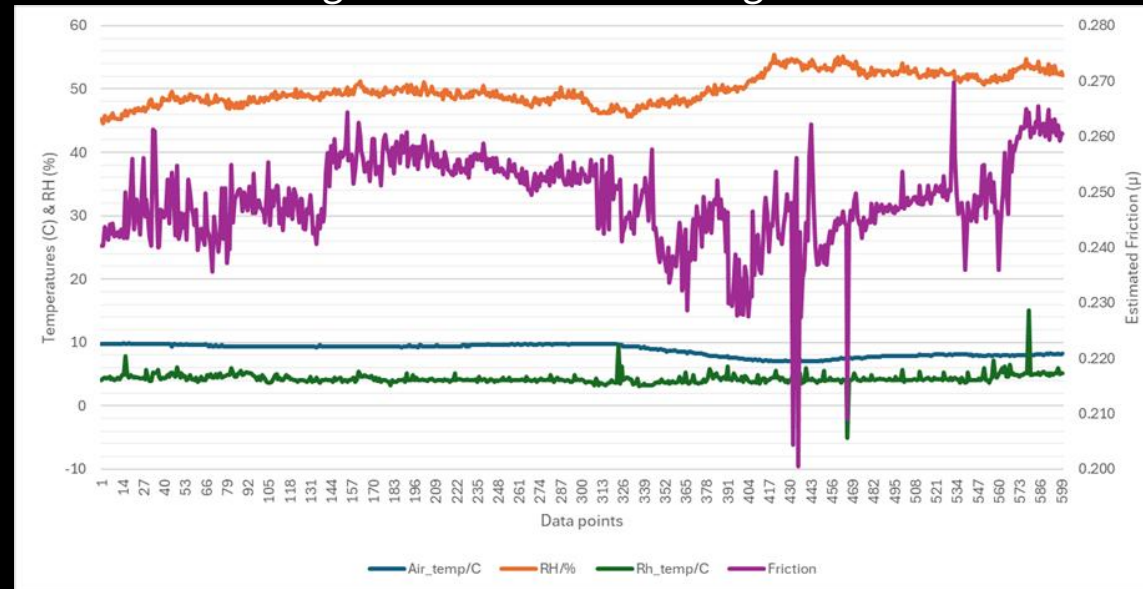
CAMERA BOX 2: Long run tests from Leeming Bar to Bedale

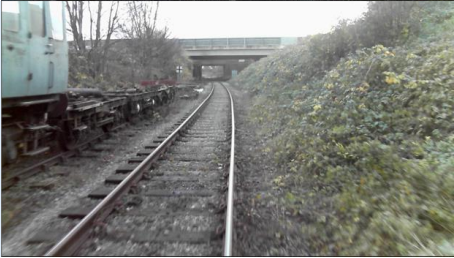
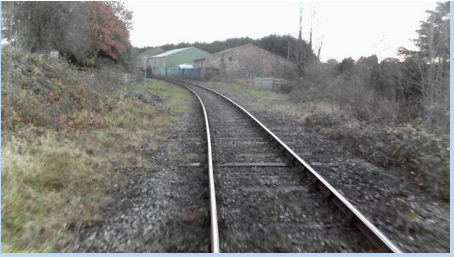
Data sample from
Camera Box 1,
Short run test. 28-
11-23

- In the final trial, the two camera boxes recorded similar air temperatures ($8\pm 2^{\circ}\text{C}$), indicating consistent sensor performance. Railhead temperatures for Camera Box 1 ranged from -1.6°C to 6.2°C , with lower readings at the train's front. Camera Box 2 recorded 1.9°C – 7.9°C , slightly with higher readings at the trailing side where the railhead had been warmed by train wheels.

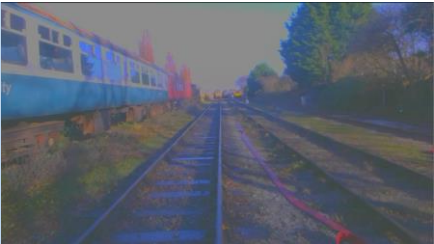
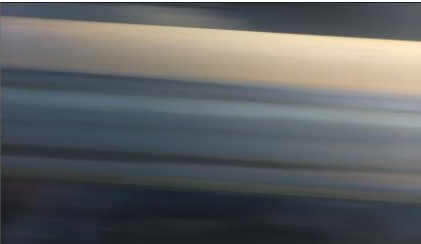
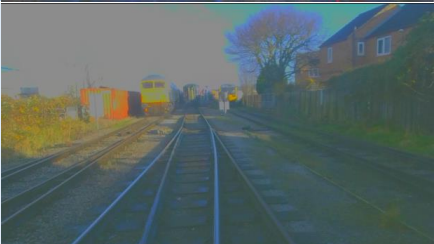
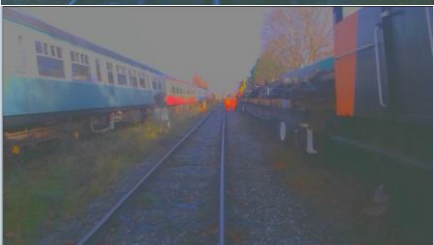
Data sample from Camera Box 2, Short run test. 28-11-23
