Optimizing Maintenance and Wheel Rail Surface Roughness to Reduce Light Rail Train Noise

Briony Croft, Mark Reimer, Shankar Rajaram, Laura Lapena, Luke
Watry, Katie Krainc

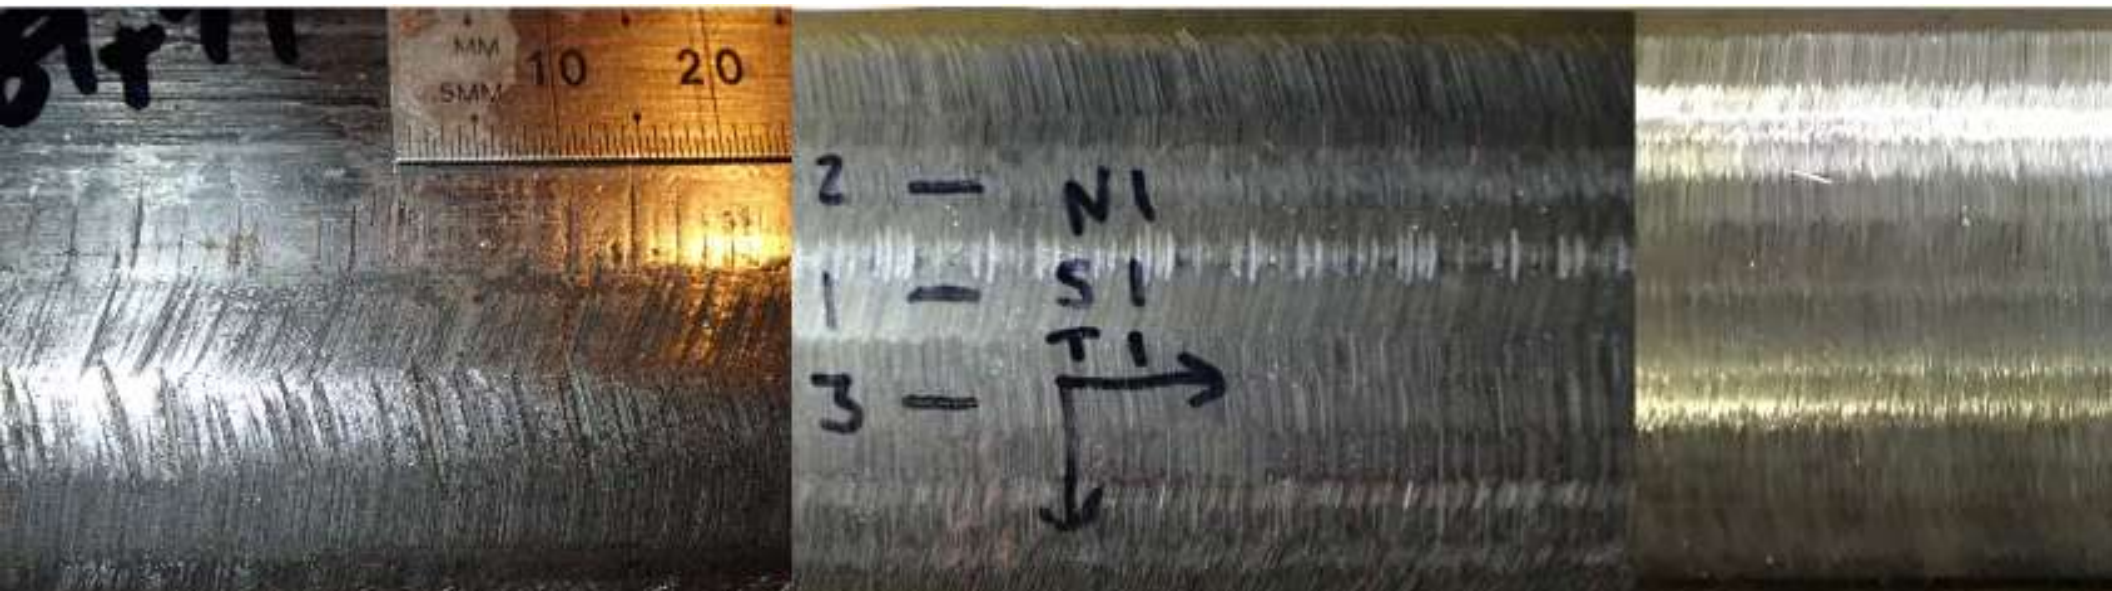
Top left: In 2016 approximately 5 miles (8 km) of track entered revenue service after rail target profile installation left coarse residual grind marks. This image is the grind signature still present 2 years after coarse grind.

Top middle: after grinding with medium grit stones.

Top right: after acoustic polishing step.

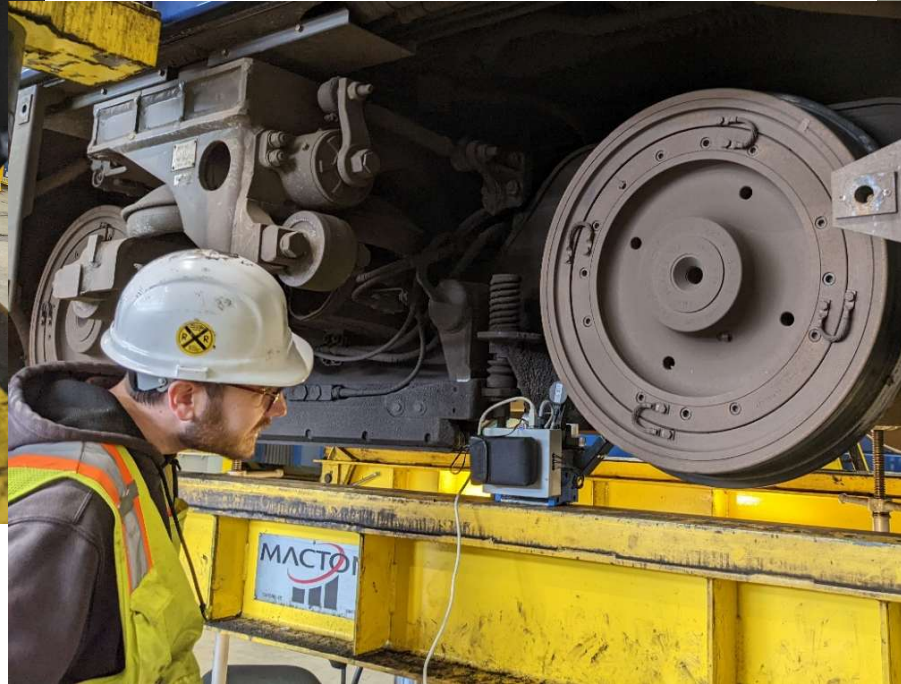
Detailed investigations of wheel roughness

- Measurements of 204 wheels (124 after quality checks)
- Freshly machined through to 198,000 miles, well beyond typical reprofiling interval
- RMS of all measured wheels similar to ISO 3095:2013
- Wheel roughness in service independent of mileage – freshly machined wheels quickly wear in
- Some outliers, but unrelated to distance travelled
- General wheel acoustic roughness (excluding discrete defects e.g. flat spots) was also independent of the vehicle and truck/bogie type
