Chasing the Magic Wear Rate

ICRI Workshop – September 22nd, 2025

Develop, validate, and use models of wear and surface fatigue to establish guidelines for the integration of the **Magic Wear Rate (MWR)** into track maintenance practices.

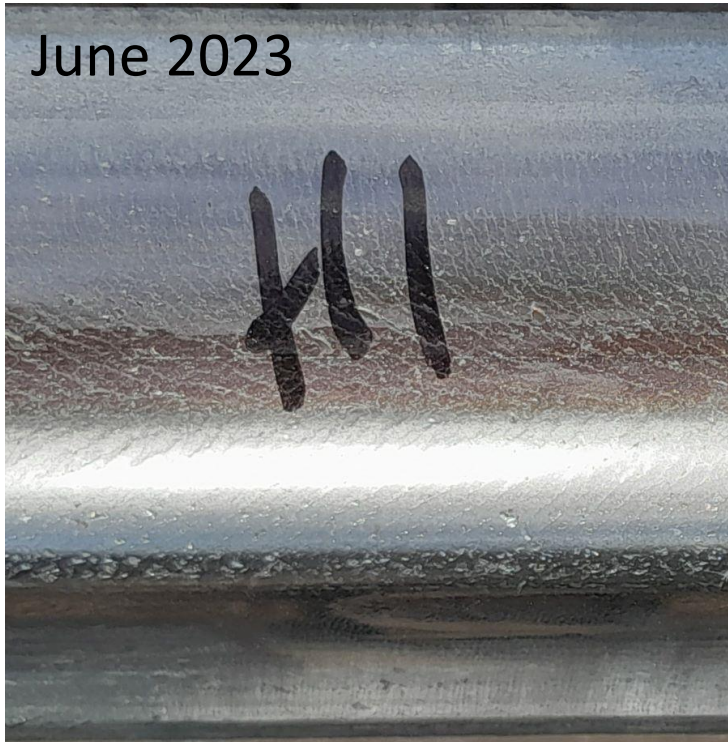
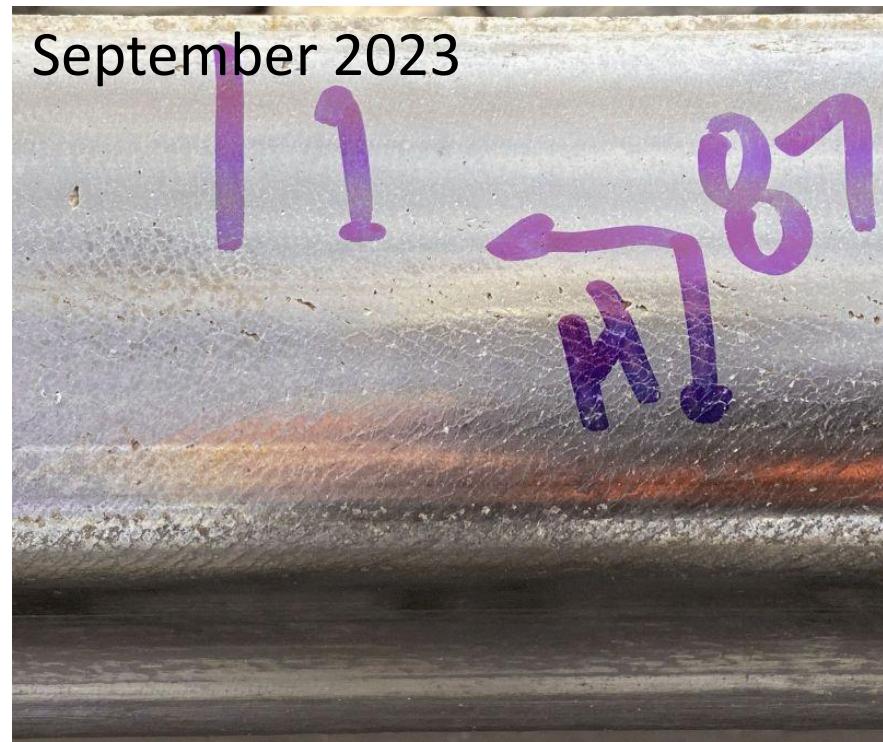
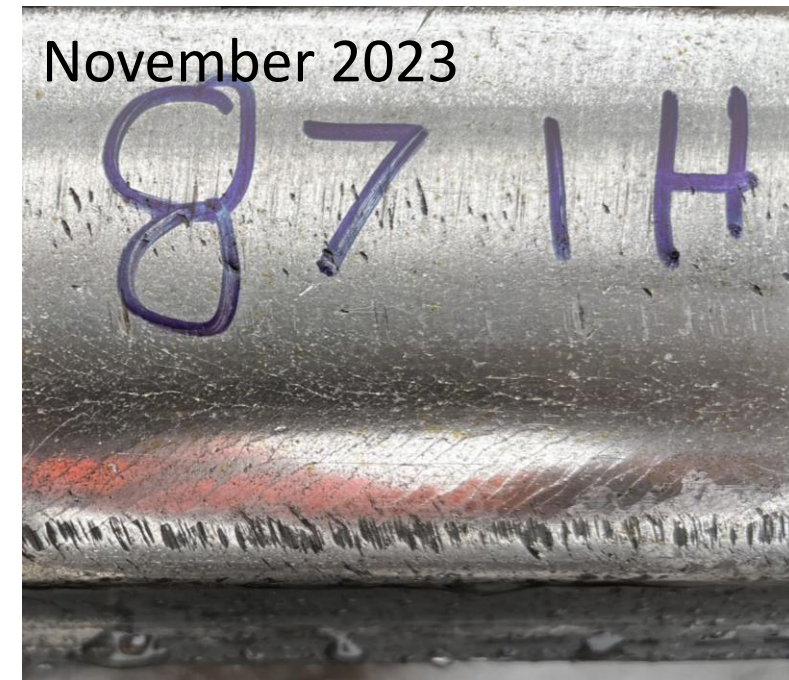
Photographs used to determine the qualitative severity of RCF damage at each site based. Demonstration with location 87's high rail shown here.

272 m curve high rail

June 2023

September 2023

November 2023

Light RCF

Mild RCF

Some RCF after grinding

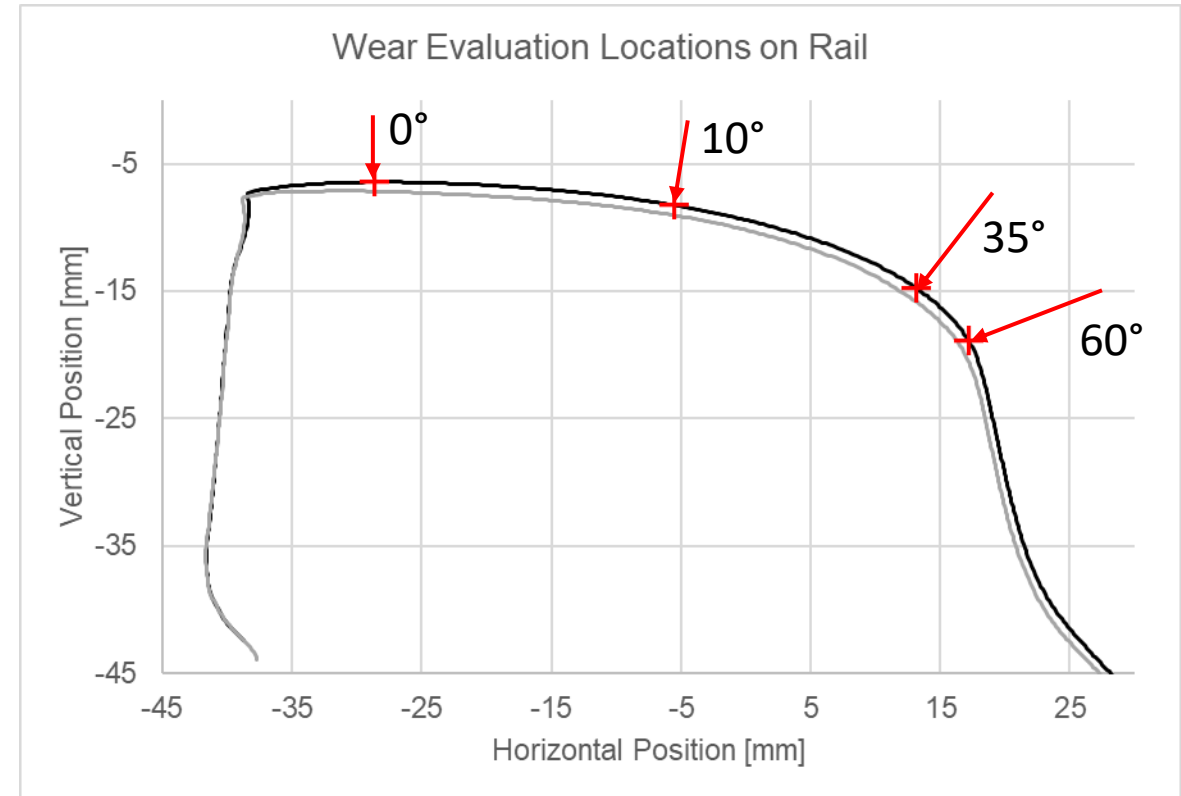
- Profiles aligned to reference by NRC
- Wear calculated at 0°, 10°, 35°, 60°
- Jun → Sep wear + MGT = wear rate
- Sep → Nov wear & grinding + MGT + wear rate = grinding depth

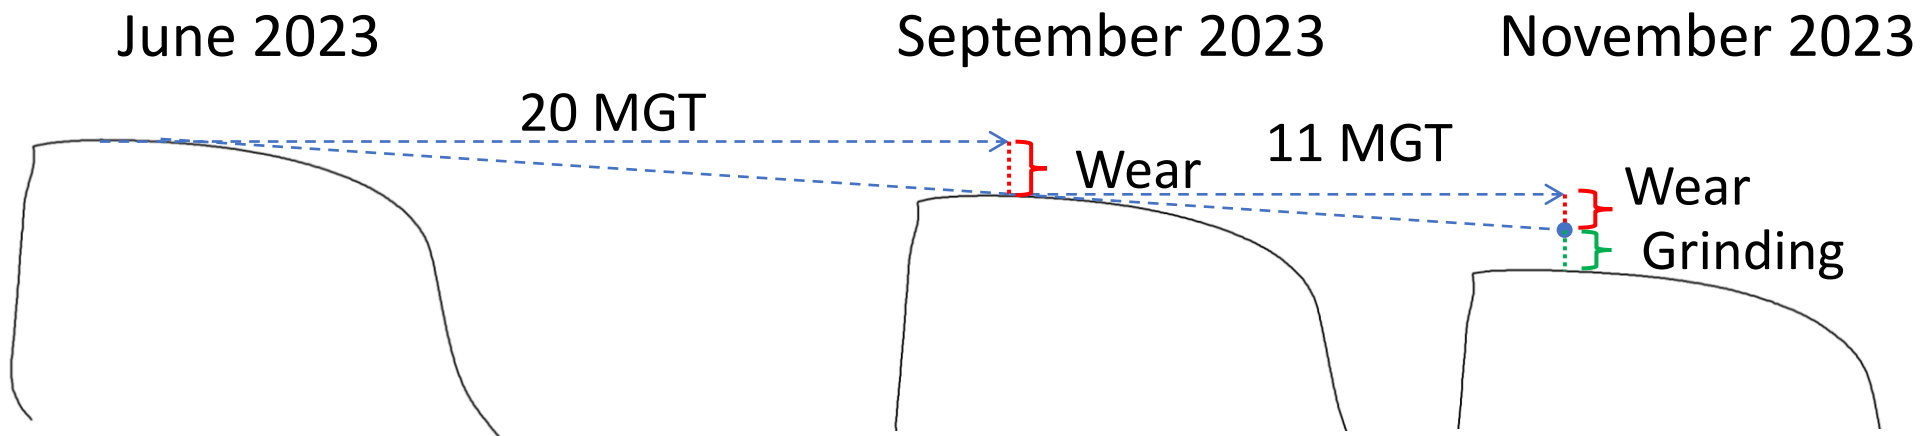
- Profiles aligned to reference by NRC
- Wear calculated at 0°, 10°, 35°, 60°
- Jun → Sep wear + MGT = wear rate
- Sep → Nov wear & grinding + MGT + wear rate = **Grinding depth**

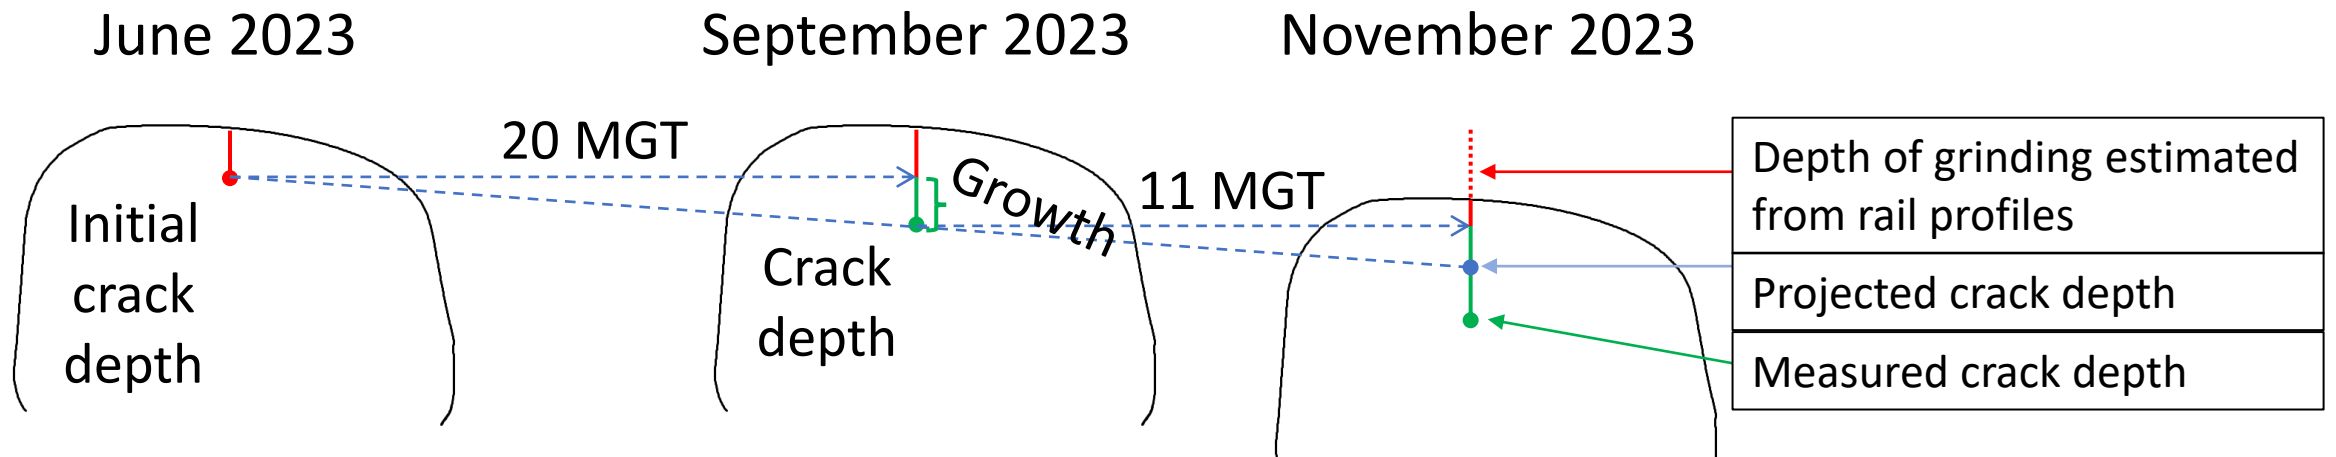
Draisine measurements available in Jun, Sep, Nov at 5 test sites.

Challenges with crack depth measurements:

- Measured crack depths do not match surface photographs

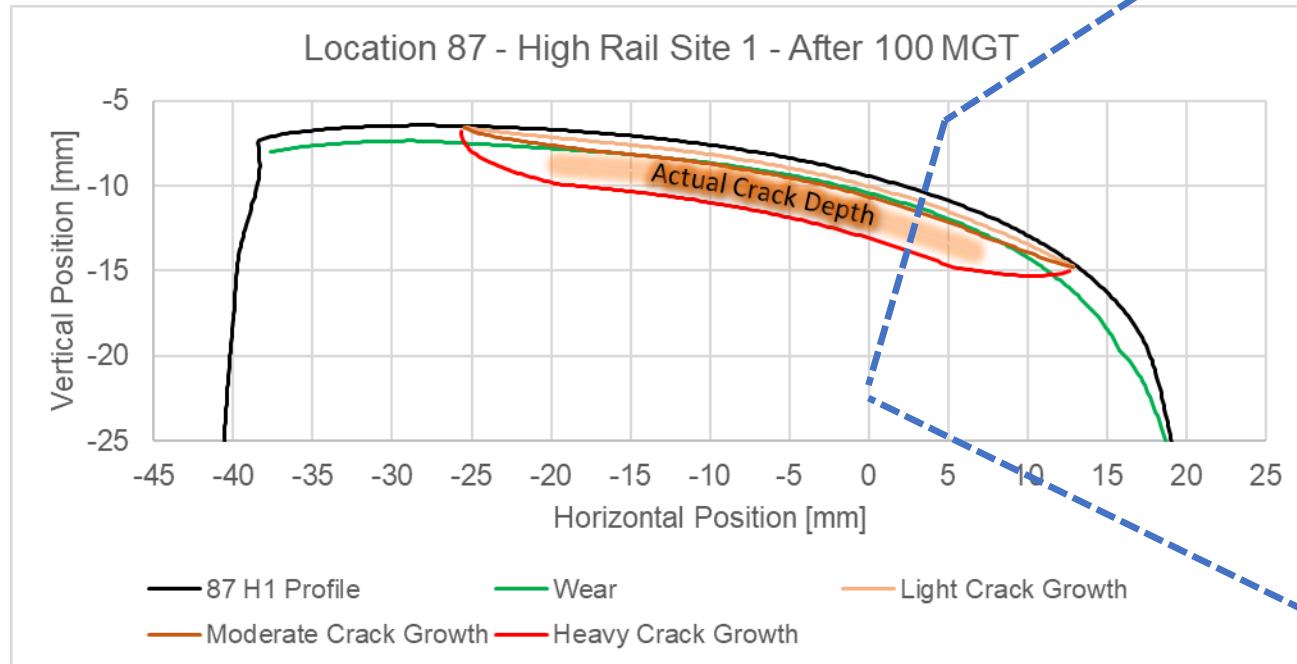
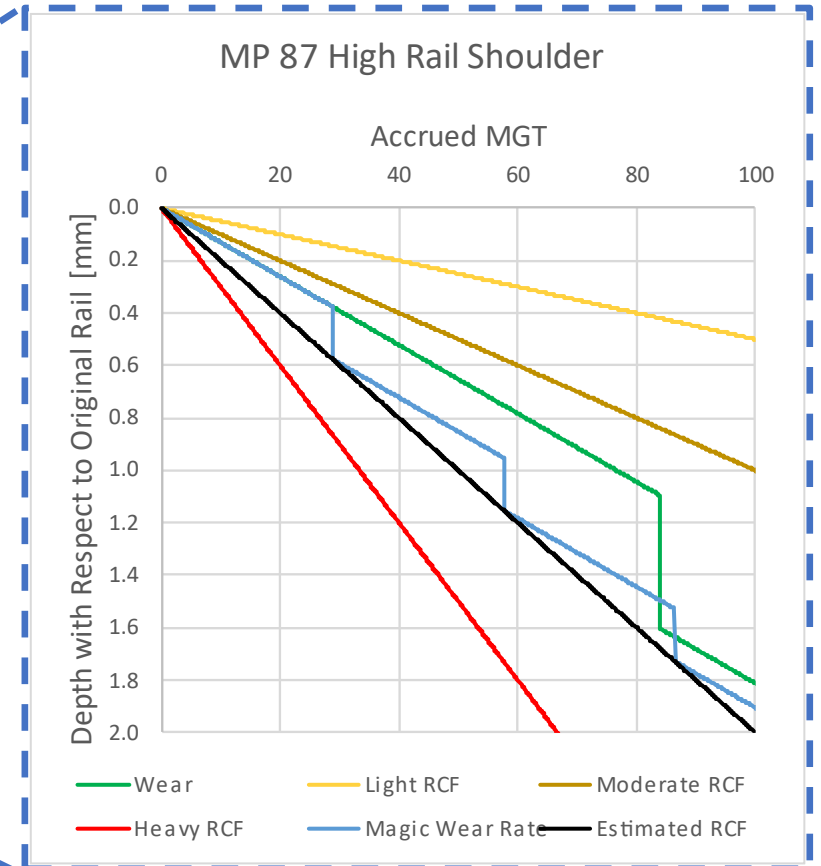
Location 87- Sharp Curve High Rail

Innotrack's 2006 "Definitive guidelines on the use of different rail grades".

- Light < 0.5 mm / 100 MGT
- Moderate ≤ 1.0 mm / 100 MGT
- Heavy ≤ 3.0 mm / 100 MGT

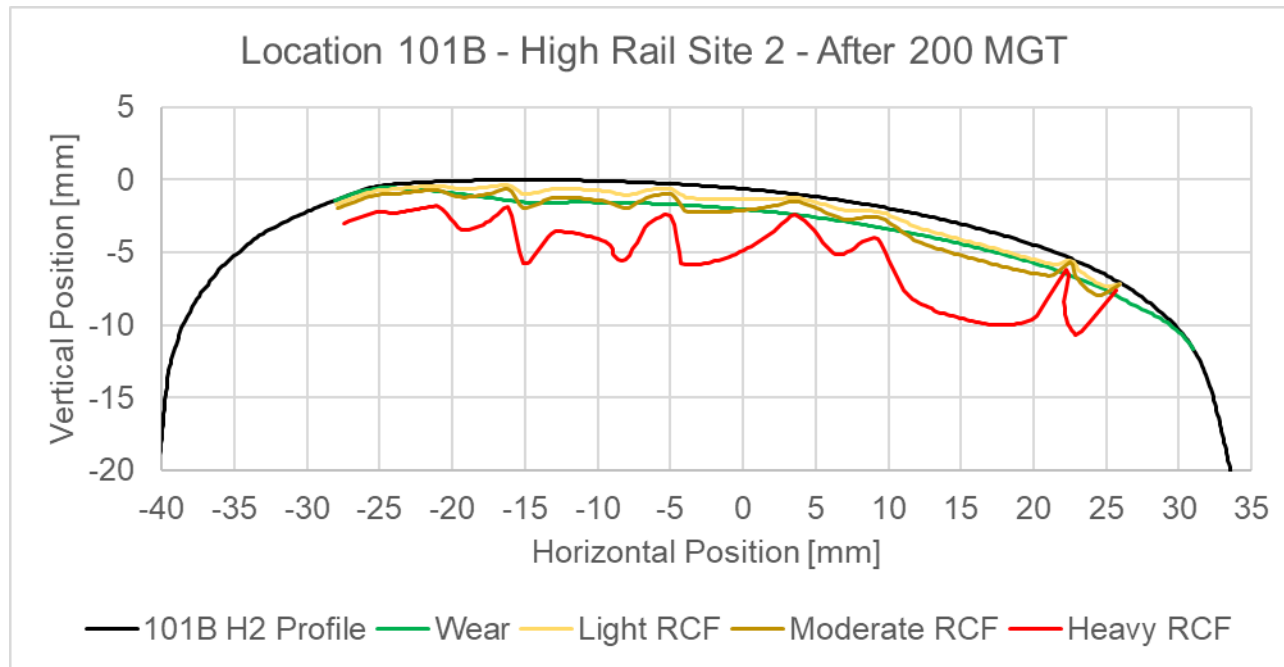
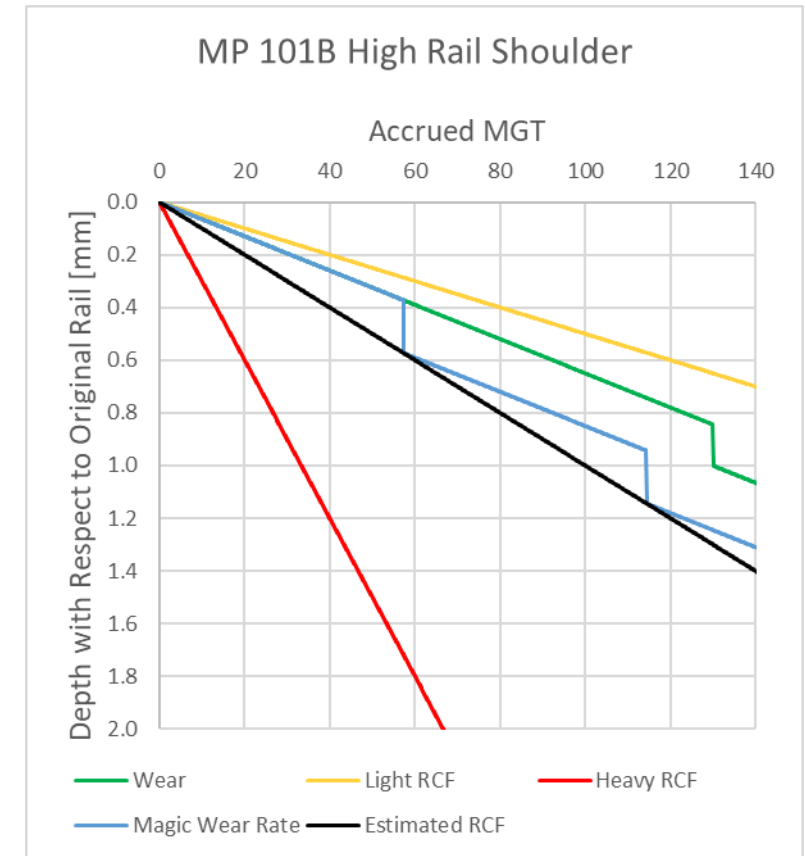
Location 101B - Mild Curve High Rail

- ICRI RCF Atlas → enabled detailed crack depth envelope
- RCF managed by 2 single grinding passes/year
