1ST FEBRUARY 2017

London Underground RCF Monitoring

Andy Vickerstaff
Senior Wheel-Rail Interface Engineer, London Underground

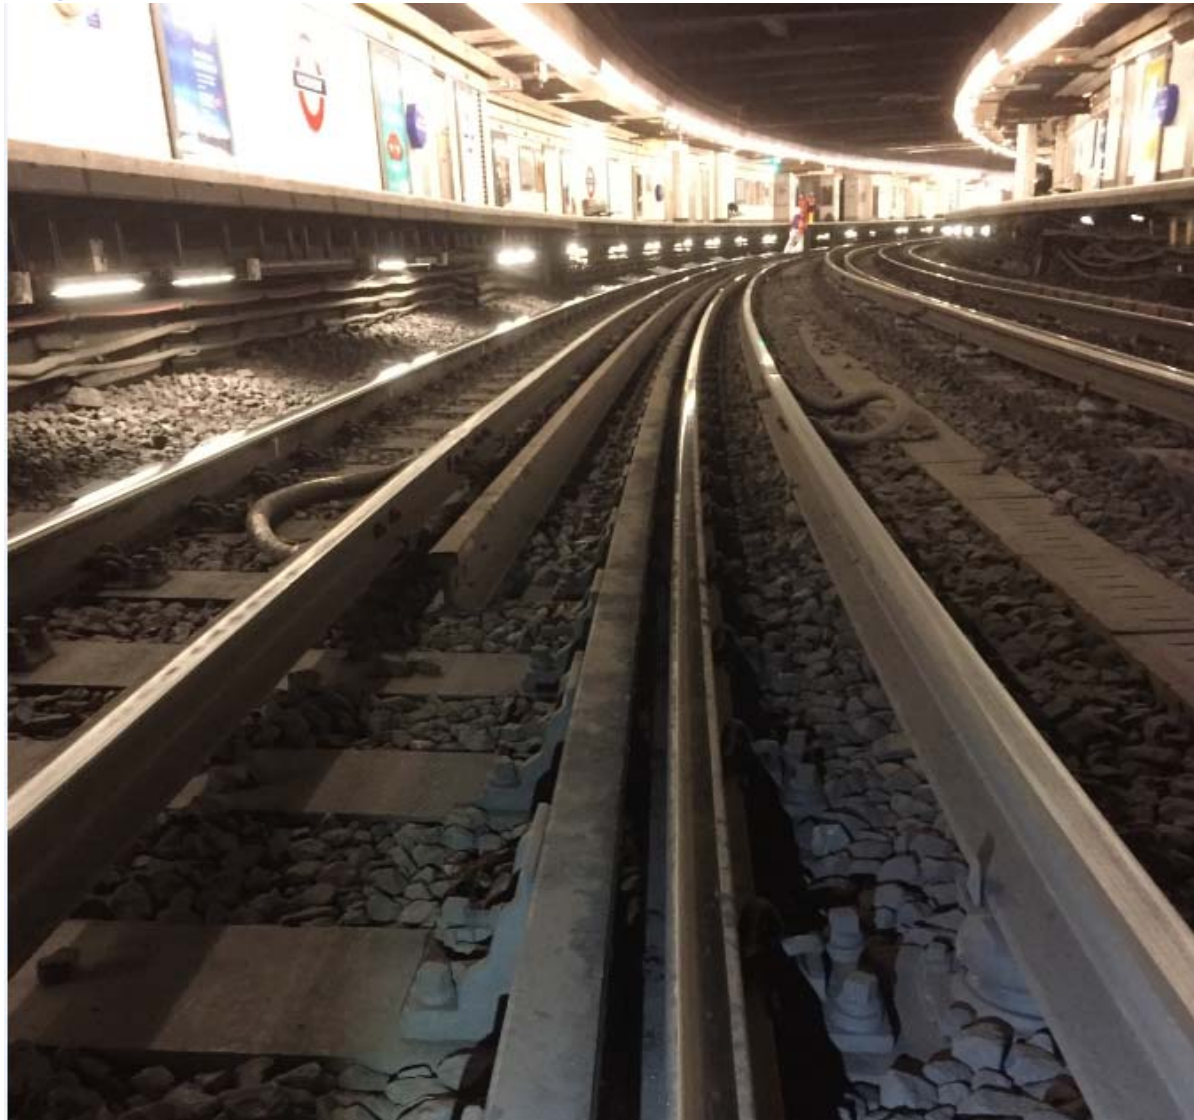
RCF-DIS-6

- Bank/Monument WB platform 0 – 123m
- S-Stock & Manually Driven
- Sub Surface, Low Rail (Right)
- Radius 200m, Cant 90mm, Deficiency 20 to - 80mm
- Flatbottom Rail, 1438mm Gauge, Check Rail
- Re-Railed: 1st June 2016
- Survey: 15th November 2016, 1st December 2016 (post grind)
- 46MGT, 3.4M axle passes

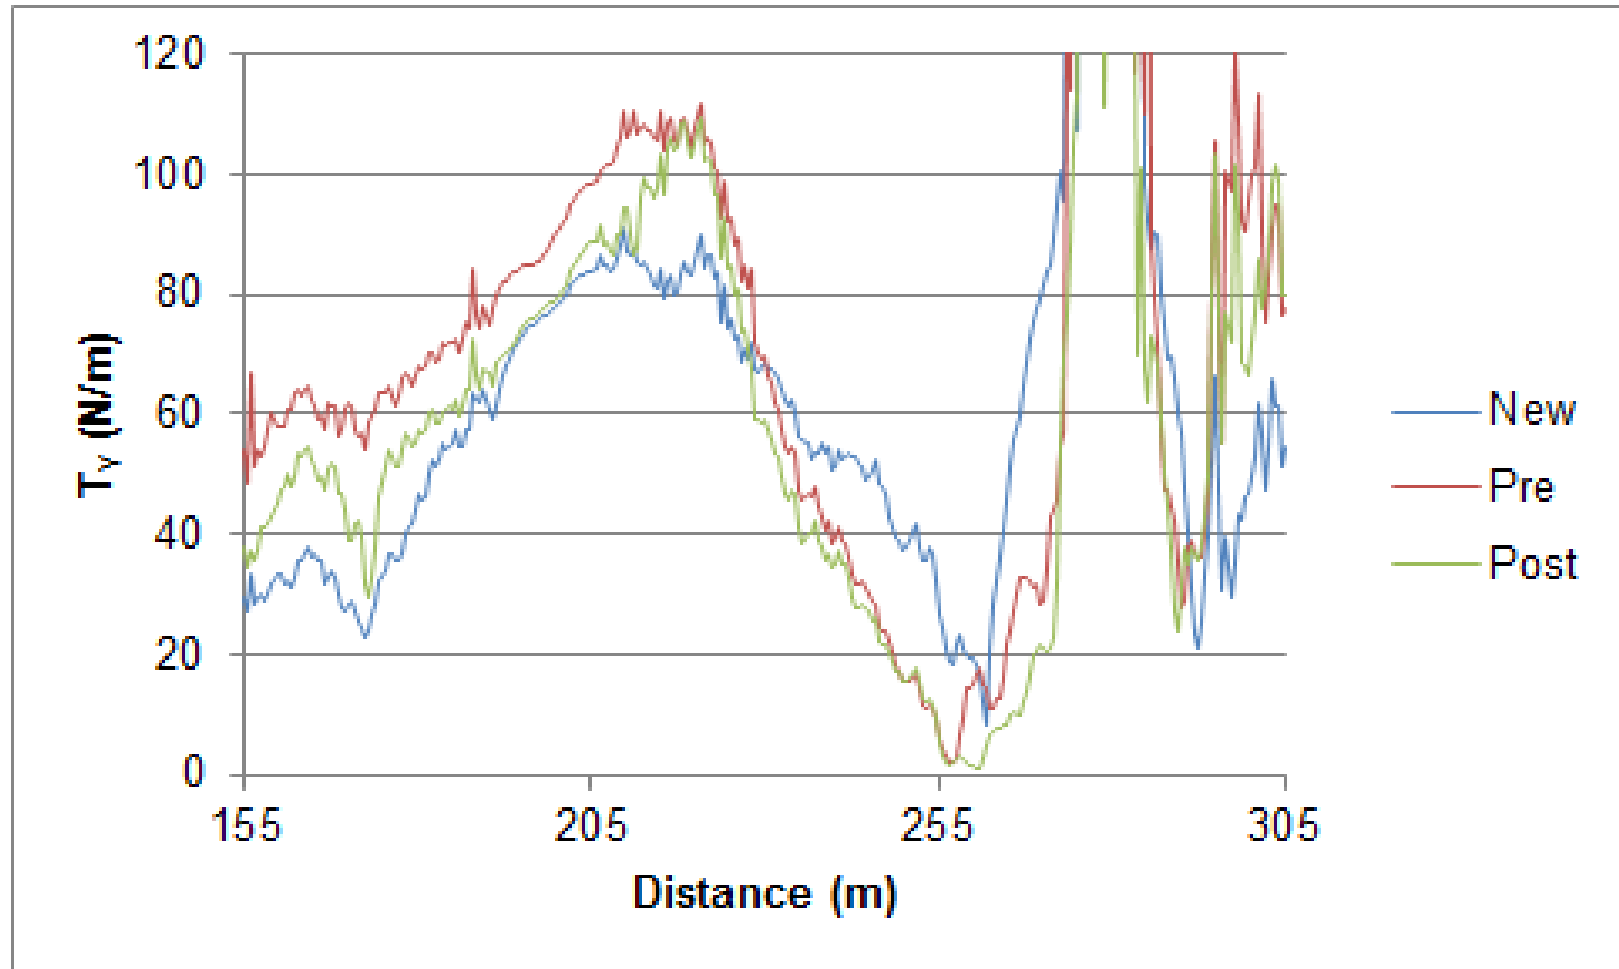
RCF-DIS-6 Low Rail Results

- Reduction in T_y between pre and post grind
- No RCF appearing on RSCM
- Some cracks removed from low rail gauge corner from 0.35mm removal
- WLRM predicts low rail RCF but again should have 'failed'
- High rail should be in wear region?
- Crack density historically more likely to result in UUR at this site
