# **Squat-Type Defects in Light Rail: Experiences in Inspections, Laboratory Tests, and Maintenance Approaches**

**Presentation to ICRI - CM**

**20 September 2025**

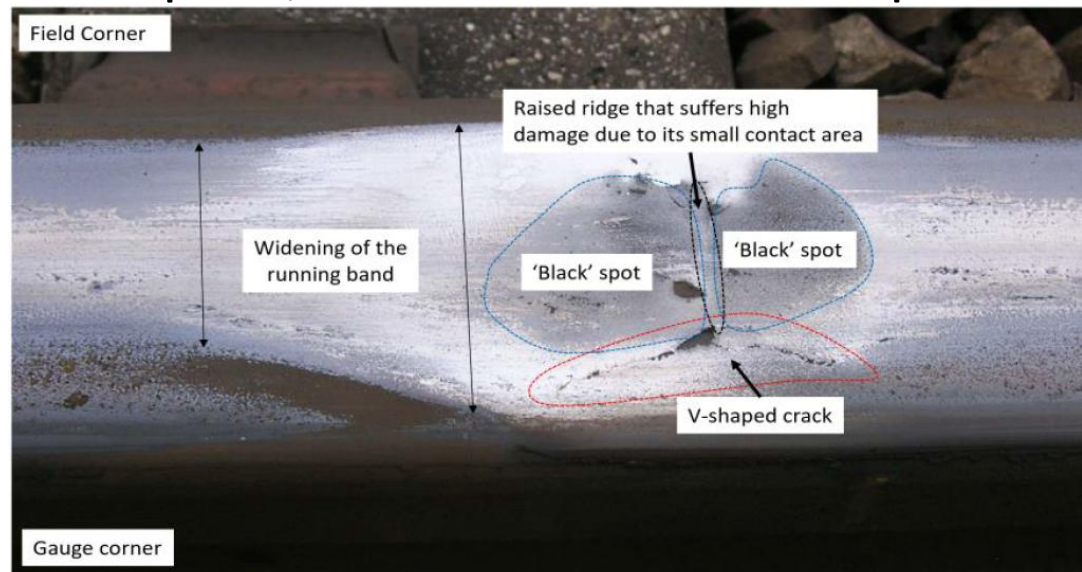
# Squat-Type Defects - Characteristics

- Several millimetres across the railhead
- Before spalling can cause rough ride
- Damage fasteners, ballast, ride quality, noise & vibration
- Increase track and vehicle maintenance
  - Substantially shortens the usable rail life
- Appear the same as Squats, but causes and consequences are different

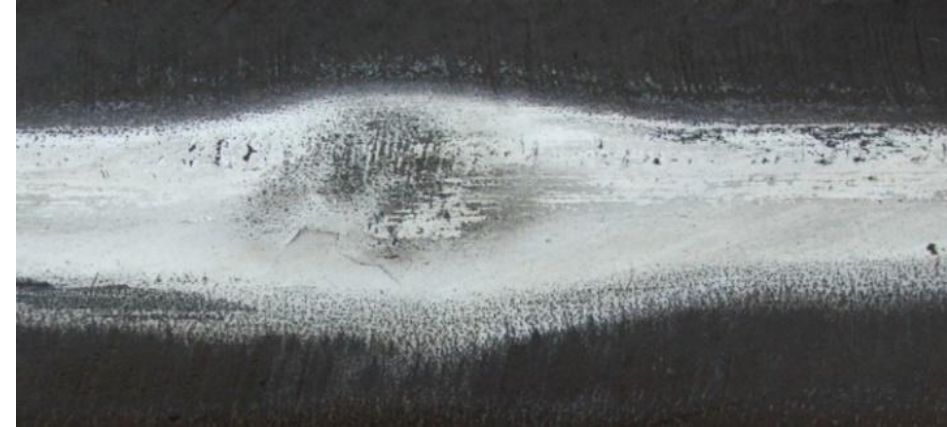
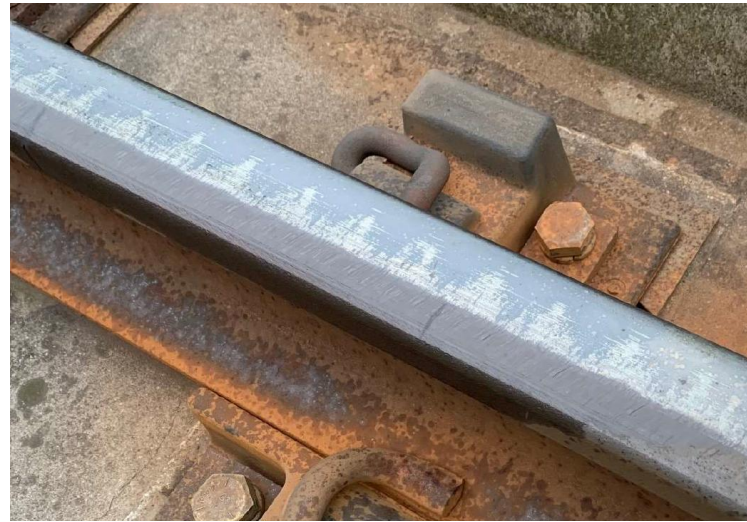
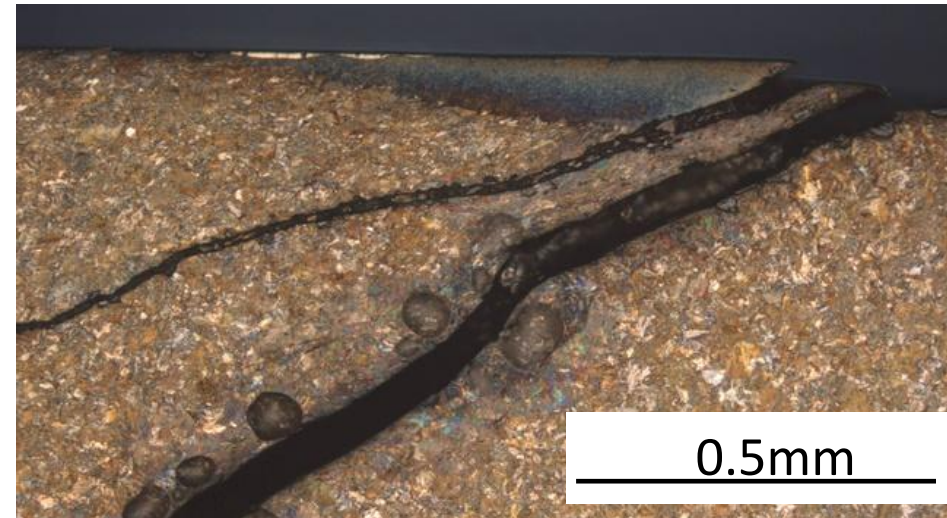
# Squat-Type Defects - Characteristics

- Almost no plastic deformation
- Formation within 10 MGT or less
- Old and new rails, tangent and curves
- Presence of WELs
- Not found in tunnels

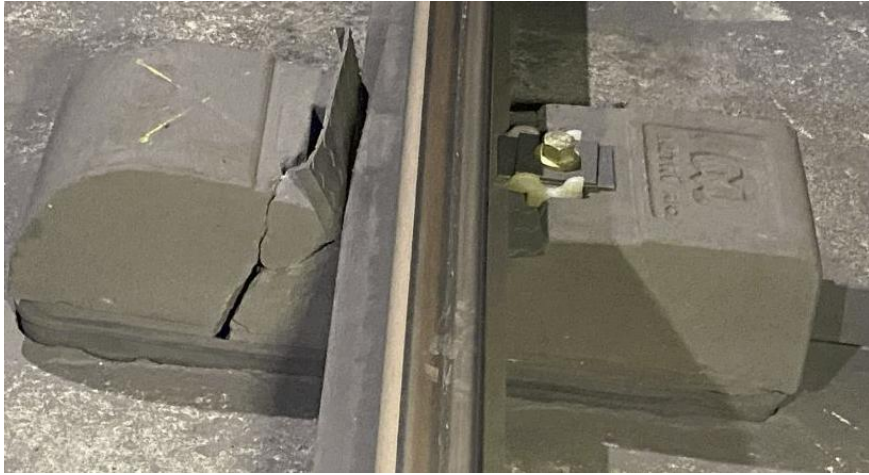
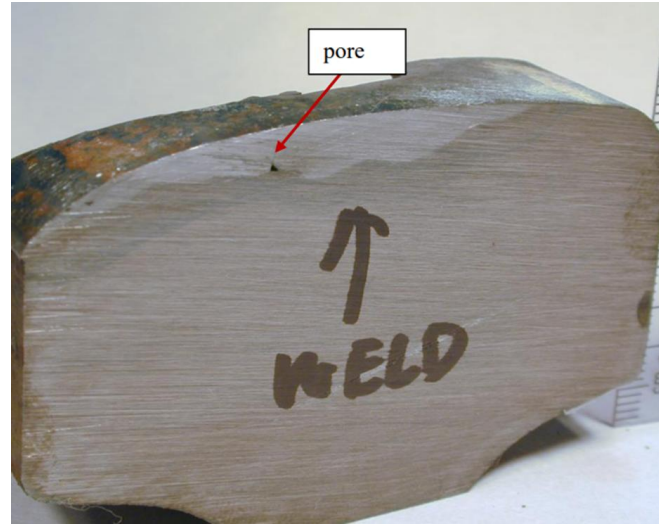
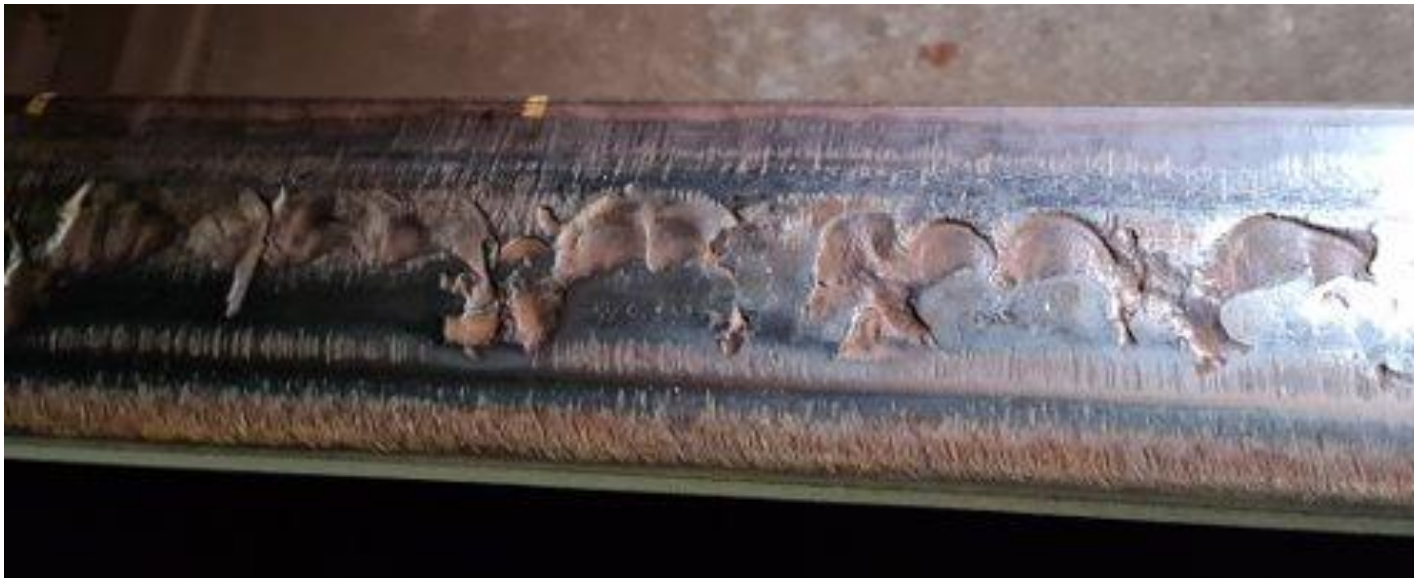
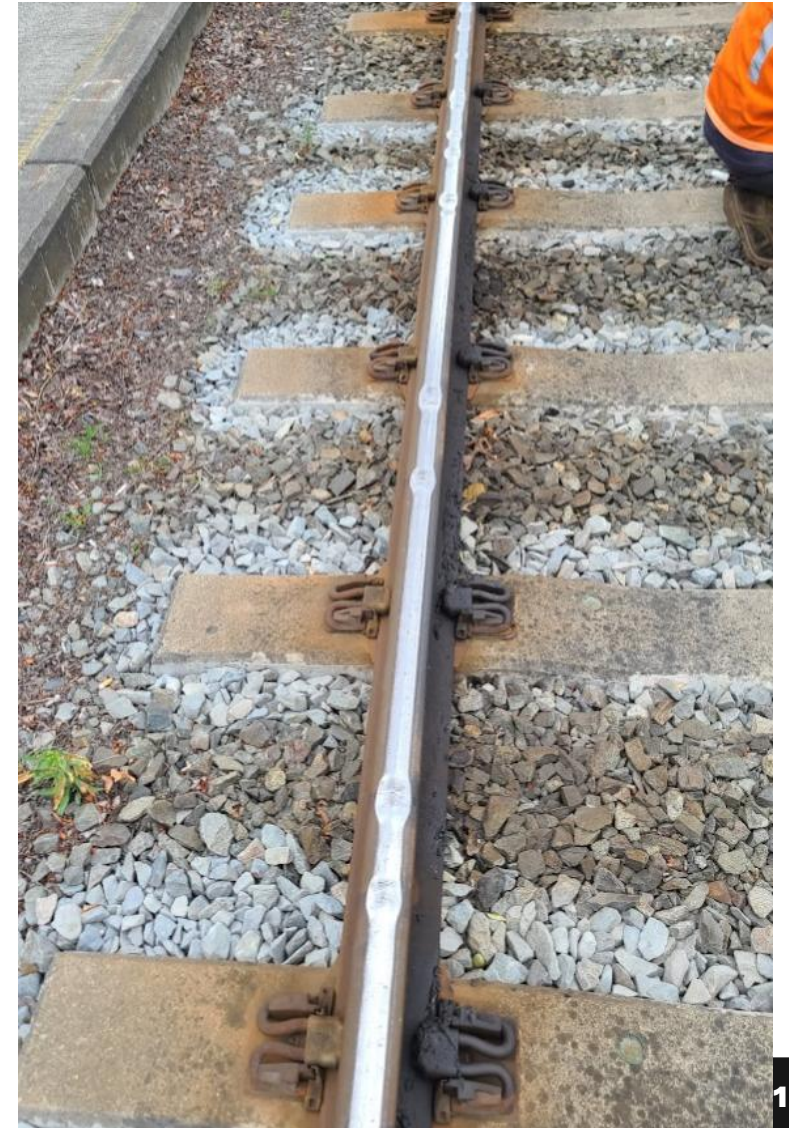
- Surface defect size can create an exception in APTA or other track standards developed by North American standards resulting in slow orders or watch and proceed
- Some maintenance activities like rail head welding have caused rail breaks that are associated, indirectly, with squat-type defects
- Early rail replacement / reduced asset life

# Squat-Type Defects - Consequences

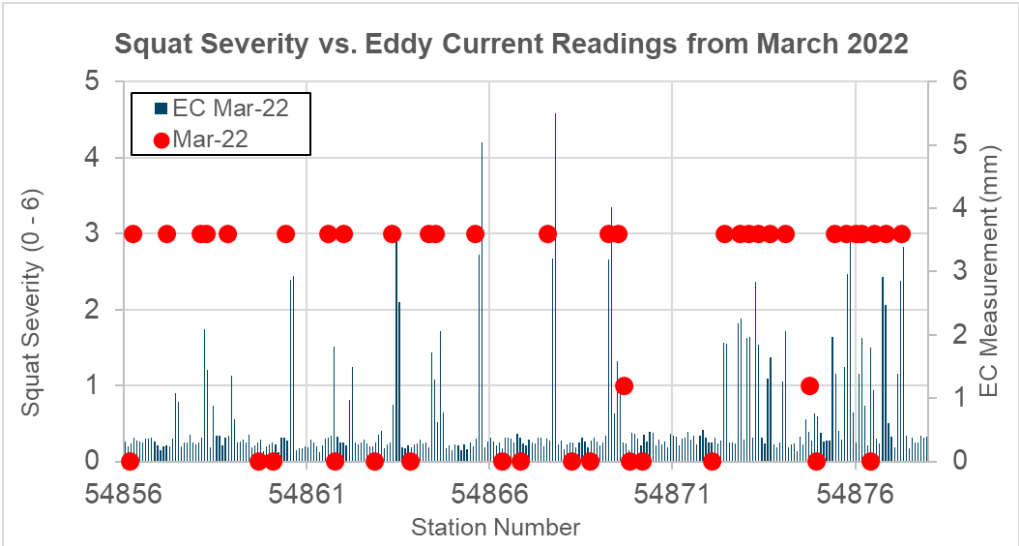
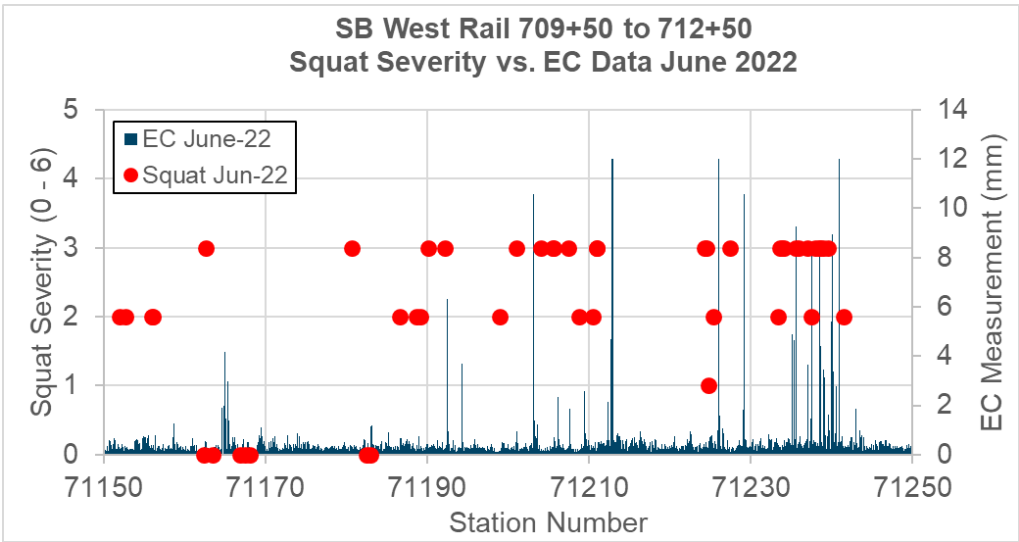
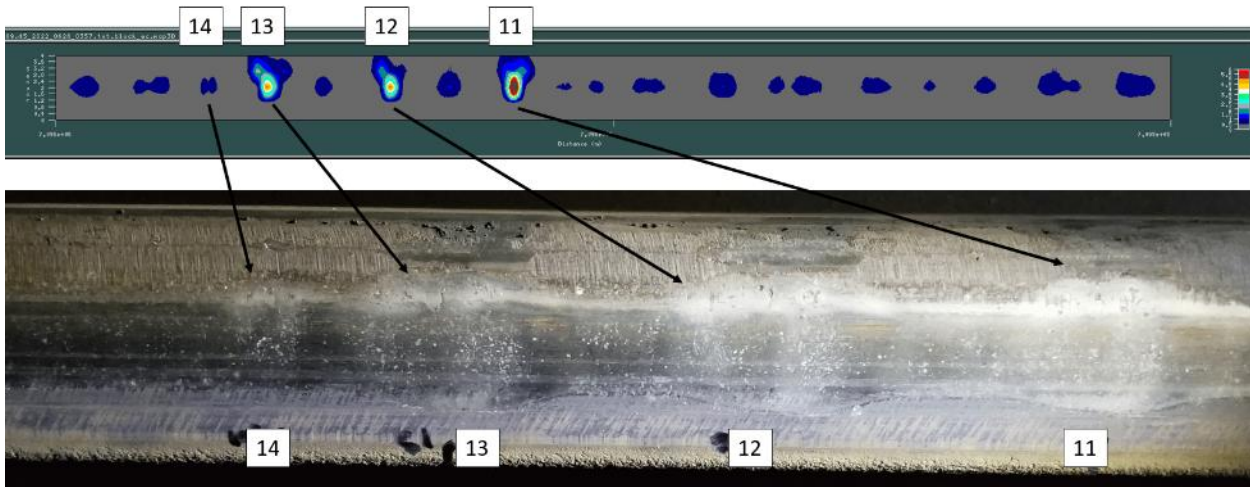
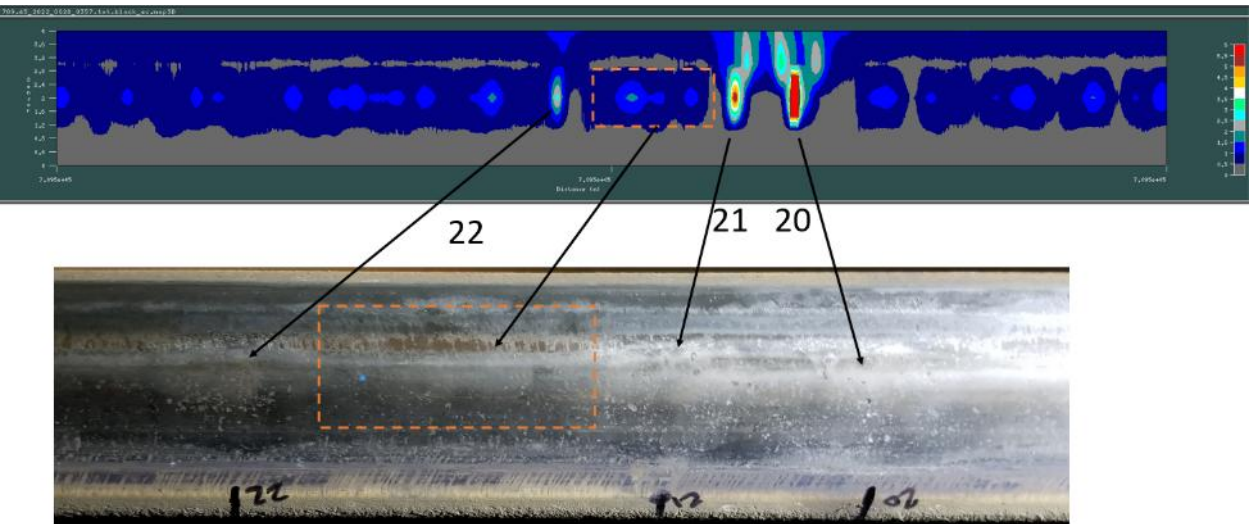
# Eddy Current

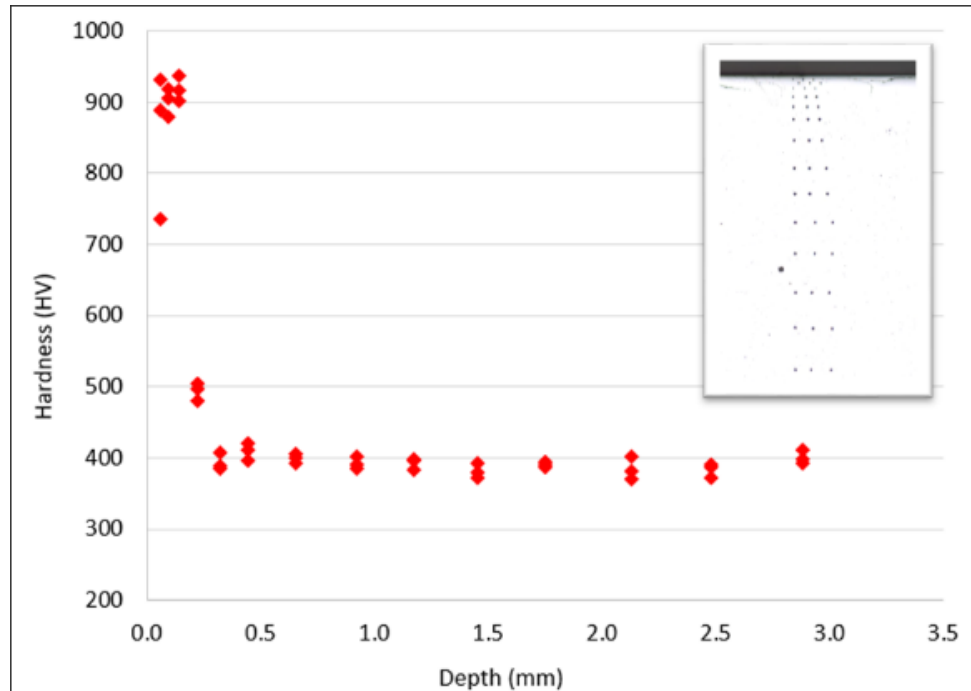
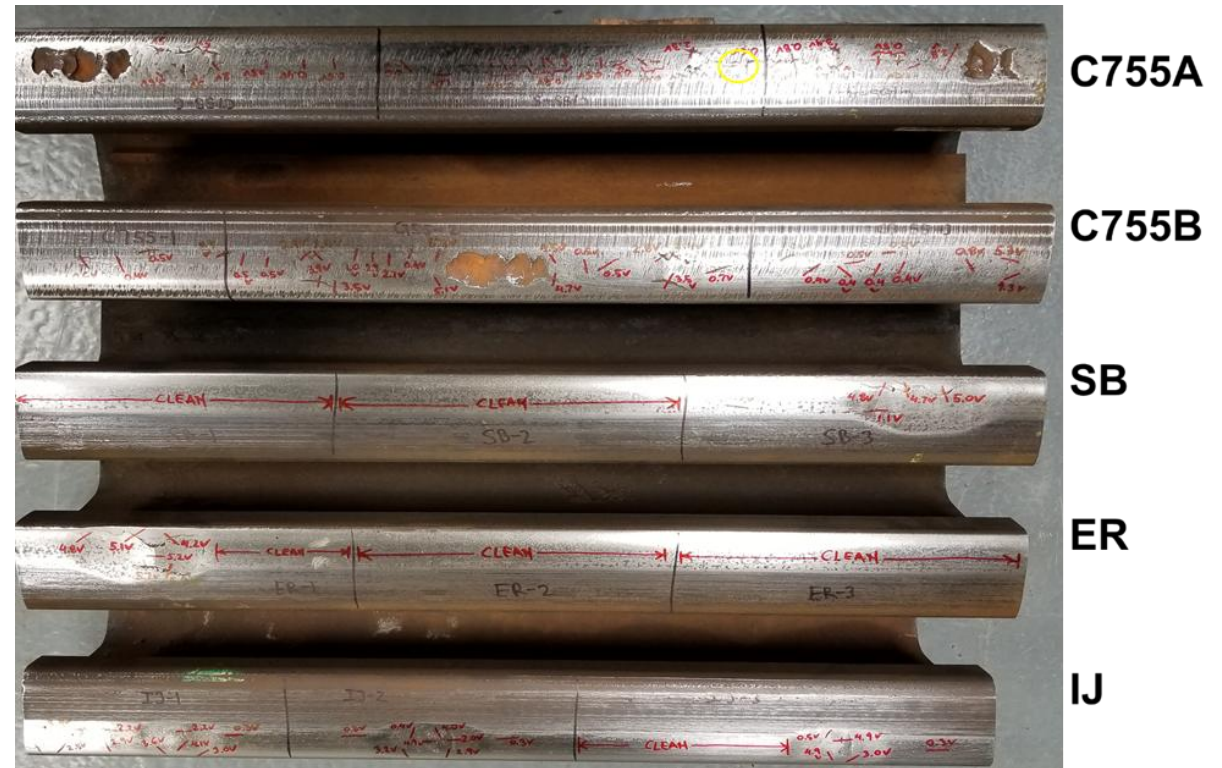
# Root Cause Analysis

- NRC/ARM report results on metallurgy, martensite, hardness, crack characteristics

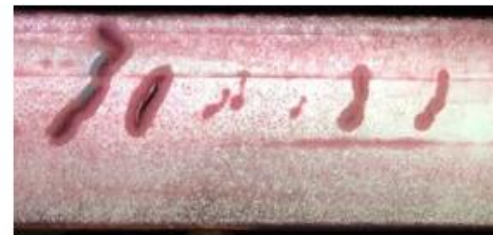
1<sup>st</sup> Pass

- Rail Milling program in one curve provide detailed analysis on metal removal, eddy current, and photos with dye penetrant
- Initial visual assessment and EC measurement did not typically match to expected level of effort

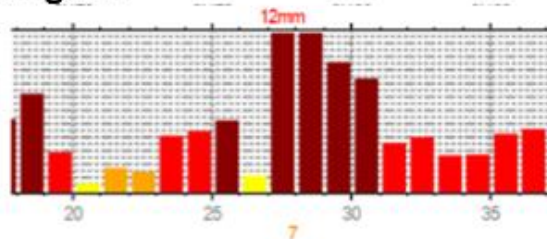
Original

EC Readings (Channel 2 of 4)
