Rail maintenance and its impact on Squat mitigation

ICRI Webinar, 30/06/2020

Dr. Richard Stock, Milling Technology Manager, LINSINGER

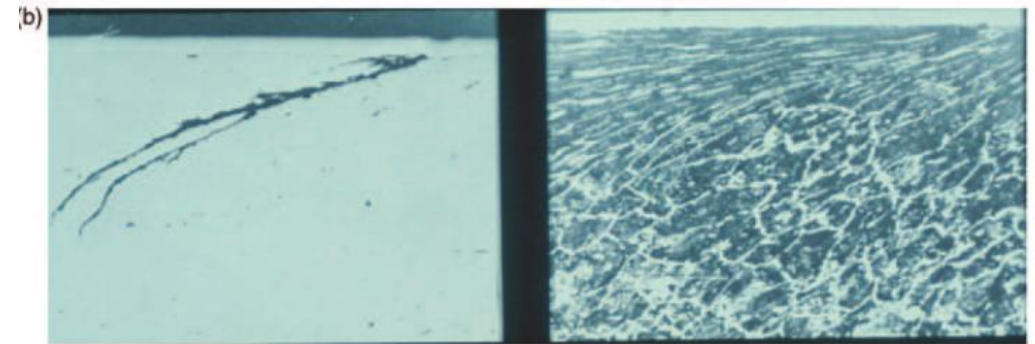
- Characteristics
 - Heavily sheared rail surface
 - Crack initiation and growth by ratcheting (RCF)
 - Initiation after a few 10s of MGT
 - Slow growth (within 100+ MGT) to full size
- Straight track and shallow curves
- Can result in rail break

Photos taken from: S.L. Grassie: Squats and squat-type defects in rails: the understanding to date. In Proceedings of the Institution of Mechanical Engineers, Part F: Journal of Rail and Rapid Transit, 2012, Volume 226, Issue 3, 235 – 242
Original: British Rail Research, CO Frederick

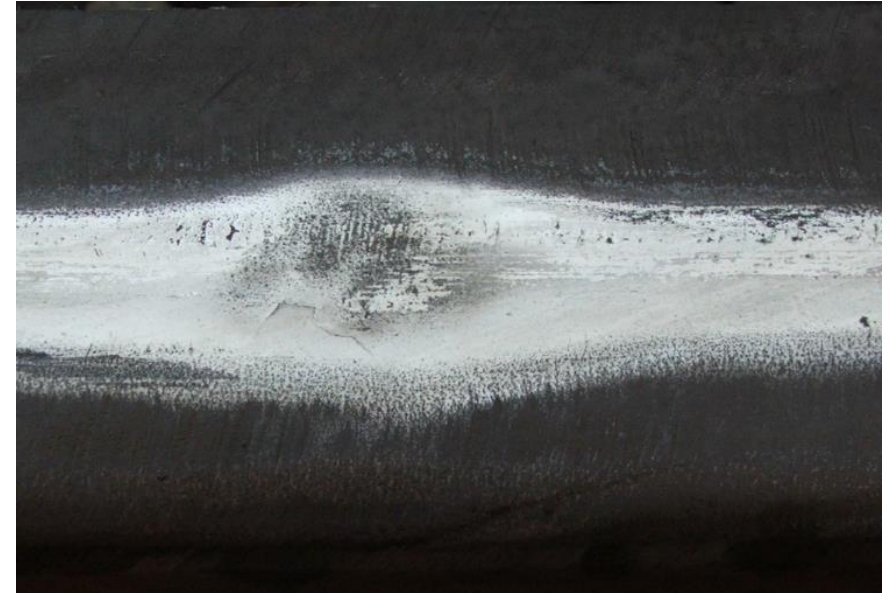
- Massed re-appearance in 90ies
- Superficial similarity to “old” Squats
- Characteristics:
 - Almost no plastic deformation
 - Formation within 10MGT or less
 - Low wear conditions
 - No directly related rail breaks reported
- Preventive rail maintenance strategies of limited mitigation success
- Also called Stud or Squat Type Defect

Photo by voestalpine

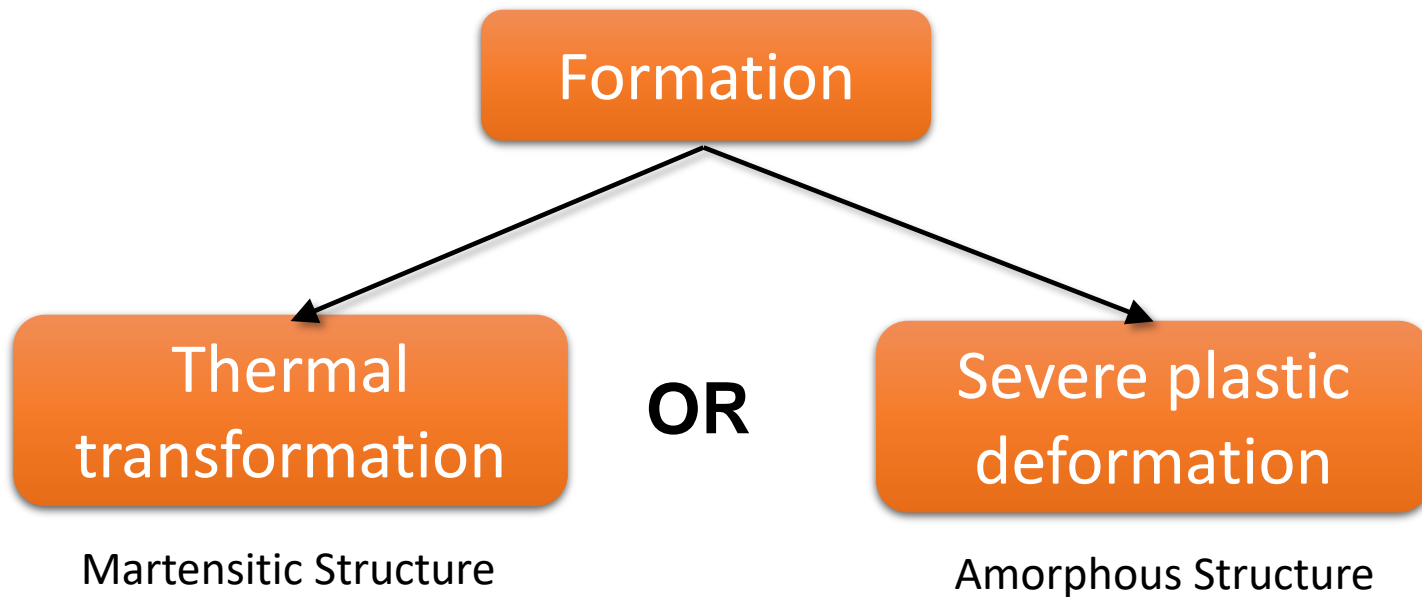
- Area that is not etched by 3% Nital Acid will appear white in light microscope
- Hard and brittle layers

Photos: Florian Wetscher, Effect of Large Shear Deformation on Rail Steels and Pure Metals, Doctoral Thesis, 2006, University of Leoben

- Origin
 - vehicle traction (accelerating and braking)
 - rail grinding activities
- WEL are widely found in track – initiation point for Squats?

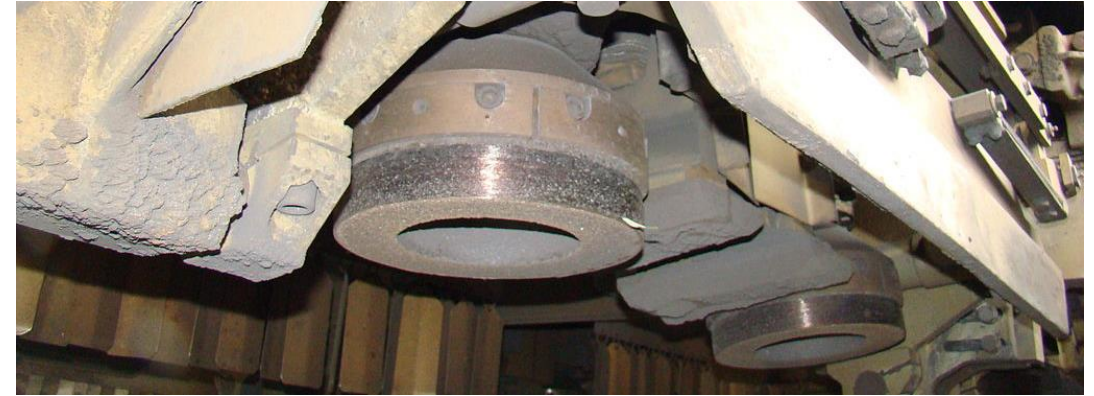
- Abrasive process with rotating grinding stones
- Flexible profile adjustment through stone alignment
- Variable machine size (4-120 stones)
- Process speed up to 15 km/h
- Capable of treating mainline track and switches (dedicated machines)

Photo by Glucke, Wikipedia, CC BY-SA 3.0

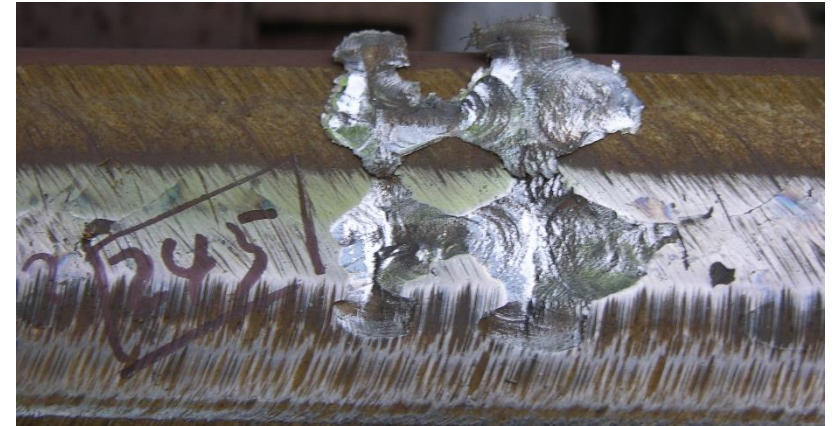
- Despite preventive maintenance strategies squat defects still persistent
- Removal of cap and extended spalling
- Repeatedly high temperature input above 723°C
- Formation of WEL layers
- Creating of characteristic surface roughness and morphology

Photo: M. Steenbergen. Rolling contact fatigue in relation to rail grinding, Wear 356-357 (2016) 110-121

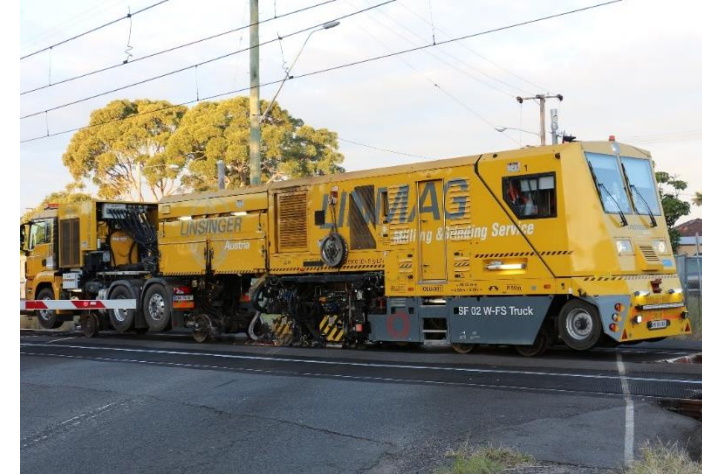
- Milling of work pieces since 19th century
- Non - abrasive rotary cutting process
 - Chips cut out of surface
 - High quality surface finish
 - High precision geometry
- High precision CNC machine upside-down on a locomotive
- Mainline and switch treatment with same machine

Rail Milling Machine SF02, 2016, LINMAG

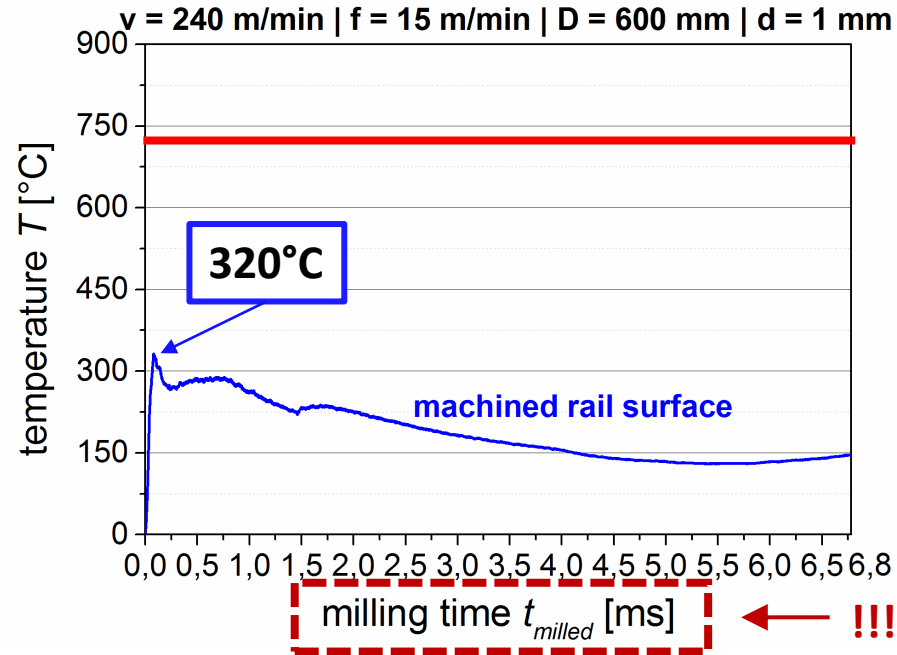
- Simulation of the milling process (2D)
- Process heat flows into milling insert and chip
- Rail temperature stays well below austenitizing temperature during and after milling
 - Temperature threshold for material transformations

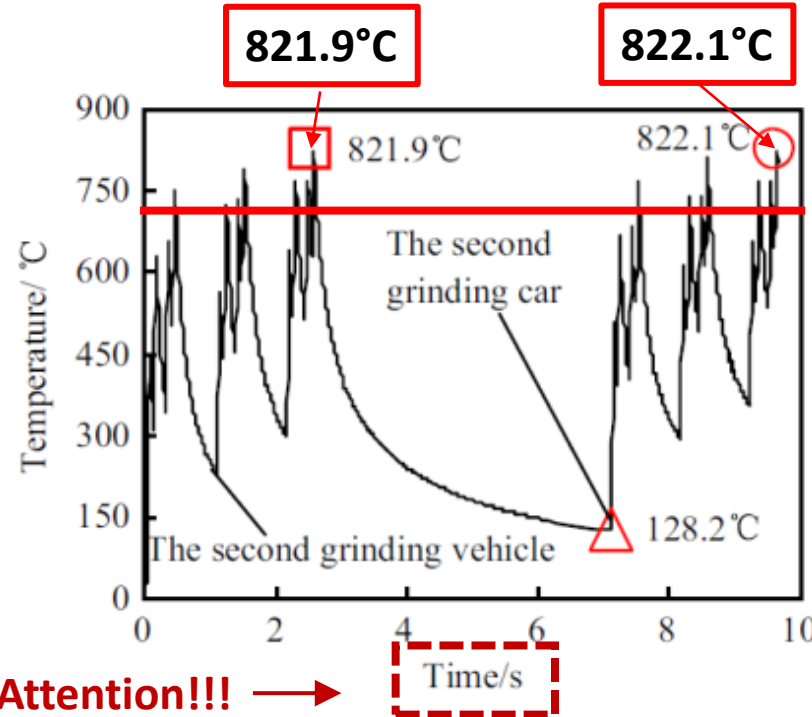
- Heat of the grinding process:
 - $T > 723^\circ\text{C}$ – austenite transformation
 - Significantly higher heat input over longer time for grinding
 - Grinding will lead to the formation of WEL

Z.Y. Zhang et. al., Thermal model and temperature field in rail grinding process based on a moving heat source, Applied Thermal Engineering 106 (2016) 855-864.

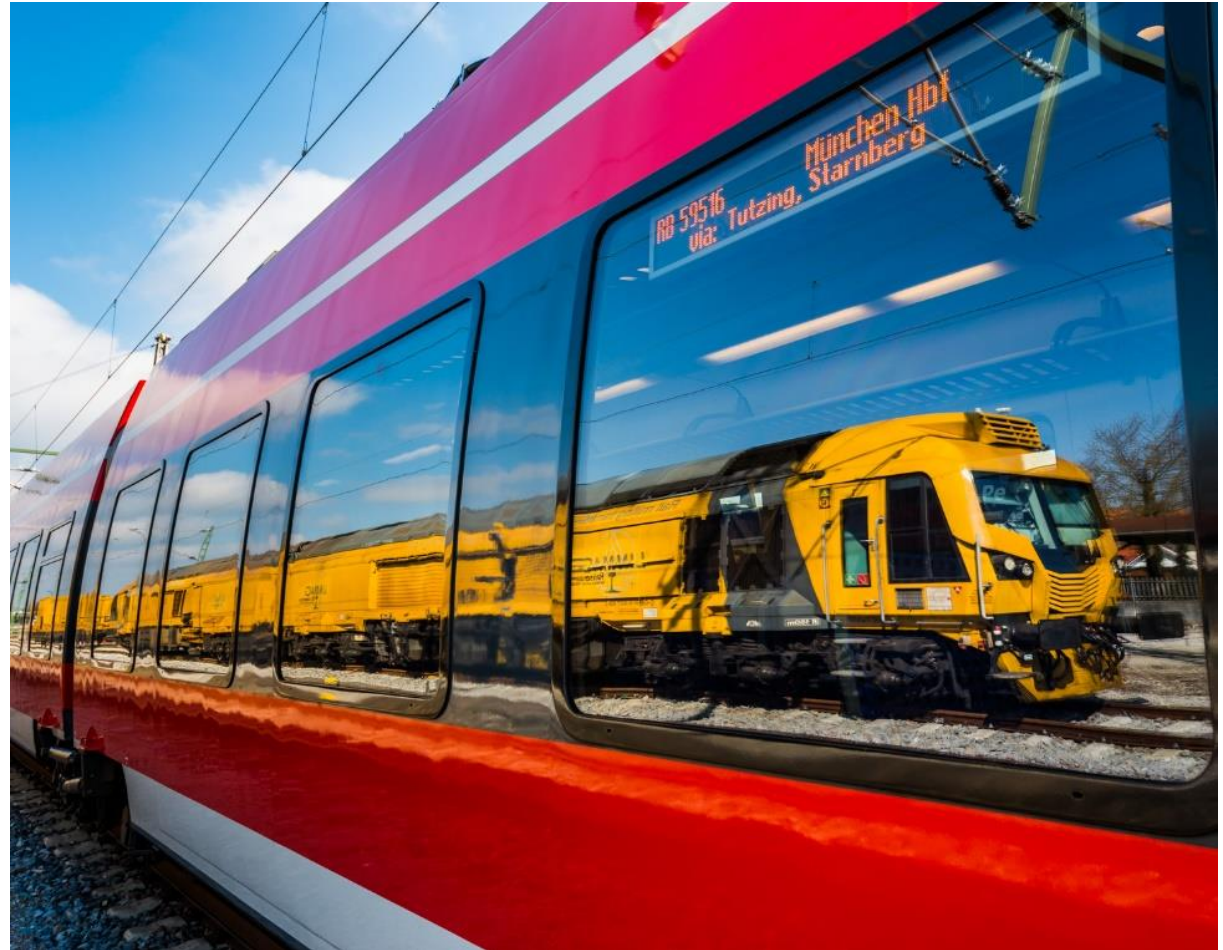
- DB specification: Milling for defects deep $> 0.8\text{mm}$
- Severe Squat defects
 - Measured depths up to 7mm
- High performance milling machine MG 31
- Regenerative Maintenance:
 - Complete damage removal
 - Max. 2 passes
